## Asbestos Survey Report

Client **Gloucestershire County Council**  
Site Ref **Boiler Room**  
Address **Stroud Library  
Lansdown  
Stroud  
GL5 1BB**  
Report Date **27 April 2009**  
Report Issue Date **06 May 2009**  
Report Reference **CWE/MM/GCC/SLBR/270409**  
Survey Type **3**

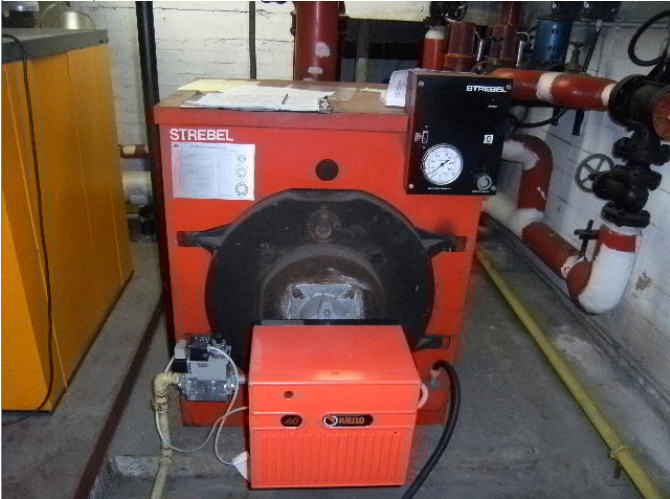
| Item | Level | Location / Room number | Survey Type | Sample Reference | Quantity | | | |
|---|---|---|---|---|---|---|---|---|
| | | | Presume asbestos containing materials within boiler | | Product Type | Extent of Damage | Surface Treatment | Asbestos Type |
| | | | | | 3 | 3 | 3 | 3 |

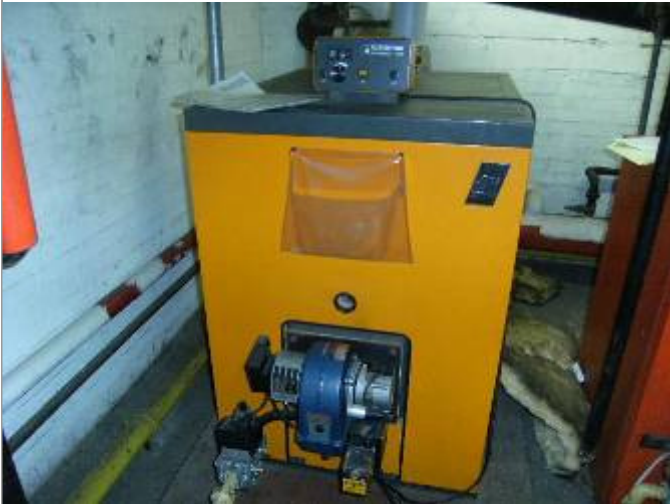
| | | | No suspect materials observed | | Product Type | Extent of Damage | Surface Treatment | Asbestos Type |

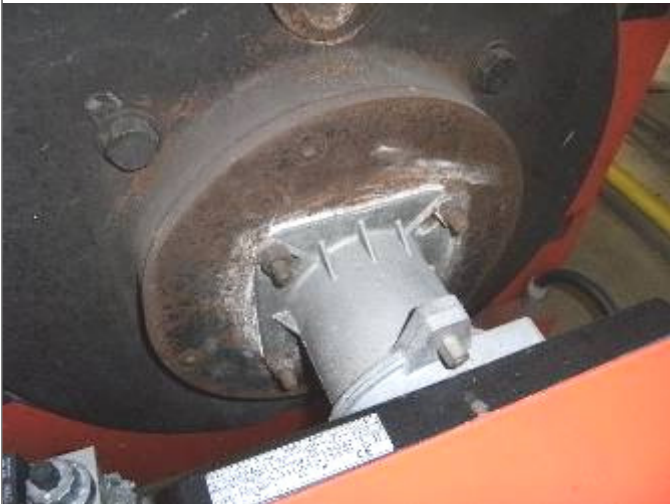
| Item | Level | Location / Room number | Survey Type | Sample Reference | Quantity | | | |
|---|---|---|---|---|---|---|---|---|
| 3 | Ground | Boiler House | 3 | SLBR/01 | - | | | |

| Item | Level | Location / Room number | Survey Type | Sample Reference | Quantity | | | |
|---|---|---|---|---|---|---|---|---|
| | | | Gaskets to front and rear of boiler flanges | | Product Type | Extent of Damage | Surface Treatment | Asbestos Type |

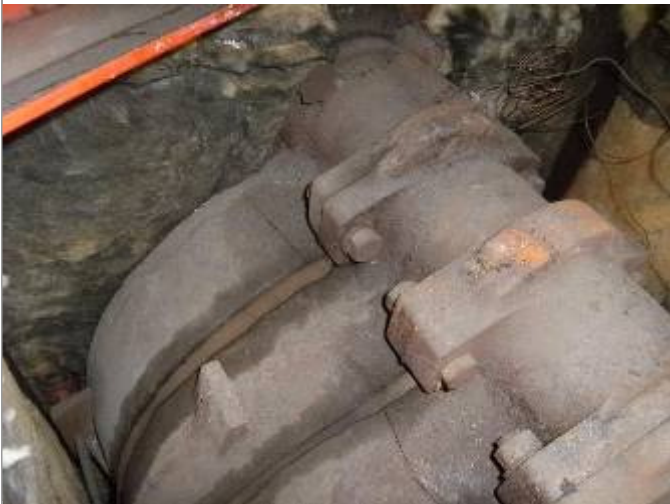
| Item | Level | Location / Room number | Survey Type | Sample Reference | Quantity | | | |
|---|---|---|---|---|---|---|---|---|
| | | | Gaskets to bulkhead within boiler | | Product Type | Extent of Damage | Surface Treatment | Asbestos Type |
| | | | Restricted access to Boiler 'A'<br>Chrome flue pipe<br>Access would risk unnecessary or irreparable damage | | Score - Material Risk | | | |

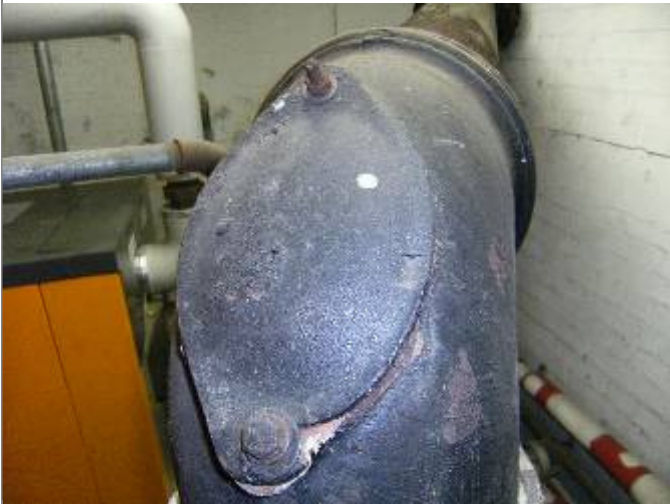
| Item | Level | Location / Room number | Survey Type | Sample Reference | Quantity | | | |
|---|---|---|---|---|---|---|---|---|
| | | | Asbestos compressed gasket to viewing hatch to flue (Black) at rear of boiler | | Product Type | Extent of Damage | Surface Treatment | Asbestos Type |
| | | | | | 2 | 1 | 1 | 1 |

| Item | Level | Location / Room number | Survey Type | Sample Reference | Quantity | | | |
|---|---|---|---|---|---|---|---|---|
| | | | Remove under asbestos controlled conditions | | High | | | |

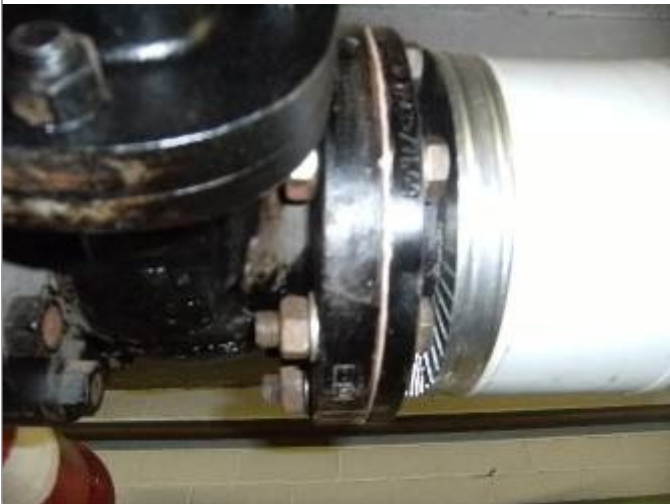
| Item | Level | Location / Room number | Survey Type | Sample Reference | Quantity | | | |
|---|---|---|---|---|---|---|---|---|
| 6 | Ground | Boiler House | 3 | SLBR/04 | Non Quantifiable | | | |

| Item | Level | Location / Room number | Survey Type | Sample Reference | Quantity | | | |
|---|---|---|---|---|---|---|---|---|
| | | | Asbestos compressed gaskets to flanges throughout | | Product Type | Extent of Damage | Surface Treatment | Asbestos Type |
| | | | | | 2 | 1 | 1 | 1 |

| Item | Level | Location / Room number | Survey Type | Sample Reference | Quantity | | | |
|---|---|---|---|---|---|---|---|---|
| | | | Remove under asbestos controlled conditions | | High | | | |

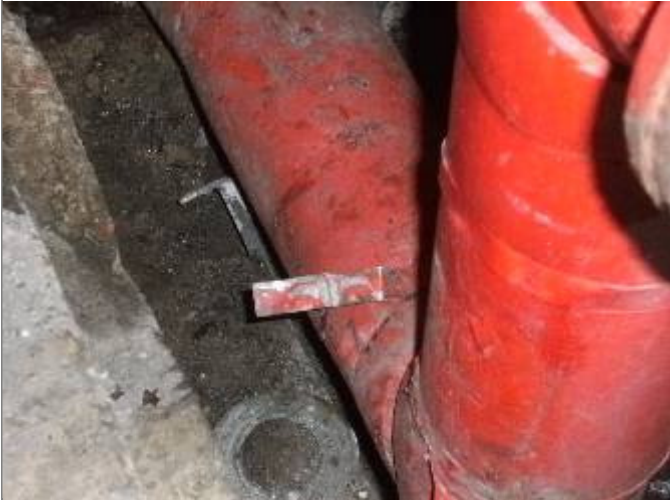
| Item | Level | Location / Room number | Survey Type | Sample Reference | Quantity | | | |
|---|---|---|---|---|---|---|---|---|
| 7 | Ground | Boiler House | 3 | Presume | <1m <sup>2</sup> | | | |

| Item | Level | Location / Room number | Survey Type | Sample Reference | Quantity | | | |
|---|---|---|---|---|---|---|---|---|
| | | | Presume asbestos compressed gasket to floor below pipework in wall void | | Product Type | Extent of Damage | Surface Treatment | Asbestos Type |
| | | | Additional Information | | 2 | 1 | 1 | 1 |

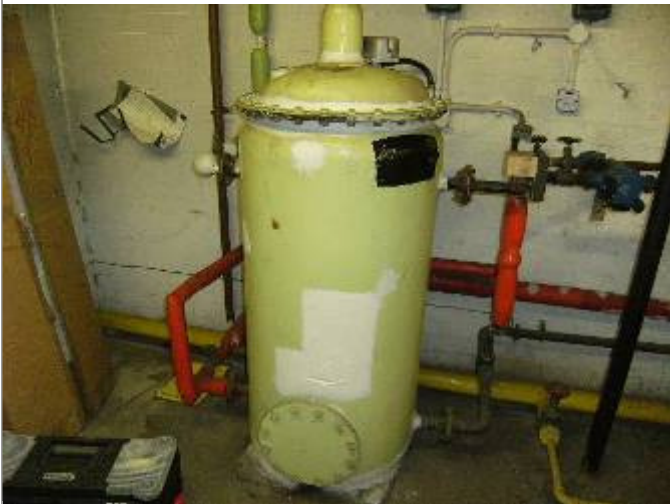
| Item | Level | Location / Room number | Survey Type | Sample Reference | Quantity | | | |
|---|---|---|---|---|---|---|---|---|
| 8 | Ground | Boiler House | 3 | SLBR/04A | 2m <sup>2</sup> | | | |

| Item | Level | Location / Room number | Survey Type | Sample Reference | Quantity | | | |
|---|---|---|---|---|---|---|---|---|
| | | | Asbestos lagging insulation to calorifier (Green) in boiler room | | Product Type | Extent of Damage | Surface Treatment | Asbestos Type |
| | | | Additional Information | | 3 | 0 | 2 | 2 |

| Item | Level | Location / Room number | Survey Type | Sample Reference | Quantity | | | |
|---|---|---|---|---|---|---|---|---|
| | | | Remove under asbestos controlled conditions | | High | | | |

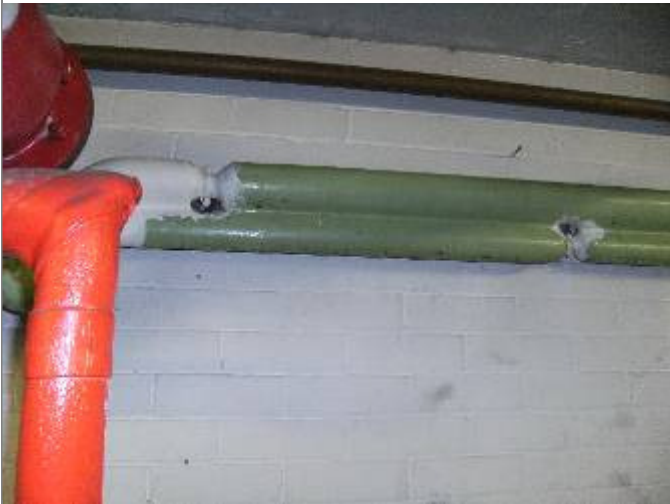
| Item | Level | Location / Room number | Survey Type | Sample Reference | Quantity | | | |
|---|---|---|---|---|---|---|---|---|
| 9 | Ground | Boiler House | 3 | As SLBR/04A | 20 Lm | | | |

| Item | Level | Location / Room number | Survey Type | Sample Reference | Quantity | | | |
|---|---|---|---|---|---|---|---|---|
| | | | Asbestos lagging insulation to pipework (Green) | | Product Type | Extent of Damage | Surface Treatment | Asbestos Type |
| | | | Additional Information | | 3 | 1 | 2 | 2 |

| Item | Level | Location / Room number | Survey Type | Sample Reference | Quantity | | | |
|---|---|---|---|---|---|---|---|---|
| Remove under asbestos controlled conditions | | High | | | | | | |

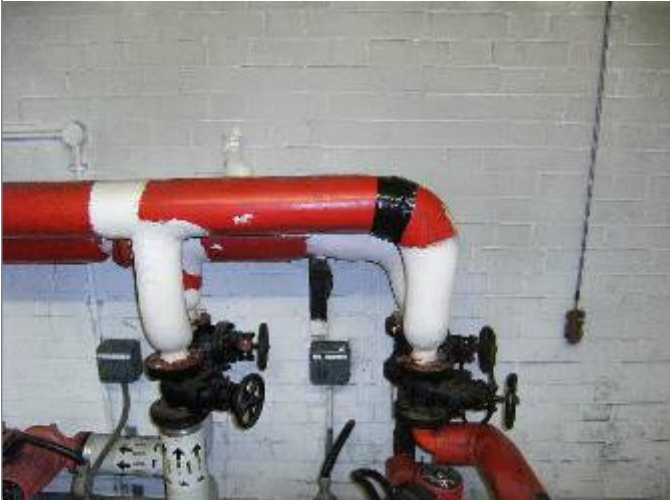
| Item | Level | Location / Room number | Survey Type | Sample Reference | Quantity | | | |
|---|---|---|---|---|---|---|---|---|
| 11 | Ground | Boiler Room | 3 | SLBR/05 | 30 Lm | | | |

| Item | Level | Location / Room number | Survey Type | Sample Reference | Quantity | | | |
|---|---|---|---|---|---|---|---|---|
| | | | Asbestos lagging insulation to pipework (Red) | | Product Type | Extent of Damage | Surface Treatment | Asbestos Type |
| | | | Additional Information | | 3 | 1 | 2 | 2 |

| Item | Level | Location / Room number | Survey Type | Sample Reference | Quantity | | | |
|---|---|---|---|---|---|---|---|---|
| Remove under asbestos controlled conditions | | High | | | | | | |

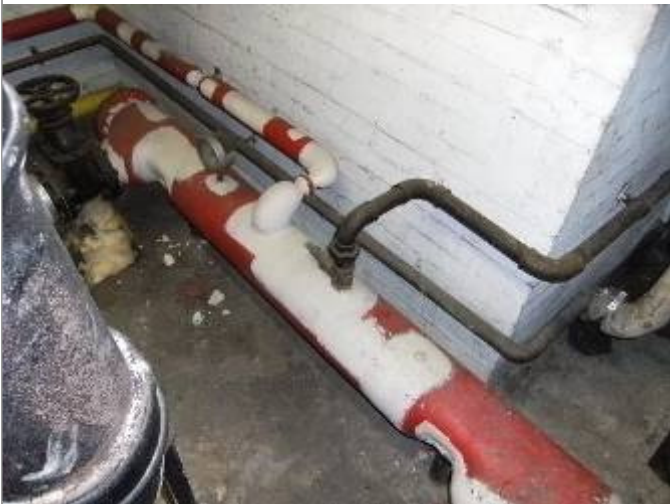
| Item | Level | Location / Room number | Survey Type | Sample Reference | Quantity | | | |
|---|---|---|---|---|---|---|---|---|
| 12 | Ground | Boiler Room | 3 | SLBR/06 | 30 Lm | | | |

| Item | Level | Location / Room number | Survey Type | Sample Reference | Quantity | | | |
|---|---|---|---|---|---|---|---|---|
| | | | Asbestos lagging insulation to pipework (Red) | | Product Type | Extent of Damage | Surface Treatment | Asbestos Type |
| | | | Additional Information | | 3 | 1 | 2 | 2 |

| Item | Level | Location / Room number | Survey Type | Sample Reference | Quantity | | | |
|---|---|---|---|---|---|---|---|---|
| Remove under asbestos controlled conditions | | High | | | | | | |

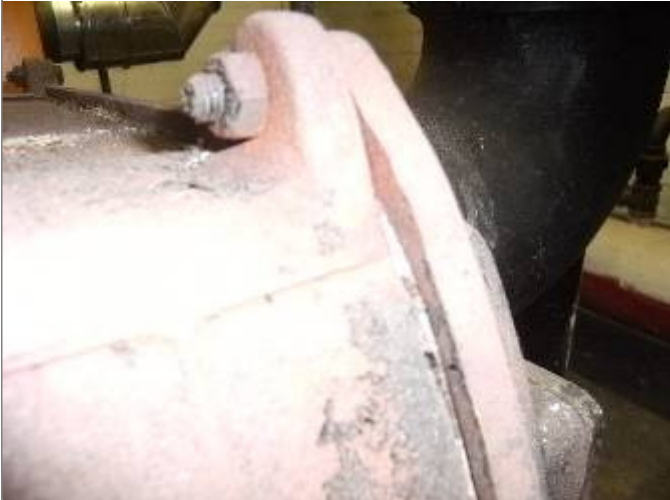
| Item | Level | Location / Room number | Survey Type | Sample Reference | Quantity | | | |
|---|---|---|---|---|---|---|---|---|
| | | | Gaskets to rear of Boiler 'B' to large rusted block | | Product Type | Extent of Damage | Surface Treatment | Asbestos Type |

| AC&MS Sample No. | CLIENT Sample No. | Sample Location / Sample Type | Fibre Type Detected |
|---|---|---|---|
| 08 | SLBR07 | Gasket To Rusted Block | NADIS |

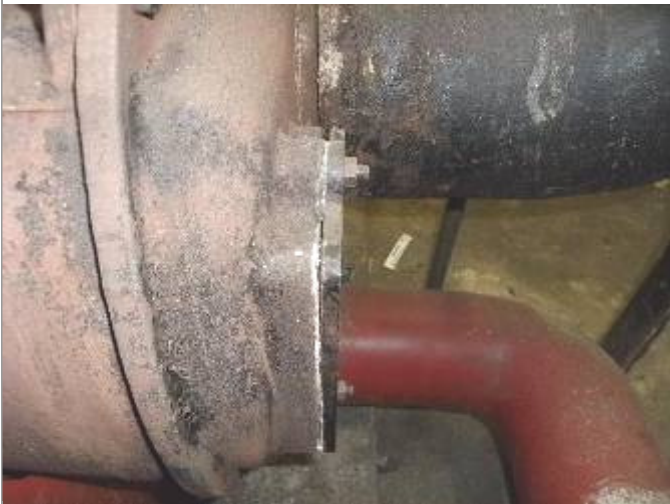
| Item | Level | Location / Room number | Survey Type | Sample Reference | Quantity | | | |
|---|---|---|---|---|---|---|---|---|
| 14 | Ground | Boiler Room | 3 | SLBR/08 | <1m <sup>2</sup> | | | |

| Item | Level | Location / Room number | Survey Type | Sample Reference | Quantity | | | |
|---|---|---|---|---|---|---|---|---|
| | | | Asbestos woven rope seals (3) to hatches at rear of Boiler 'B' | | Product Type | Extent of Damage | Surface Treatment | Asbestos Type |
| | | | Additional Information | | 2 | 2 | 3 | 1 |
| | | | Situated to front of rusted block and below | | Score - Material Risk | | | |

| Item | Level | Location / Room number | Survey Type | Sample Reference | Quantity | | | |
|---|---|---|---|---|---|---|---|---|
| | | | Remove under asbestos controlled conditions | | High | | | |

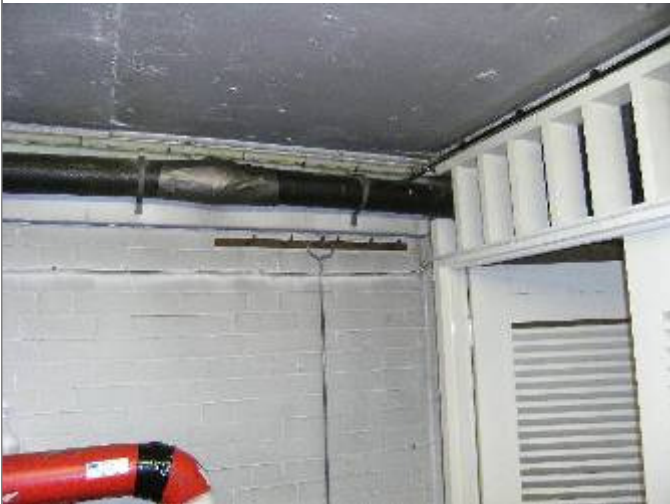
| Item | Level | Location / Room number | Survey Type | Sample Reference | Quantity | | | |
|---|---|---|---|---|---|---|---|---|
| 15 | Ground | Boiler Room | 3 | SLBR/09 | 8 Lm | | | |

| Item | Level | Location / Room number | Survey Type | Sample Reference | Quantity | | | |
|---|---|---|---|---|---|---|---|---|
| | | | Asbestos bonded bitumen paint to pipework (Black) | | Product Type | Extent of Damage | Surface Treatment | Asbestos Type |
| | | | Additional Information | | 1 | 0 | 0 | 1 |

| Item | Level | Location / Room number | Survey Type | Sample Reference | Quantity | | | |
|---|---|---|---|---|---|---|---|---|
| Remove under asbestos controlled conditions | | High | | | | | | |

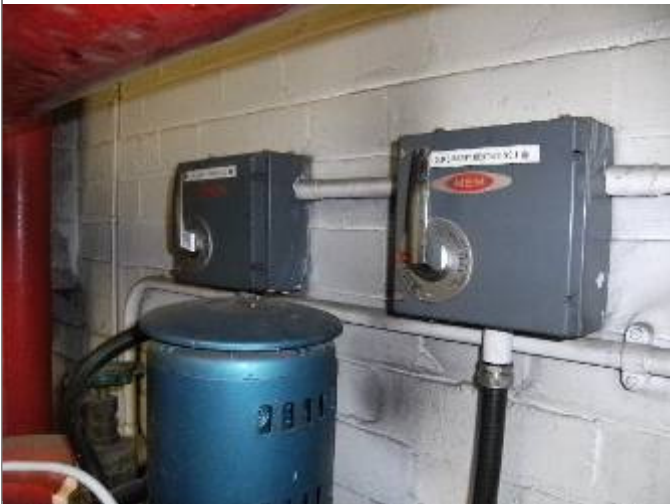
| Item | Level | Location / Room number | Survey Type | Sample Reference | Quantity | | | |
|---|---|---|---|---|---|---|---|---|
| | | | Presume asbestos containing material within all wall mounted switch / fuse boxes visually similar to photograph | | Product Type | Extent of Damage | Surface Treatment | Asbestos Type |
| | | | Additional Information | | 3 | 3 | 3 | 3 |
