ASBESTOS SURVEY REPORT

Client : **Gloucestershire County Council**
Site Ref : **Specific Areas**
Site Address : **Stroud Library
Lansdown
Stroud
GL5 1BB**
Survey Date : **17th December 2021**
Report Issue Date : **20th December 2021**
Report Reference : **J030802**
Survey Type : **Refurbishment Survey**

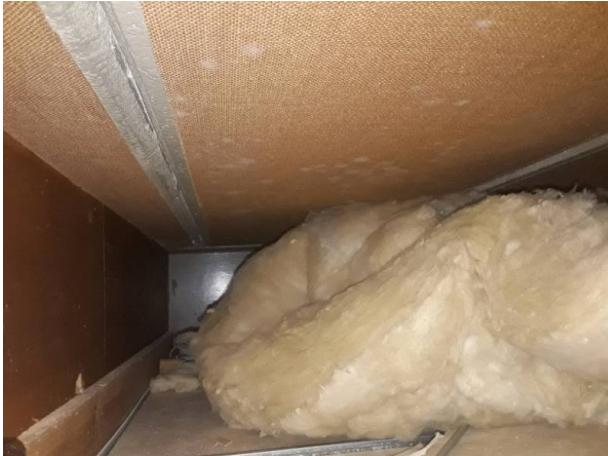
Item	Level	Building Name / Location / Room Number	Survey Type	Sample Reference	Quantity		
1	First Floor	Office Ceiling Void	Refurbishment	Visual Inspection	-

Material Description / Location No suspect materials observed within surveyed area			Material Risk	
			Additional Information MMMF suspended ceiling tiles below concrete soffit. Hessian lining to concrete soffit. MMMF wrapped pipework within timber boxing. MMMF insulation on suspended ceiling tiles.			Score - Material Risk	
			Recommendations			Accessibility	
			-			Review Period	
			Product Type			Licensed / Non-Licensed	
			-			-

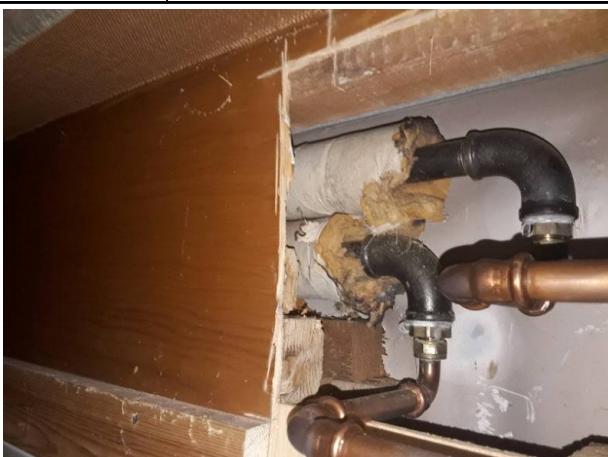
Item	Level	Building Name / Location / Room Number	Survey Type	Sample Reference	Quantity		
2	First Floor	Drop-in Ceiling Void	Refurbishment	Visual Inspection	-

Material Description / Location No suspect materials observed within surveyed area			Material Risk	
			Additional Information MMMF suspended ceiling tiles below concrete soffit. Hessian lining to concrete soffit. MMMF wrapped pipework within timber boxing. MMMF insulation on suspended ceiling tiles.			Score - Material Risk	
			Recommendations			Accessibility	
			-			Review Period	
			Product Type			Licensed / Non-Licensed	
			-			-

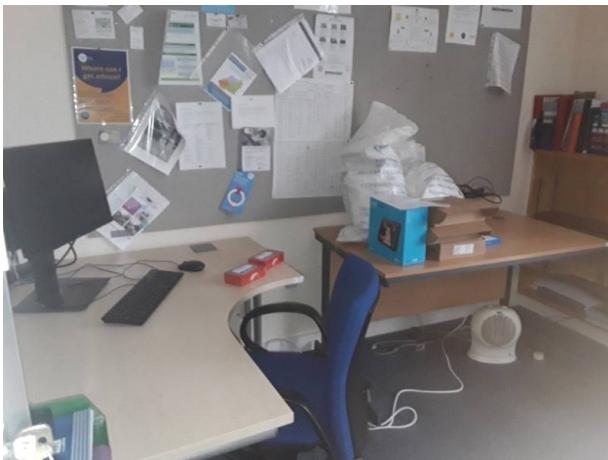
Item	Level	Building Name / Location / Room Number	Survey Type	Sample Reference	Quantity				
3	First Floor	Office	Refurbishment	Visual Inspection	-

Material Description / Location No suspect materials observed within surveyed area			Material Risk			
			Additional Information UPVC window. Non asbestos timber door. Carpet tiles laid over fixed timber and screed floor. MMMF wrapped pipework within timber boxing.			Score - Material Risk			
			Recommendations			Accessibility			
						Review Period			
Inspection Level	Analysis Result		Product Type		Licensed / Non-Licensed				
-	-		-		-

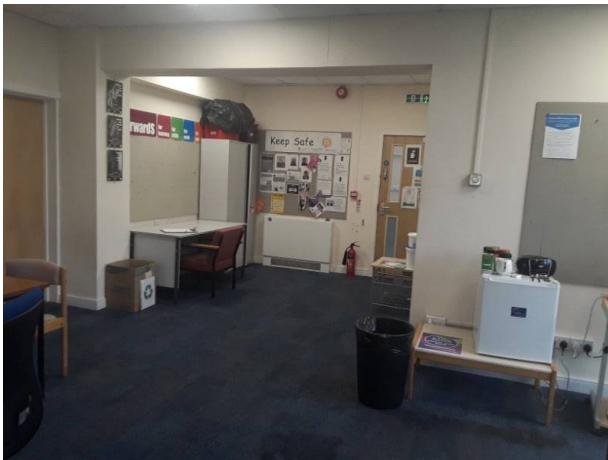
Item	Level	Building Name / Location / Room Number	Survey Type	Sample Reference	Quantity				
4	First Floor	Drop-in	Refurbishment	Visual Inspection	-

Material Description / Location No suspect materials observed within surveyed area			Material Risk			
			Additional Information UPVC window. Non asbestos timber doors. Carpet tiles laid over fixed timber and screed floor. MMMF wrapped pipework within timber boxing. Plastic soil pipe within timber boxing.			Score - Material Risk			
			Recommendations			Accessibility			
						Review Period			
Inspection Level	Analysis Result		Product Type		Licensed / Non-Licensed				
-	-		-		-

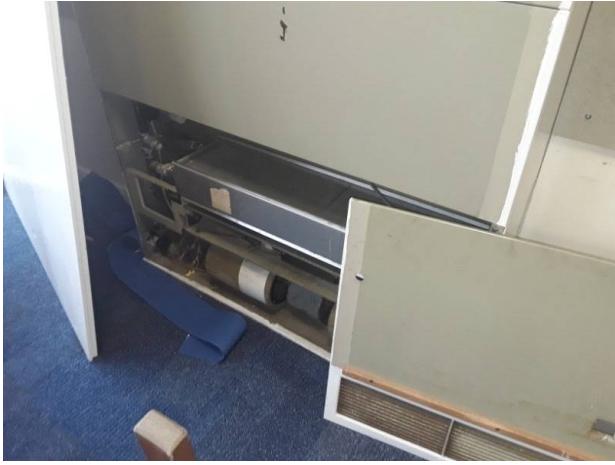
Item	Level	Building Name / Location / Room Number	Survey Type	Sample Reference	Quantity					
5	First Floor	Drop-in Heater	Refurbishment	Visual Inspection	-

Material Description / Location No suspect materials observed within surveyed area		Material Risk					
					Product Type	Surface Treatment	Asbestos Type			
			Additional Information Unlagged pipework within heater. Timber cover panel. Unlagged pipework within timber boxing.		Score - Material Risk - -					
			Recommendations -		Accessibility -					
					Review Period -					
Inspection Level		Analysis Result	Product Type	Licensed / Non-Licensed						
-		-	-	-
