REPORT ON
CONDITION OF RAAC CONCRETE
AT
STROUD LIBRARY, LANSDOWN, STROUD

DATE: 15th March 2024

CONTRACT NO: 13827

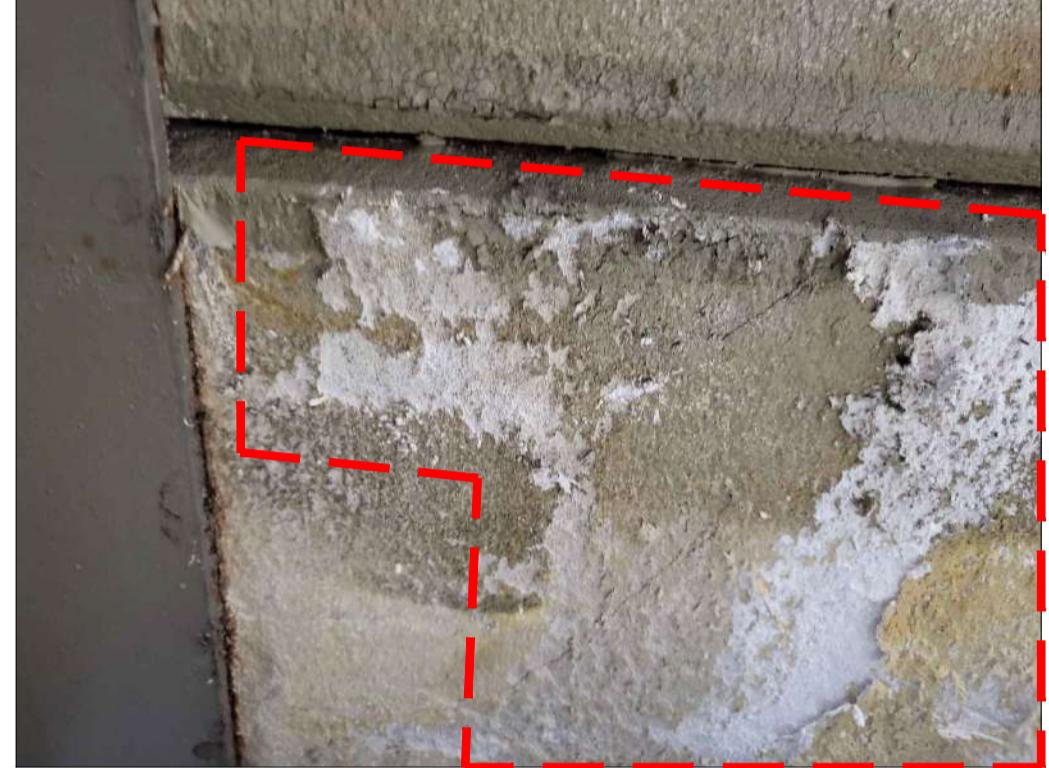
PHOTO 1 - PLANK No. 1

CRACKS & DELAMINATION/EFFLORESCENCE AT END 2

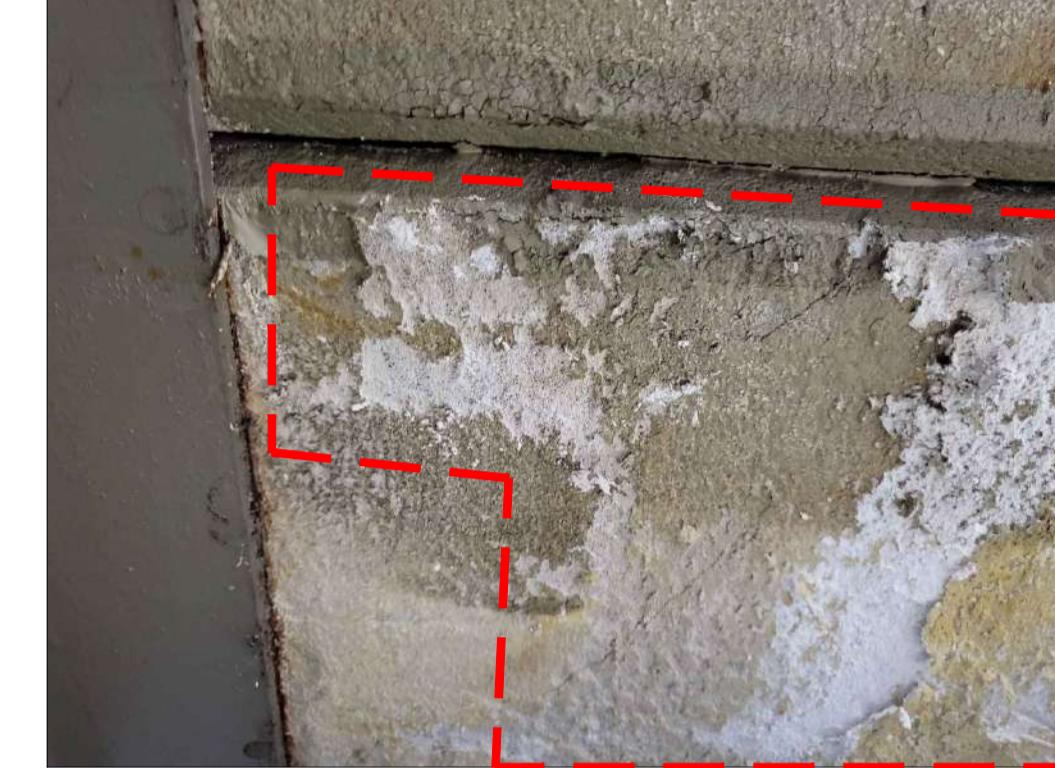
PHOTO 2 - PLANK No. 1

DELAMINATION/EFFLORESCENCE AT ENDS 1 & 2

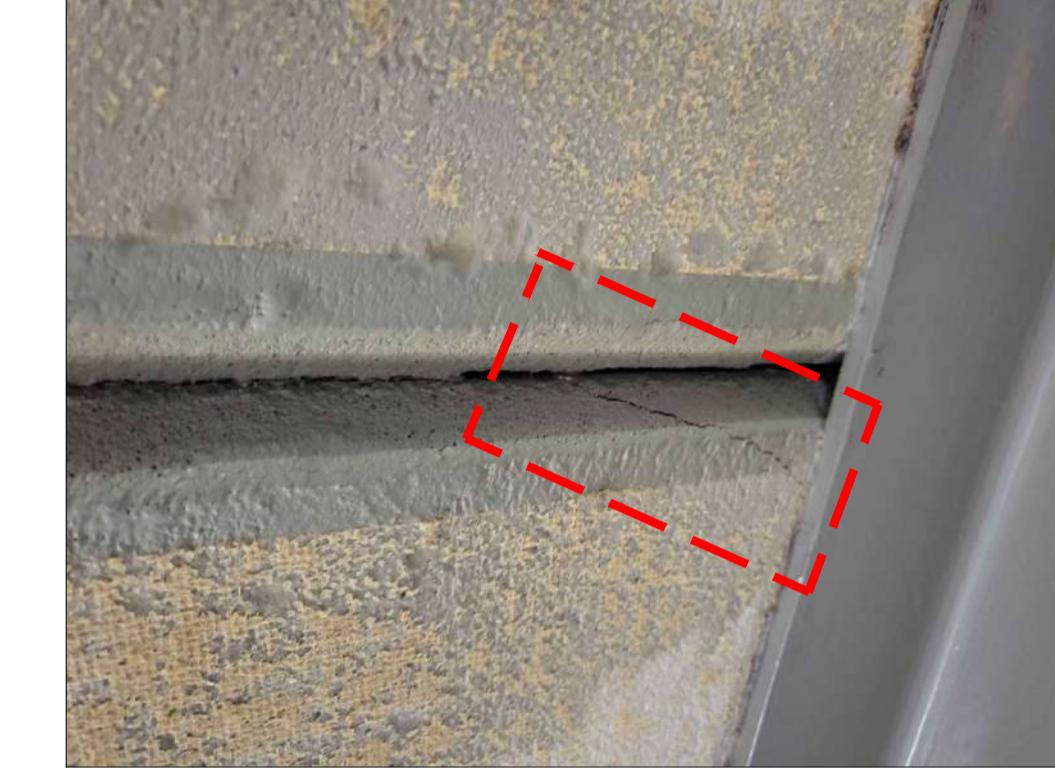
PHOTO 3 - PLANK No. 15

CRACK AT END 2

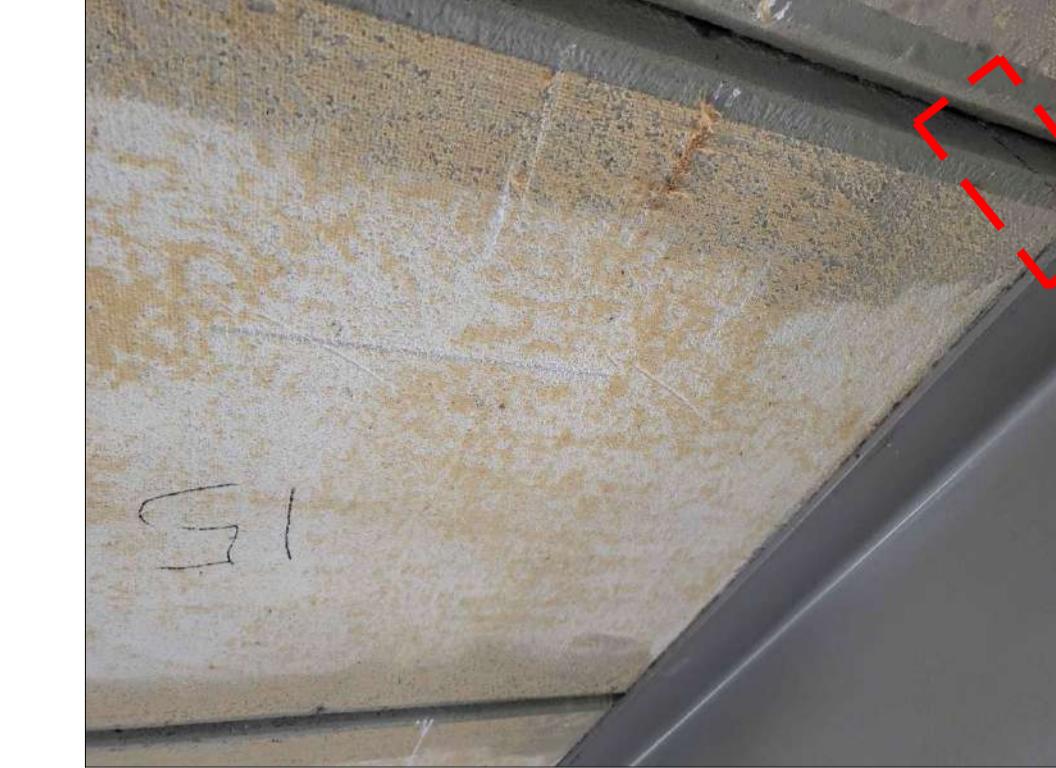
PHOTO 4 - PLANK No. 15

CRACK AT END 2

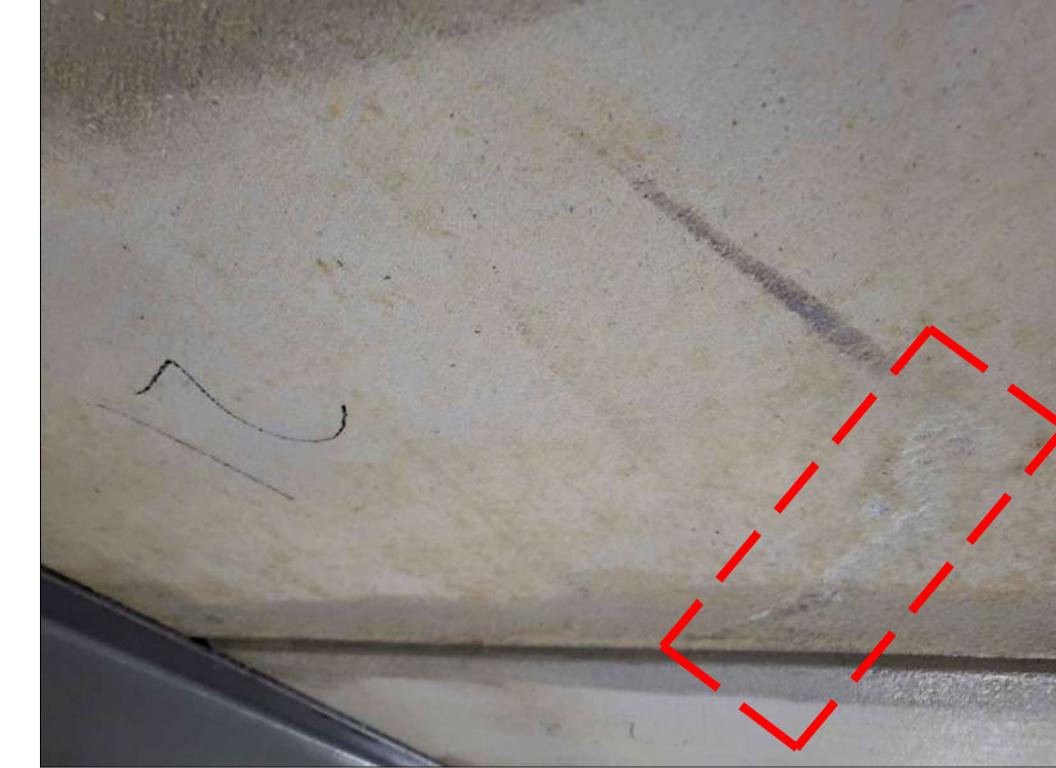
PHOTO 5 - PLANK No. 21

SCARRING AT END 1

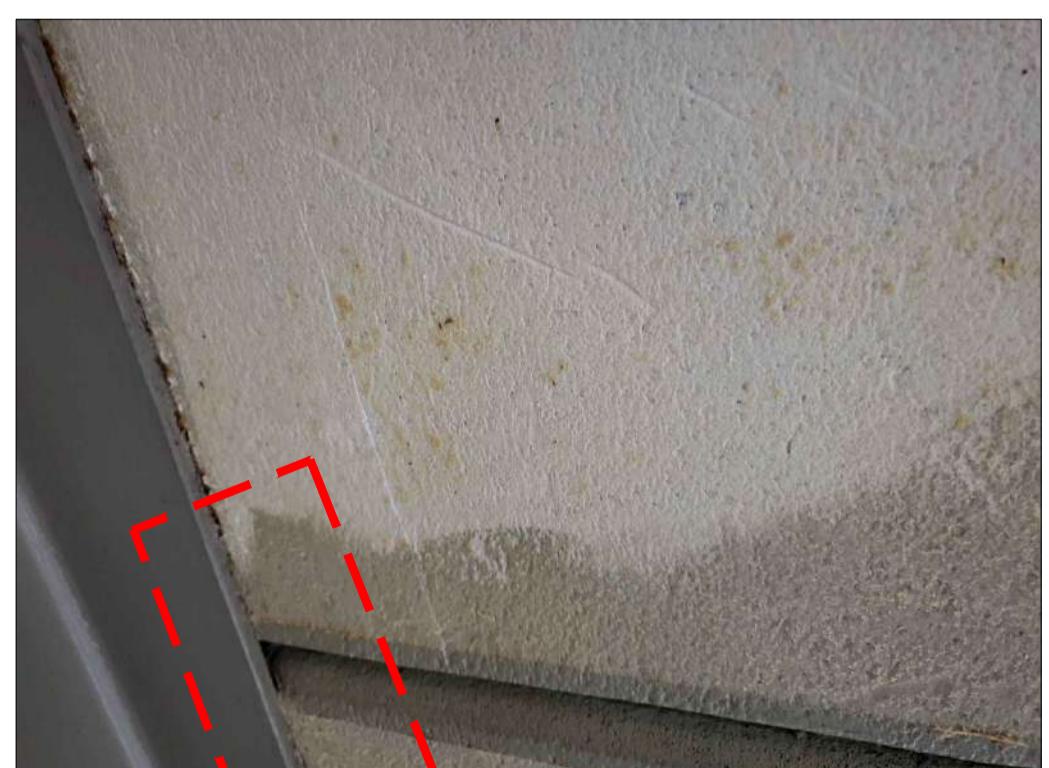
PHOTO 11 - PLANK No. 32

CRACK AT END 2

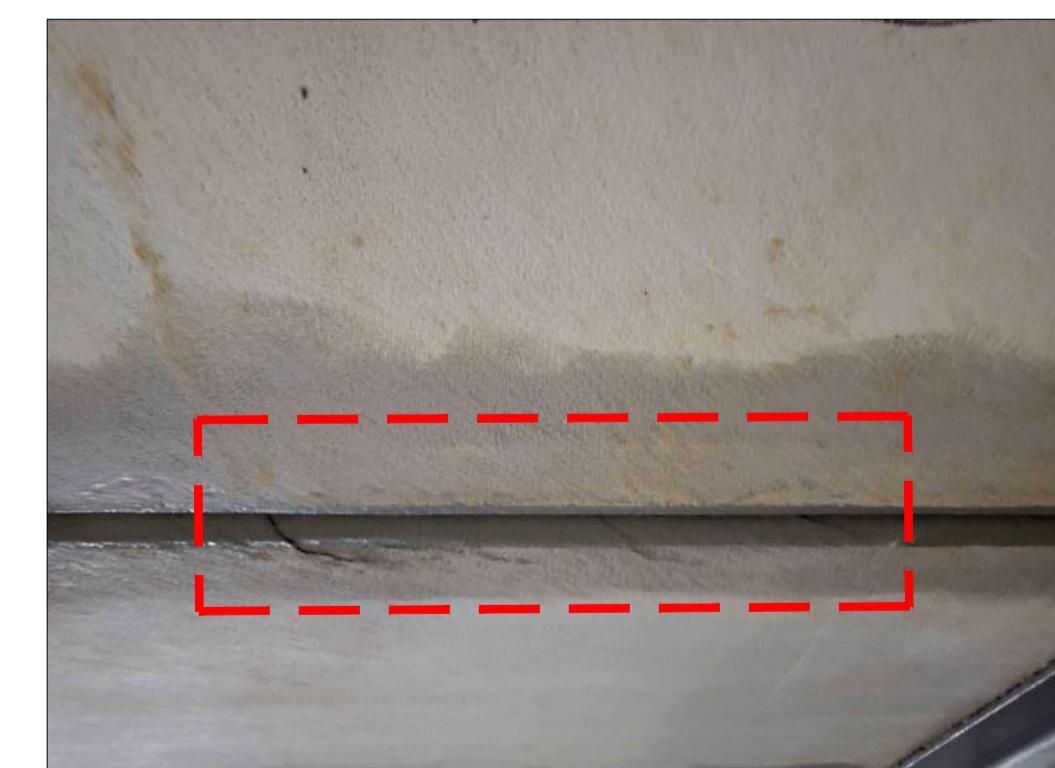
PHOTO 12 - PLANK No. 22

CRACKS AT END 2

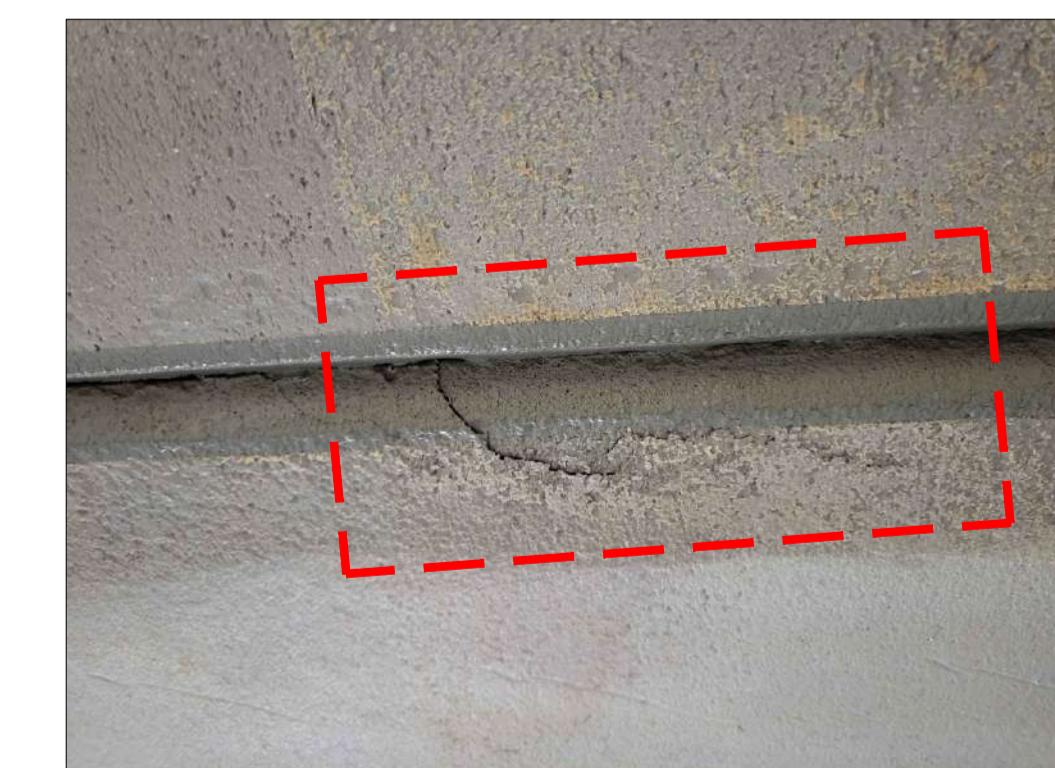
PHOTO 13 - PLANK No. 22

CRACKS AT END 2

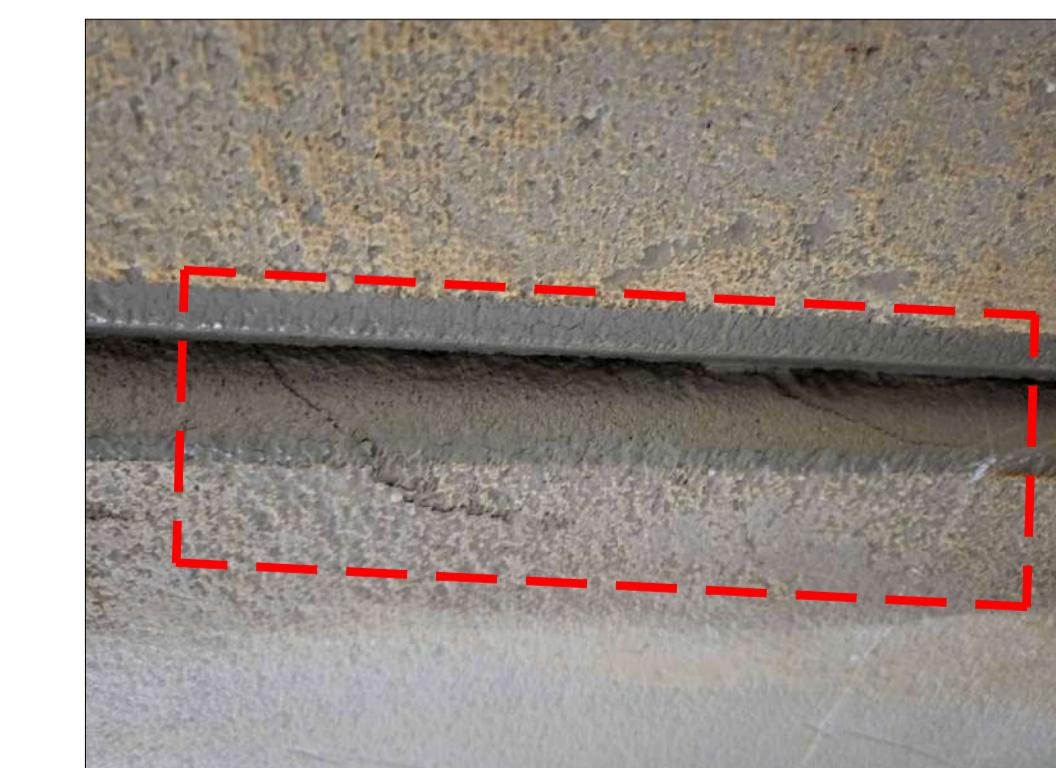
PHOTO 14 - PLANK No. 22

CRACKS AT END 2

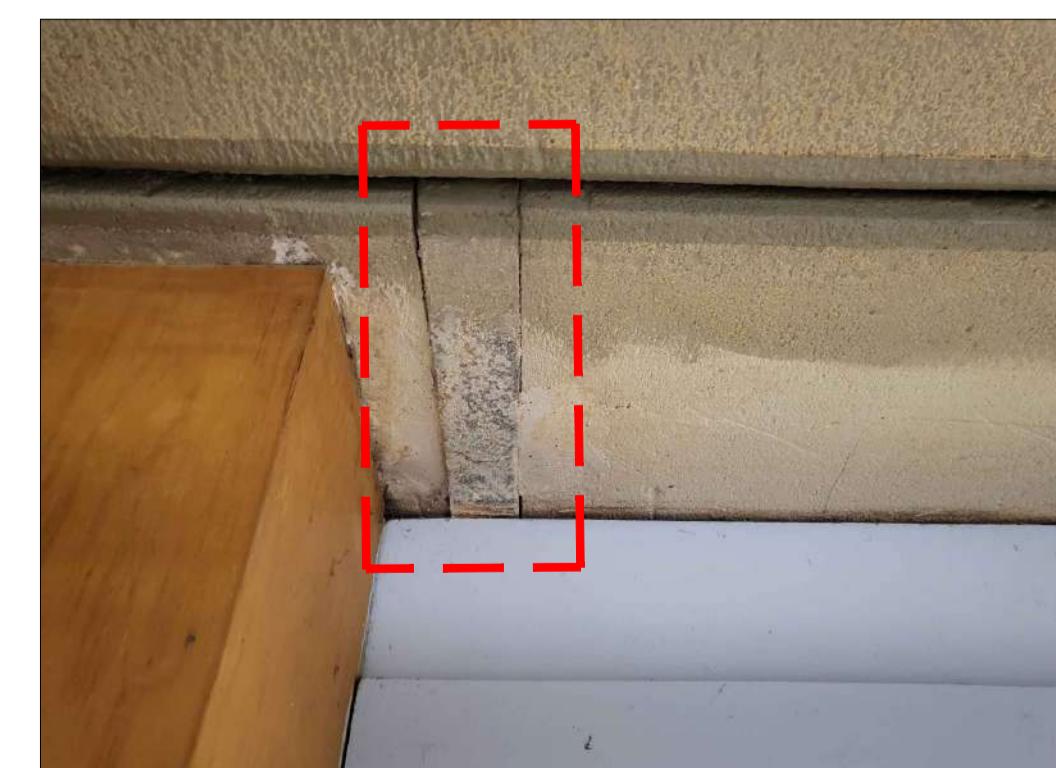
PHOTO 15 - PLANK No. 17

BRACKET AT END 2

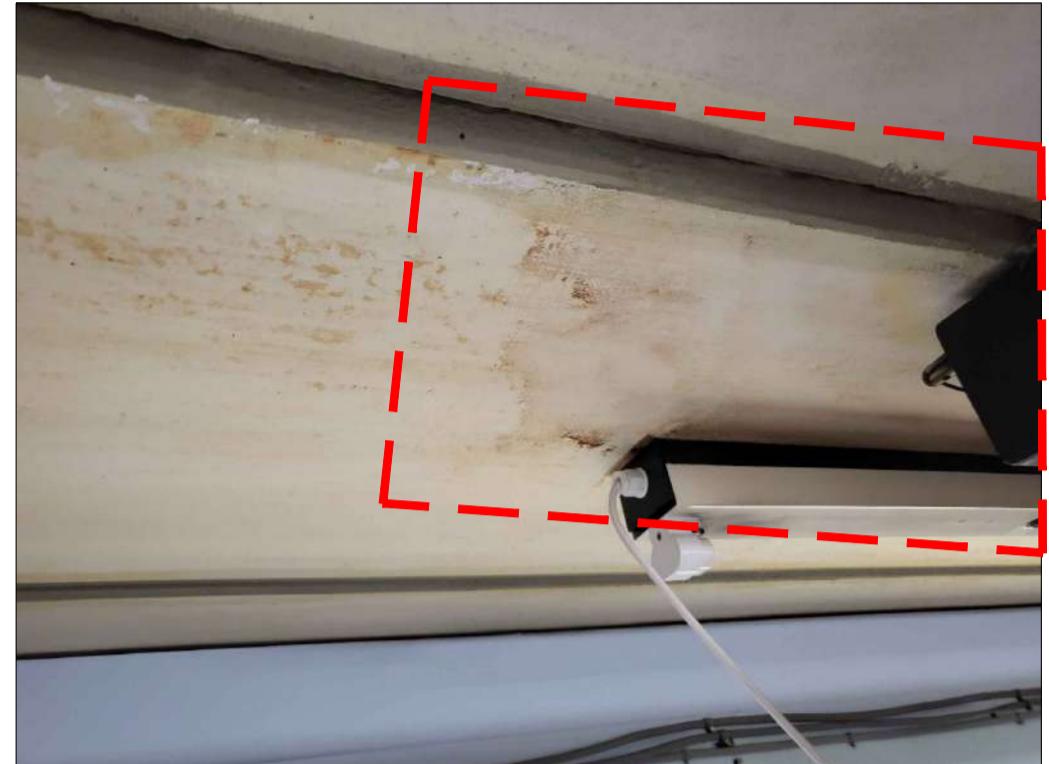
PHOTO 16 - PLANK No. 43

POSSIBLE WATER STAINS AT END 1

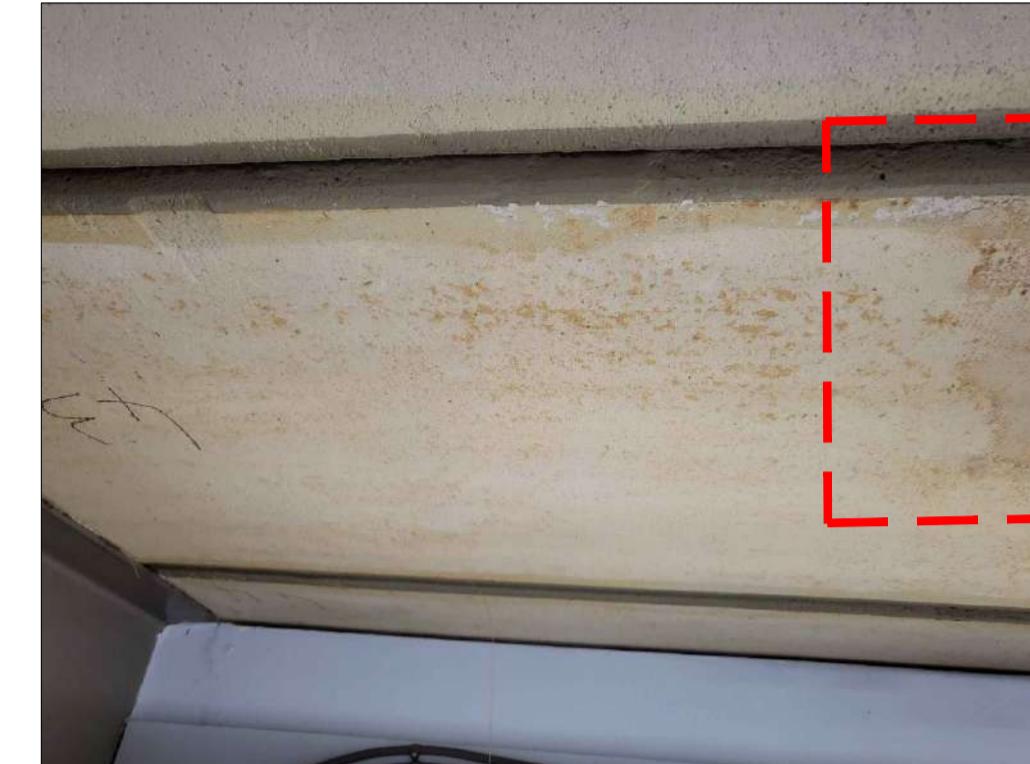
PHOTO 17 - PLANK No. 43

POSSIBLE WATER STAINS AT END 1

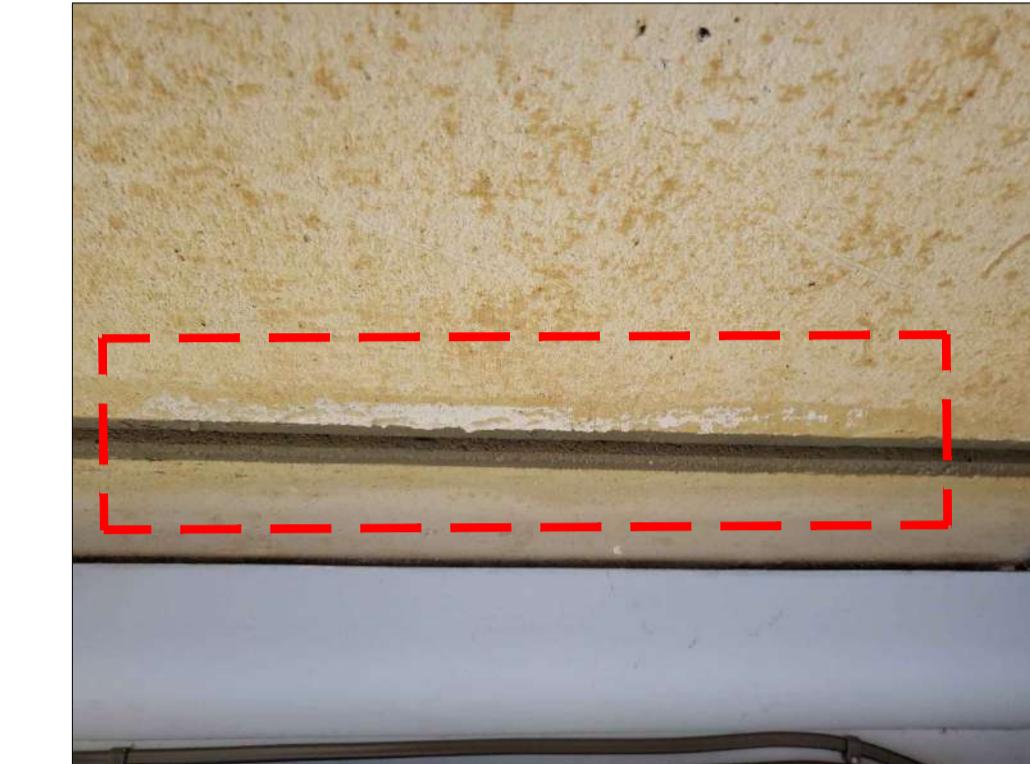
PHOTO 18 - PLANK No. 43

DELAMINATION/EFFLORESCENCE AT END 2

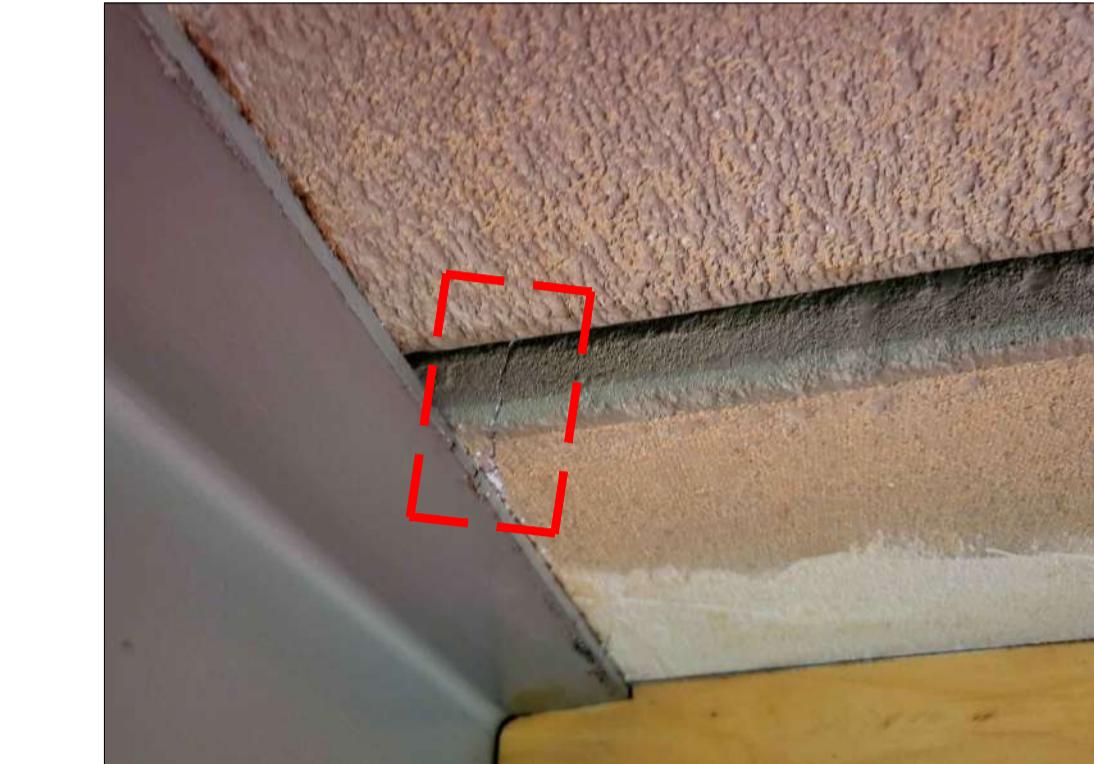
PHOTO 19 - PLANK No. 33

CRACK AT END 2

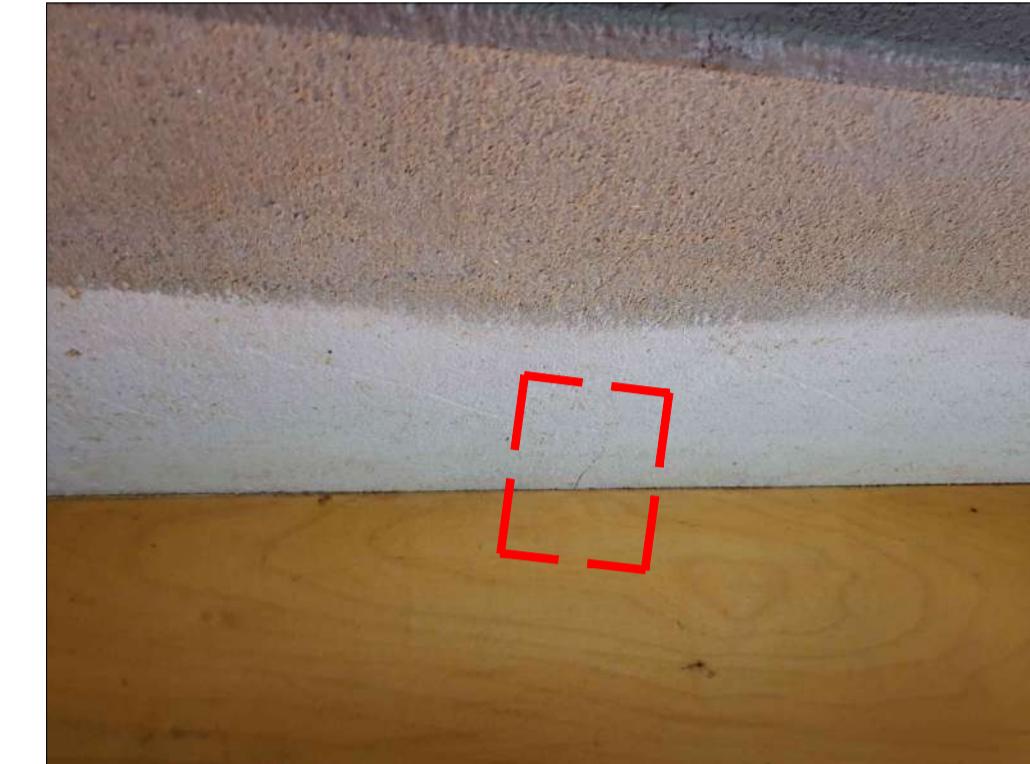
PHOTO 20 - PLANK No. 33

CRACK @ 700-800mm CTRS ALONG EDGE

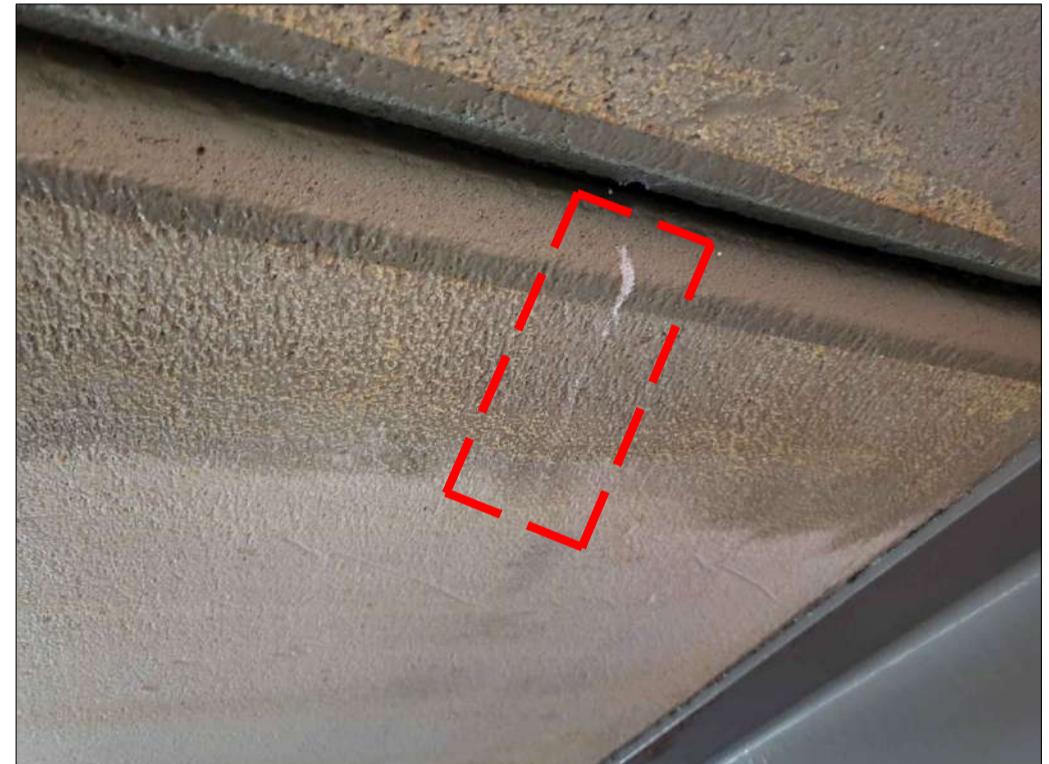
PHOTO 21 - PLANK No. 38

CRACK AT END 2

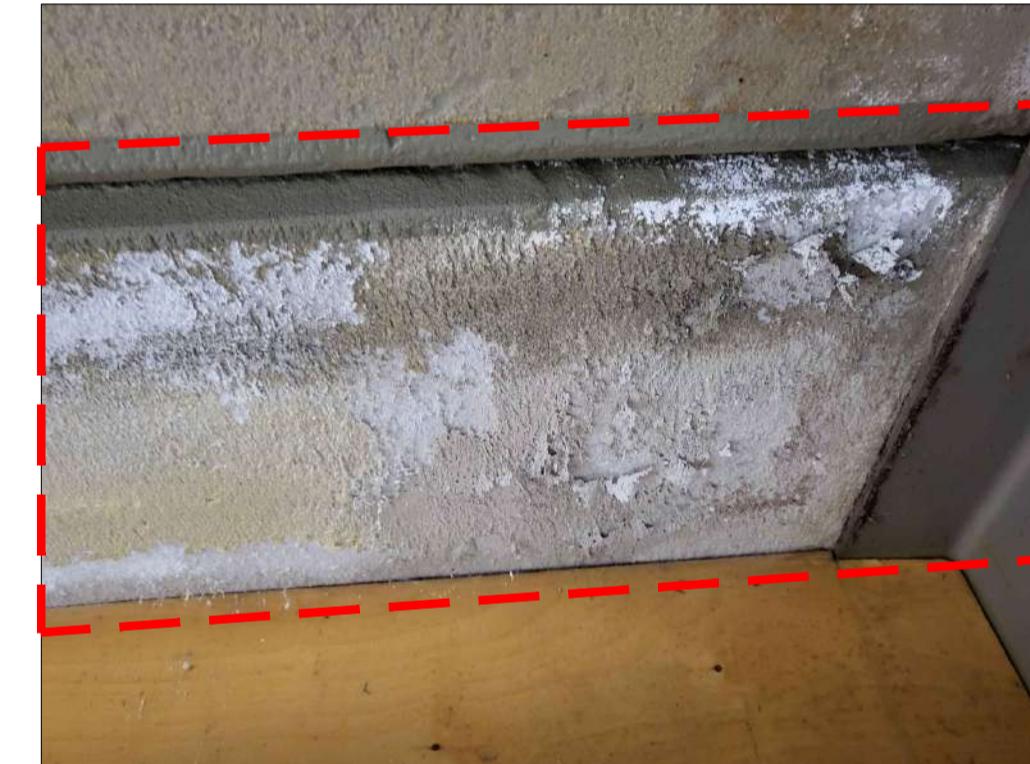
PHOTO 22 - PLANK No. 33

EFFLORESCENCE AT END 1

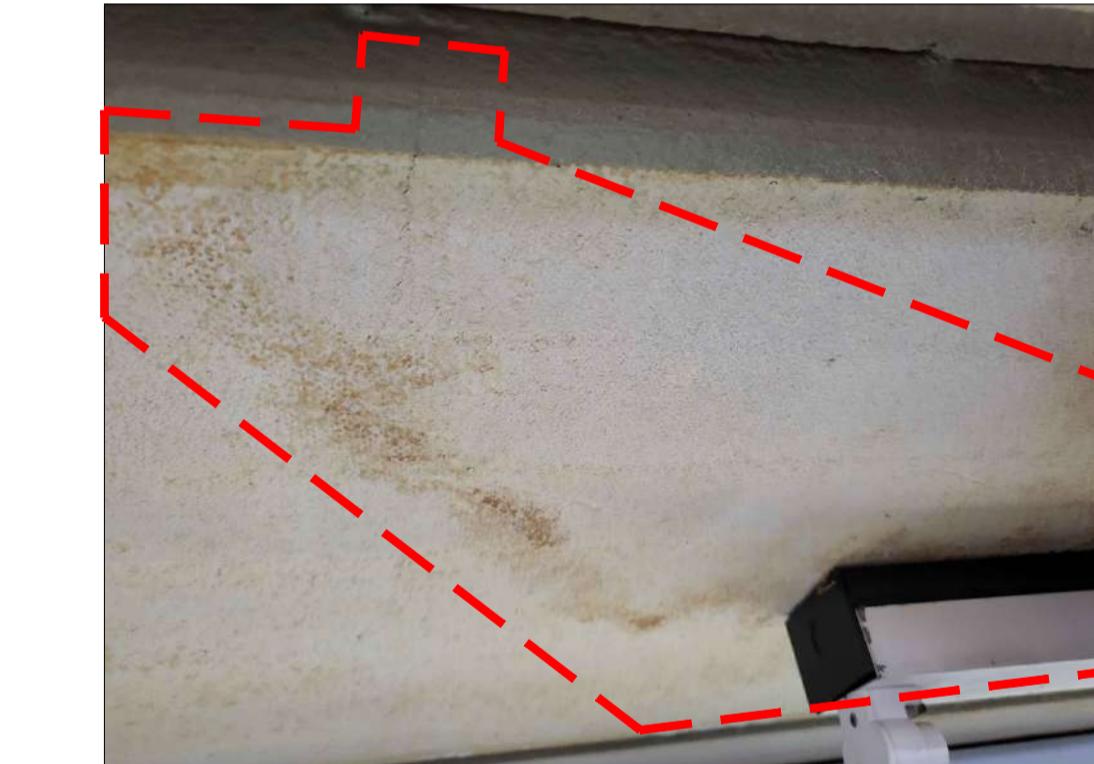
PHOTO 24 - PLANK No. 57

DAMP BY LIGHT
CRACK AT END 1

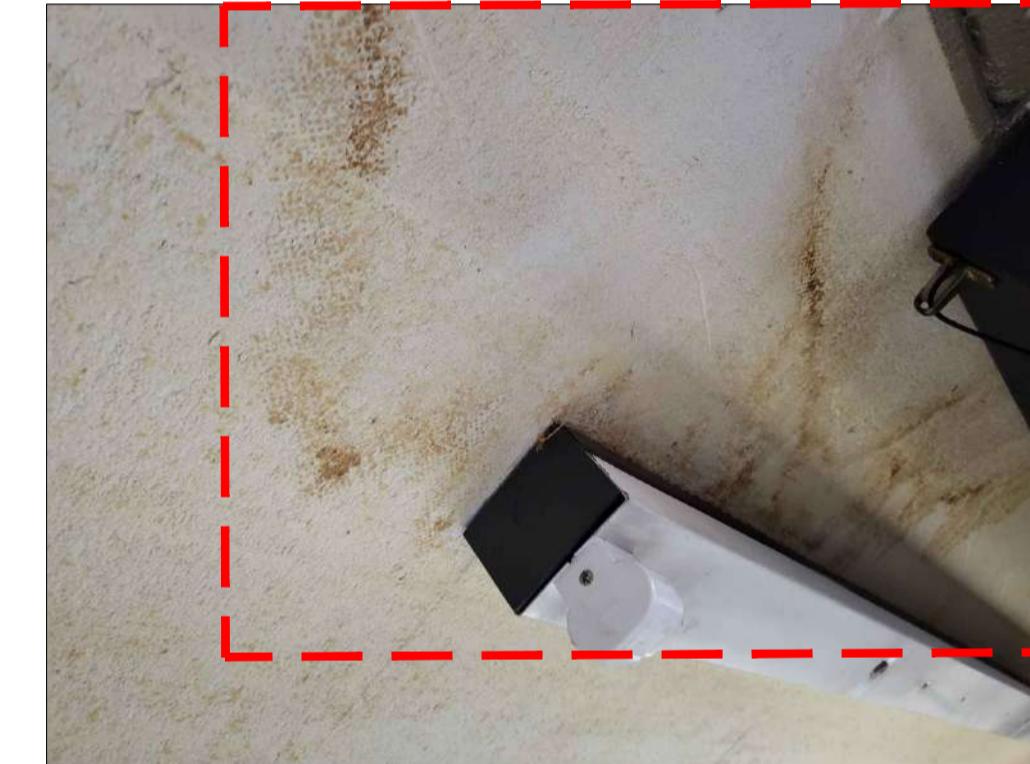
PHOTO 25 - PLANK No. 57

DAMP BY LIGHT

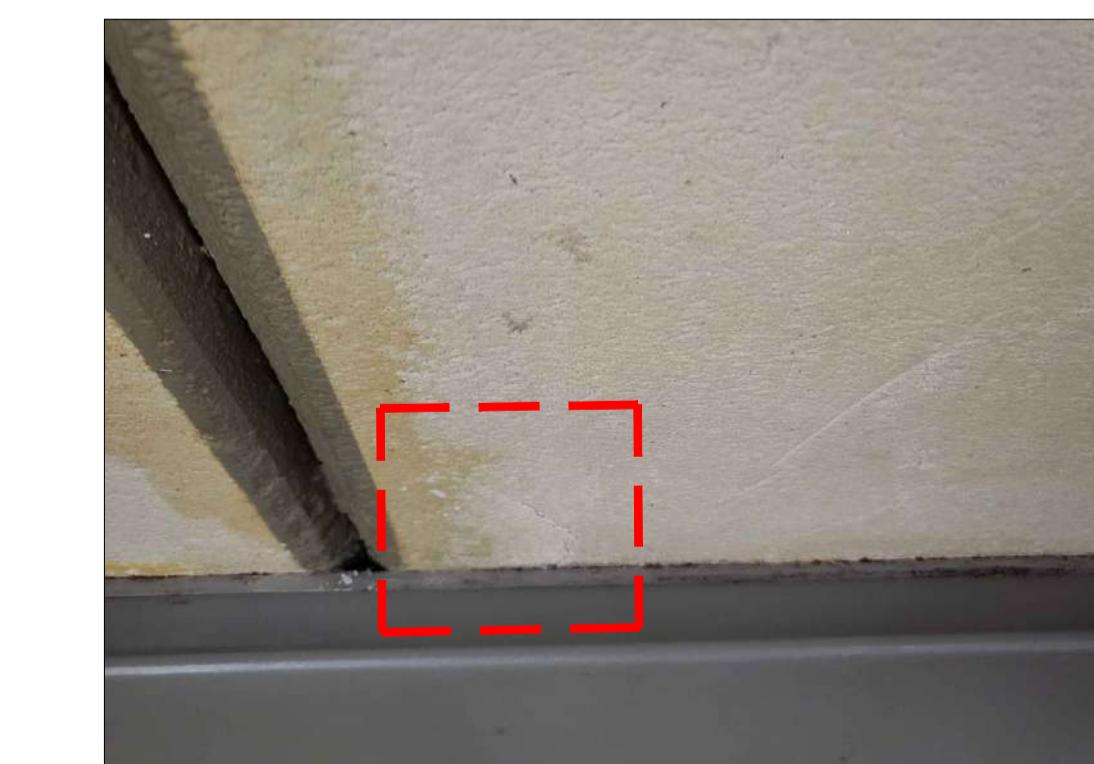
PHOTO 29 - PLANK No. 60

CRACK AT END 2

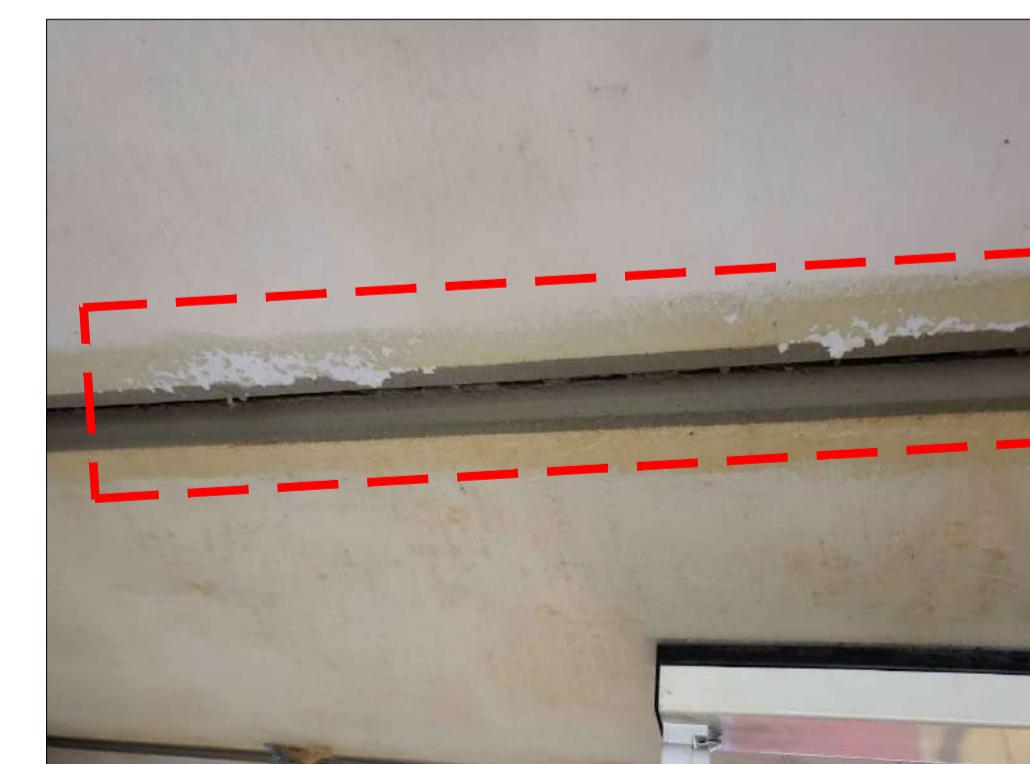
PHOTO 30 - PLANK No. 54

SIDE DELAMINATION/EFFLORESCENCE AT END 2

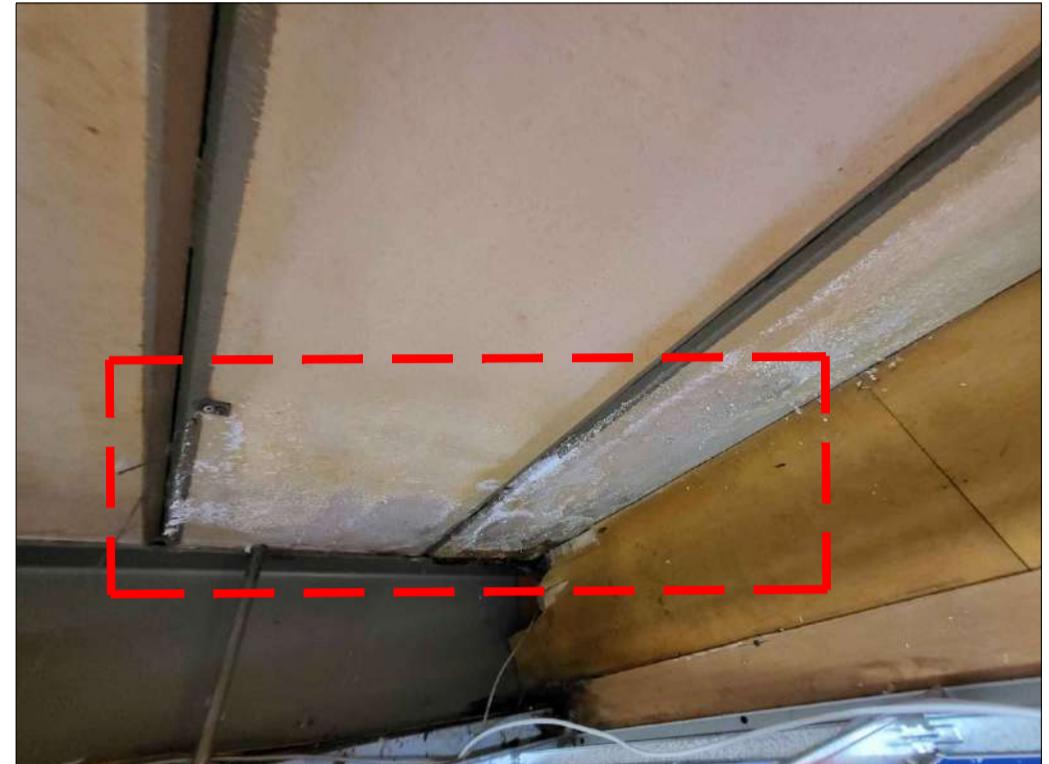
PHOTO 31 - PLANK No. 47 & 48

RUST STAIN
EFFLORESCENCE AT END 2

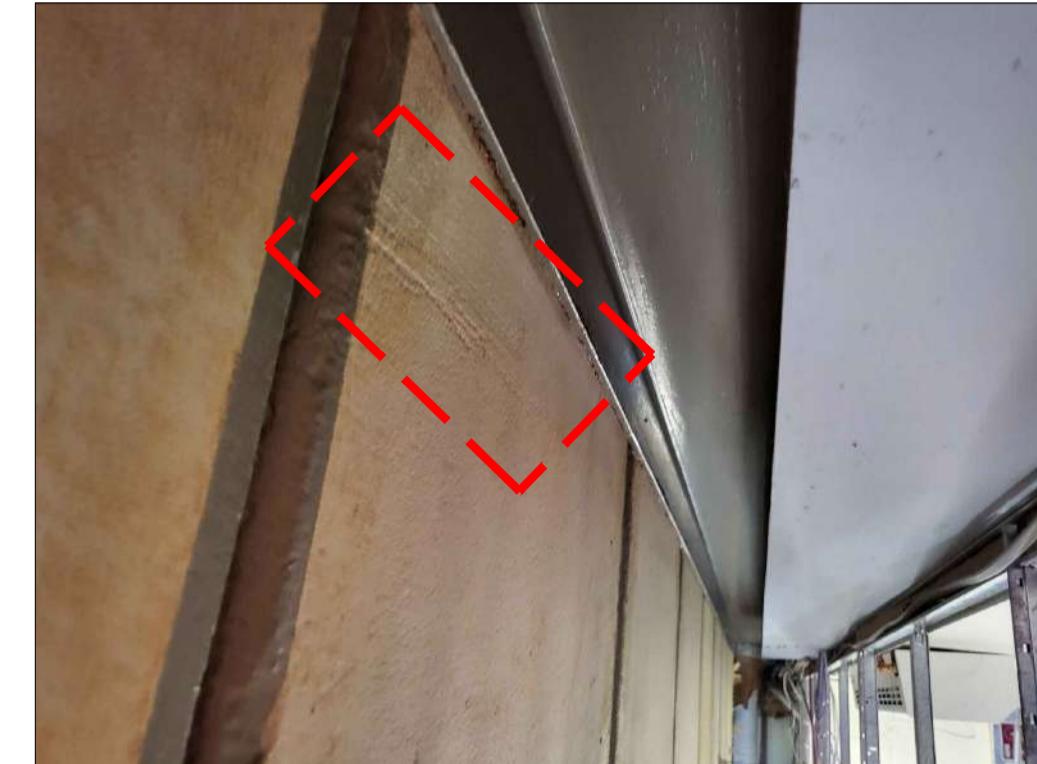
PHOTO 32 - PLANK No. 50

SCARRING AT END 2

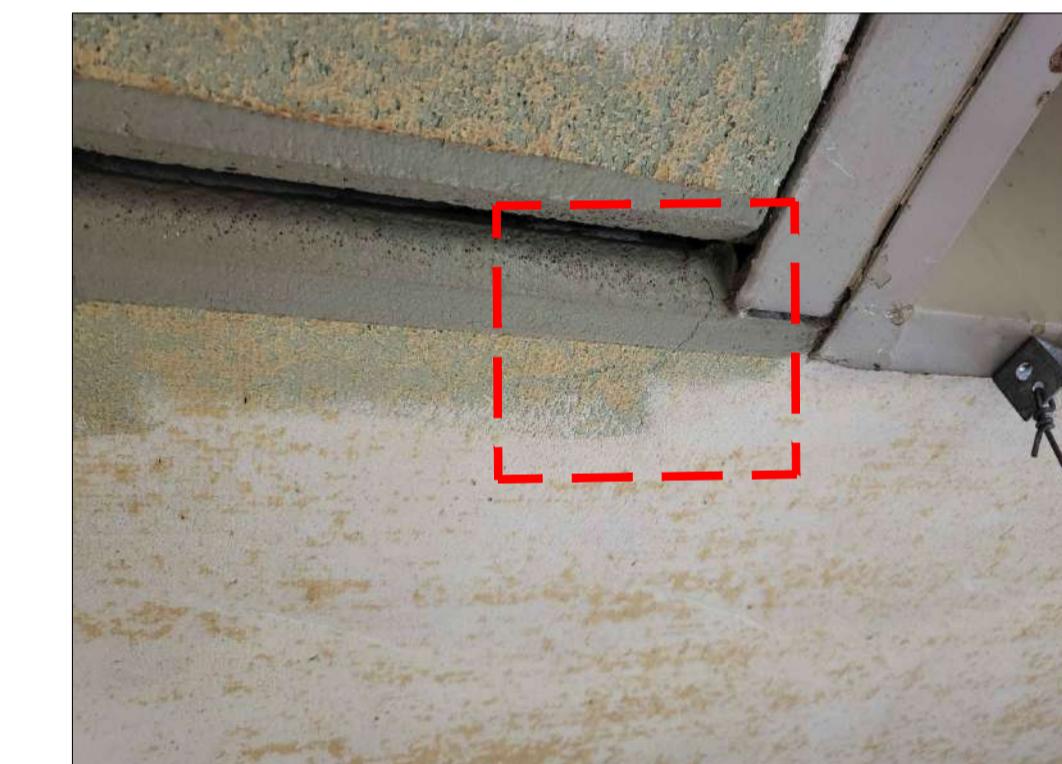
PHOTO 39 - PLANK No. 86

CRACK AT END 1

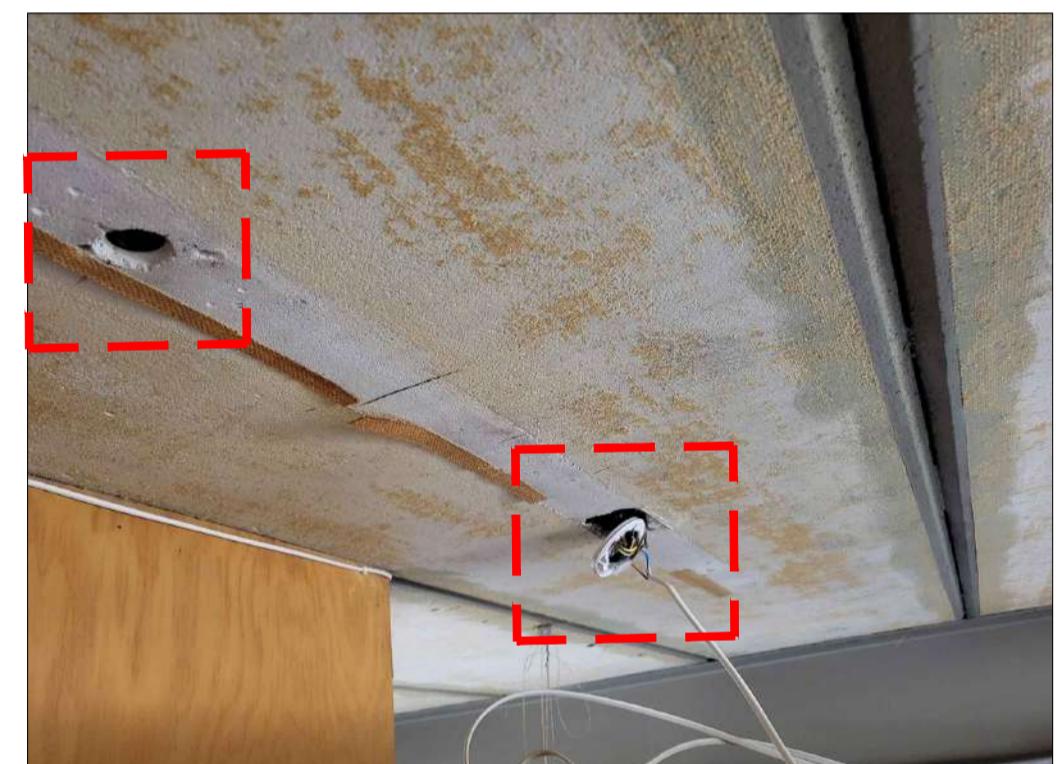
PHOTO 40 - PLANK No. 87

2No. SERVICE HOLES

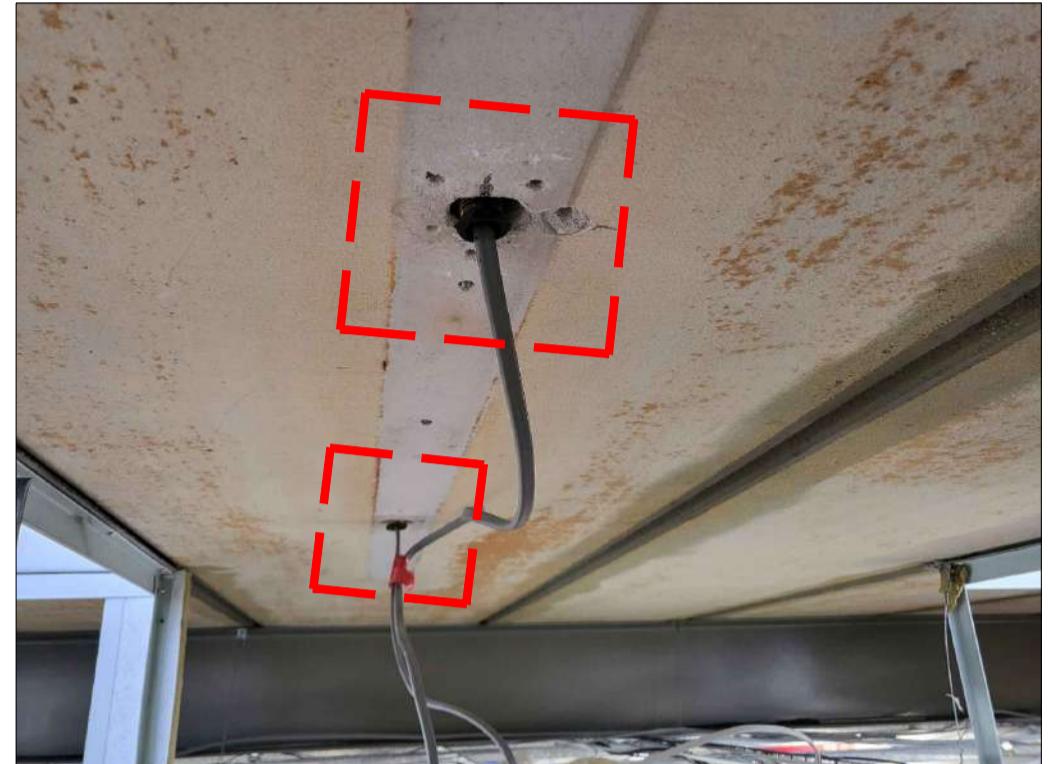
PHOTO 46 - PLANK No. 100

2No. SERVICE HOLES

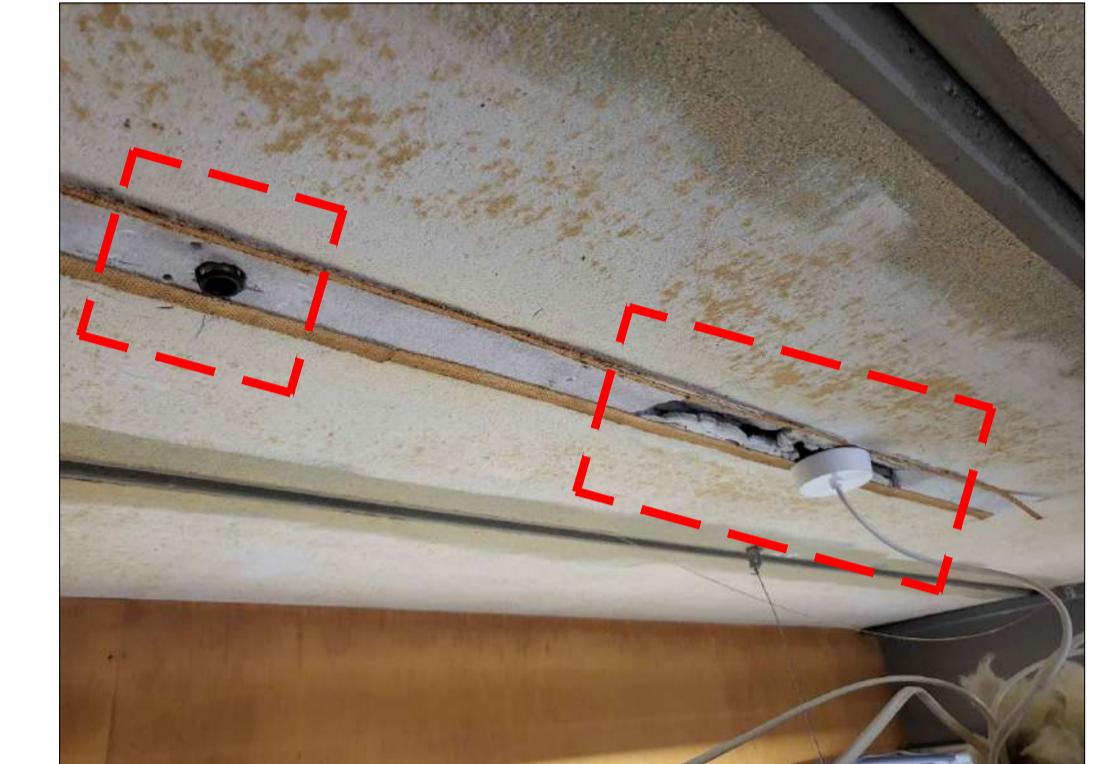
PHOTO 50 - PLANK No. 112

1No. SMALL HOLE
1No. LONG HOLE

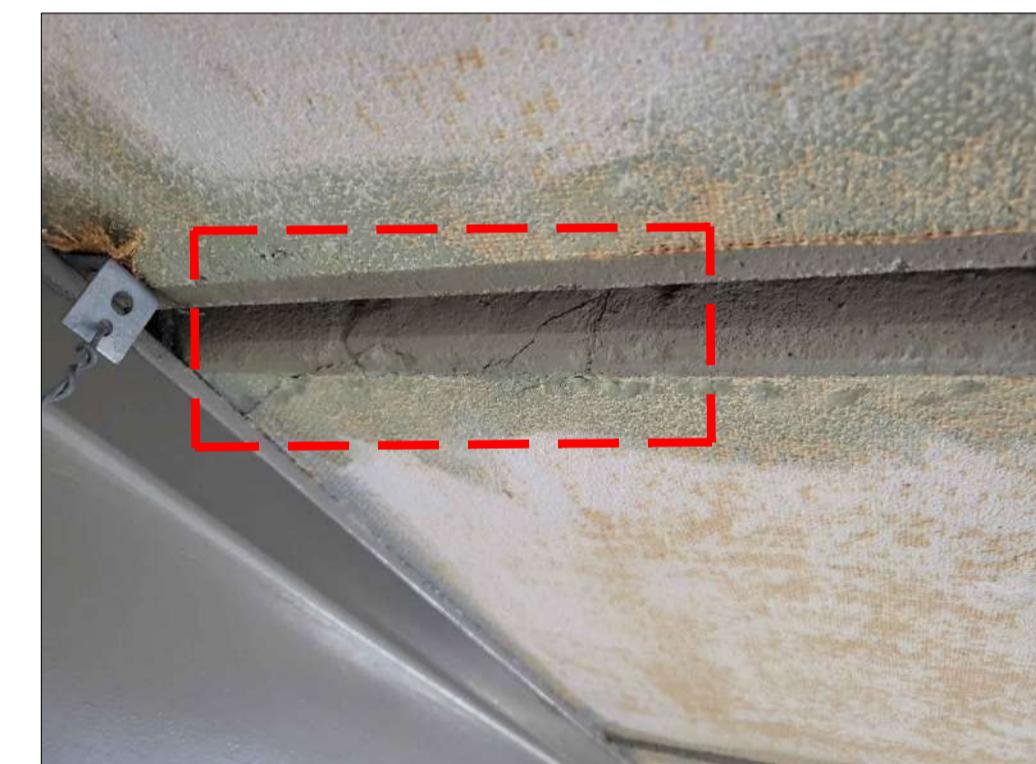
PHOTO 52 - PLANK No. 100

2No. HOLES
CRACK AT ENDS 1 & 2
