REPORT ON
CONDITION OF RAAC CONCRETE
AT
STROUD LIBRARY, LANSDOWN, STROUD

DATE: 15th March 2024

CONTRACT NO: 13827

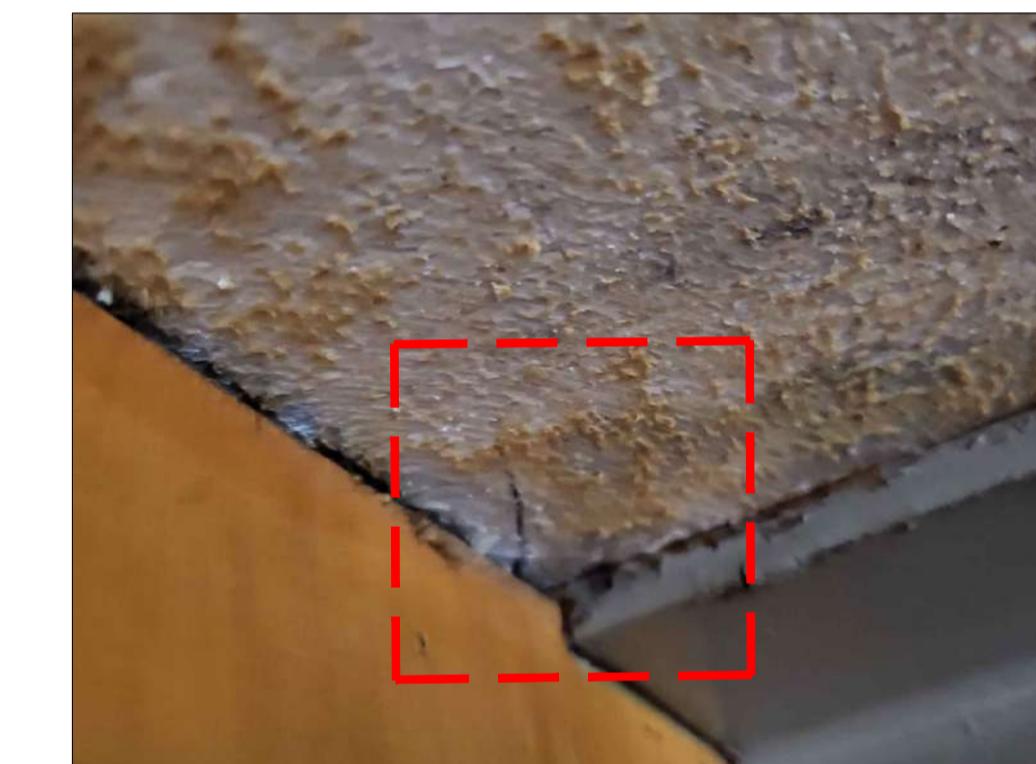
PHOTO 53 - PLANK No. 122

CRACK AT END 1

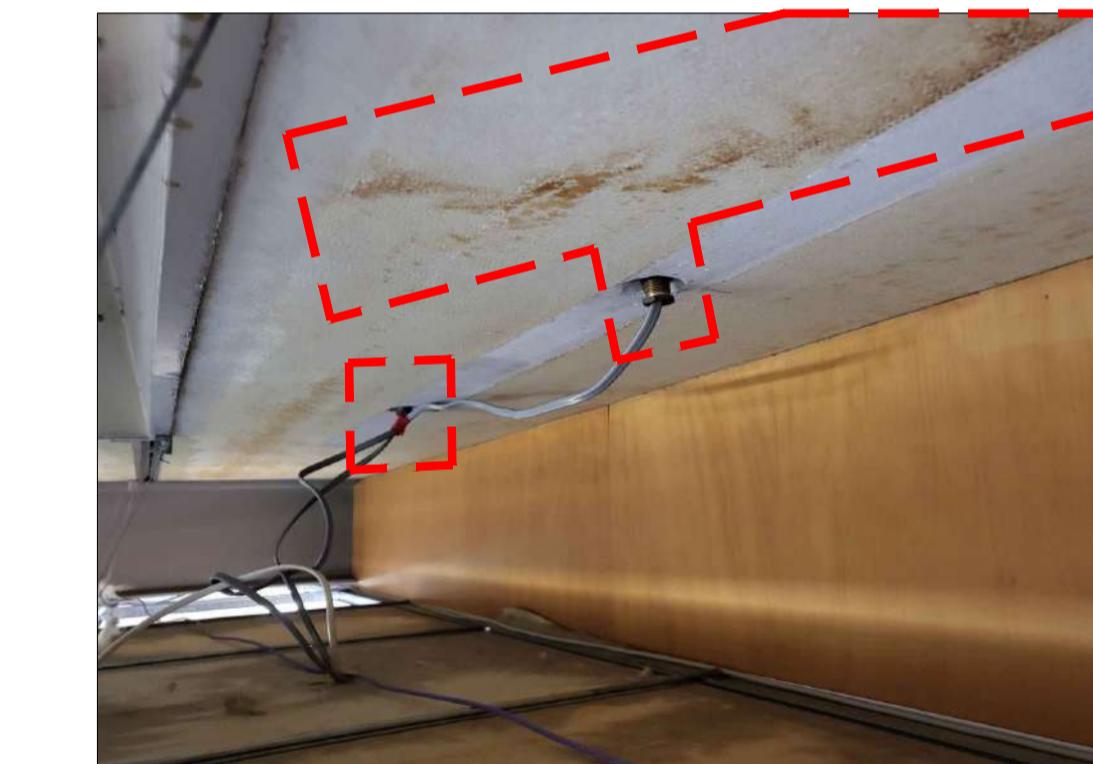
PHOTO 54 - PLANK No. 126

2No. SERVICE HOLES
DAMP PATCH

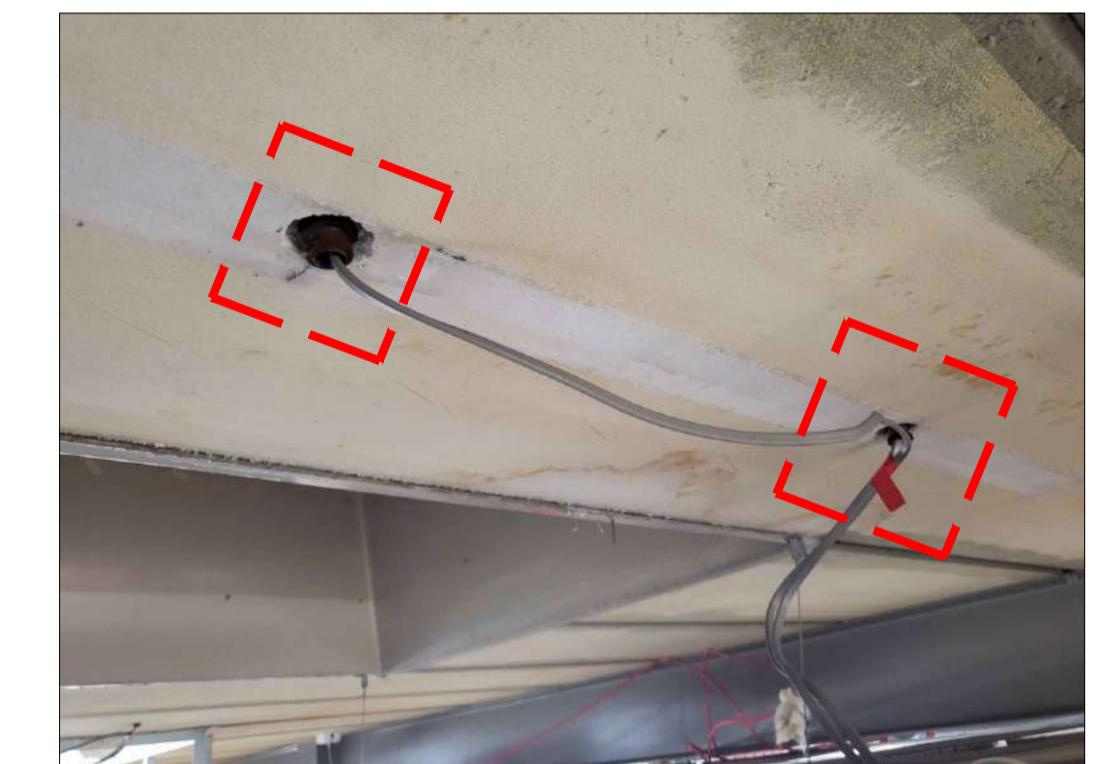
PHOTO 55 - PLANK No. 130

2No. SERVICE HOLES

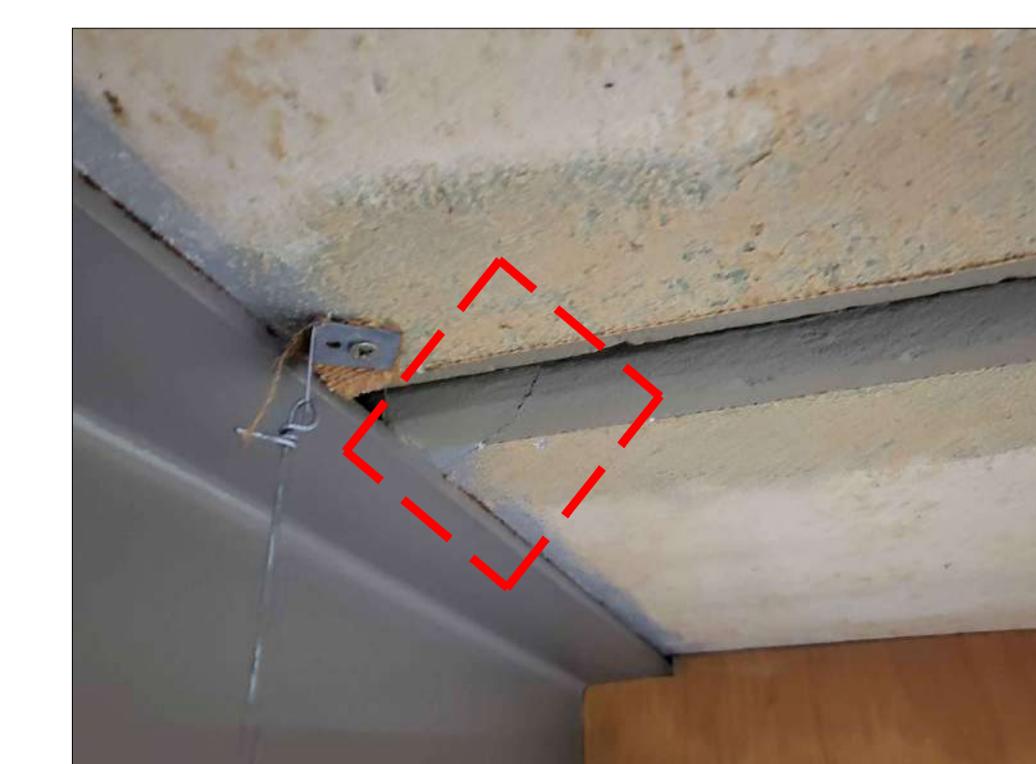
PHOTO 58 - PLANK No. 139

CRACK AT END 1

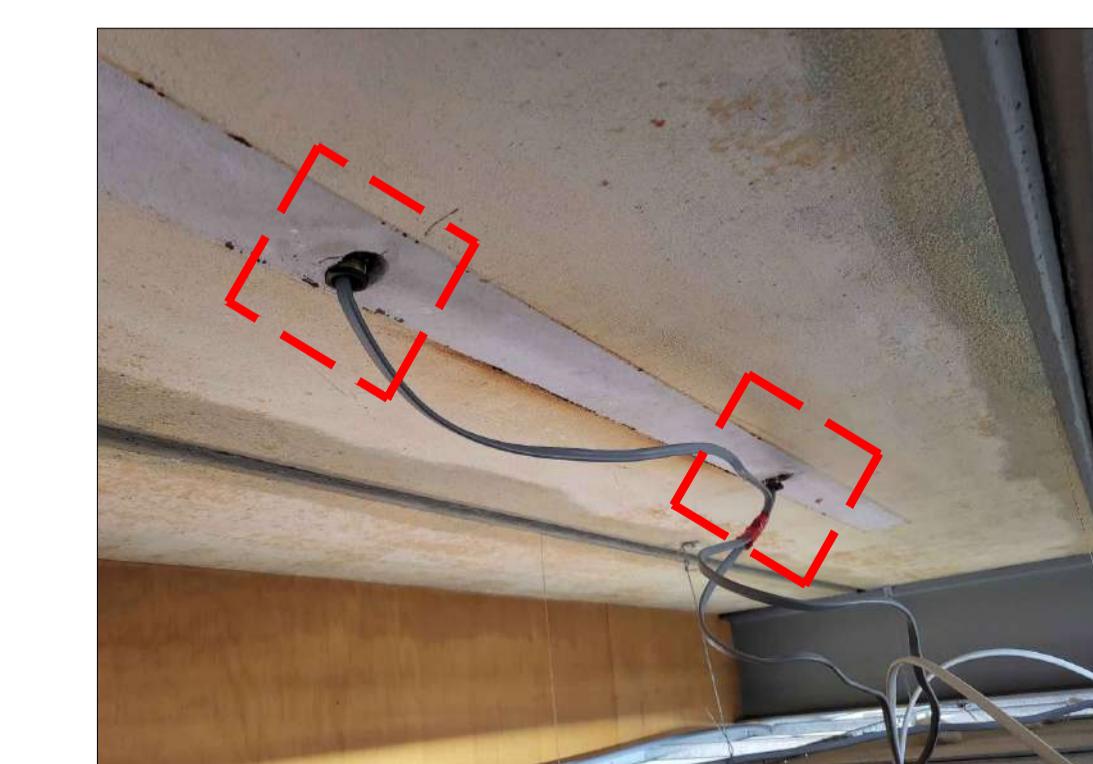
PHOTO 59 - PLANK No. 148

2No. SERVICE HOLES

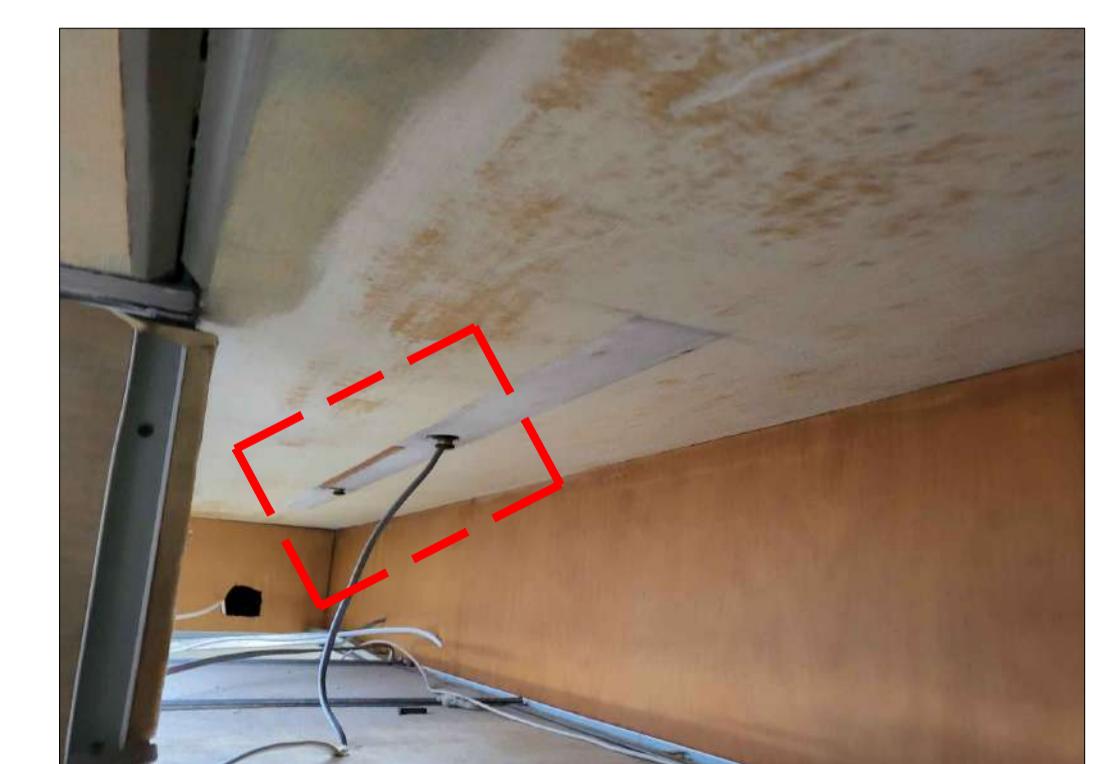
PHOTO 60 - PLANK No. 152

2No. SERVICE HOLES

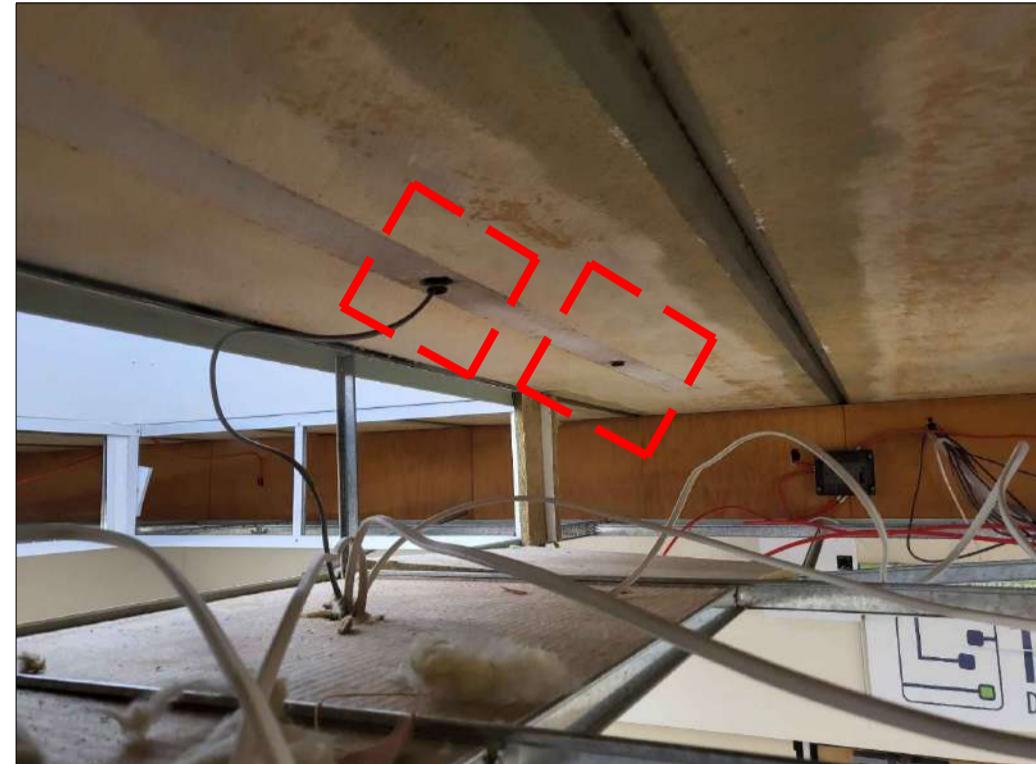
PHOTO 61 - PLANK No. 156

2No. SERVICE HOLES

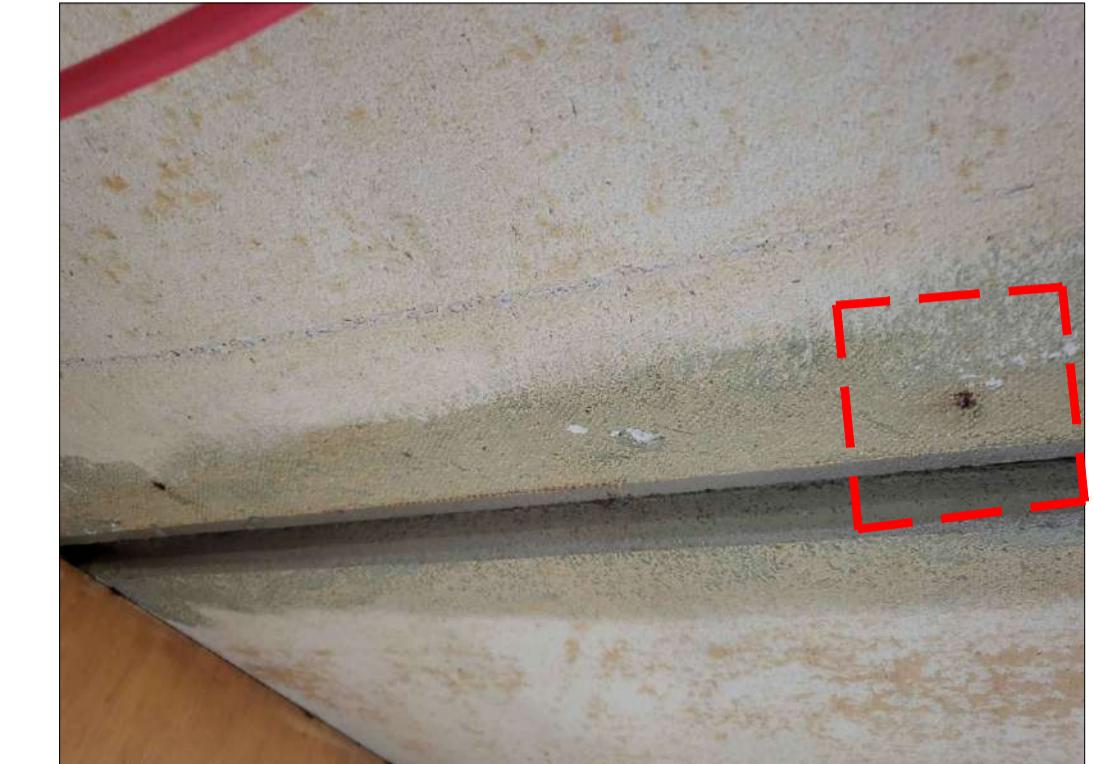
PHOTO 65 - PLANK No. 155

EXPOSED FIXINGS

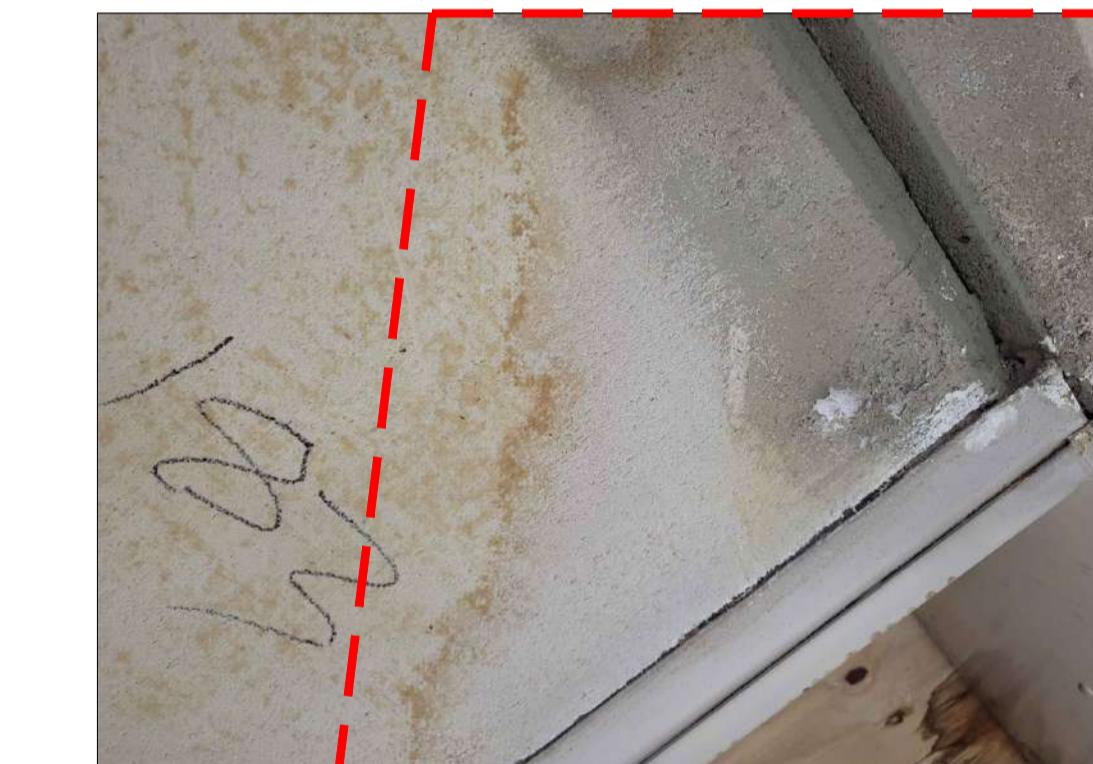
PHOTO 69 - PLANK No. 183

DELAMINATION
WATER STAIN

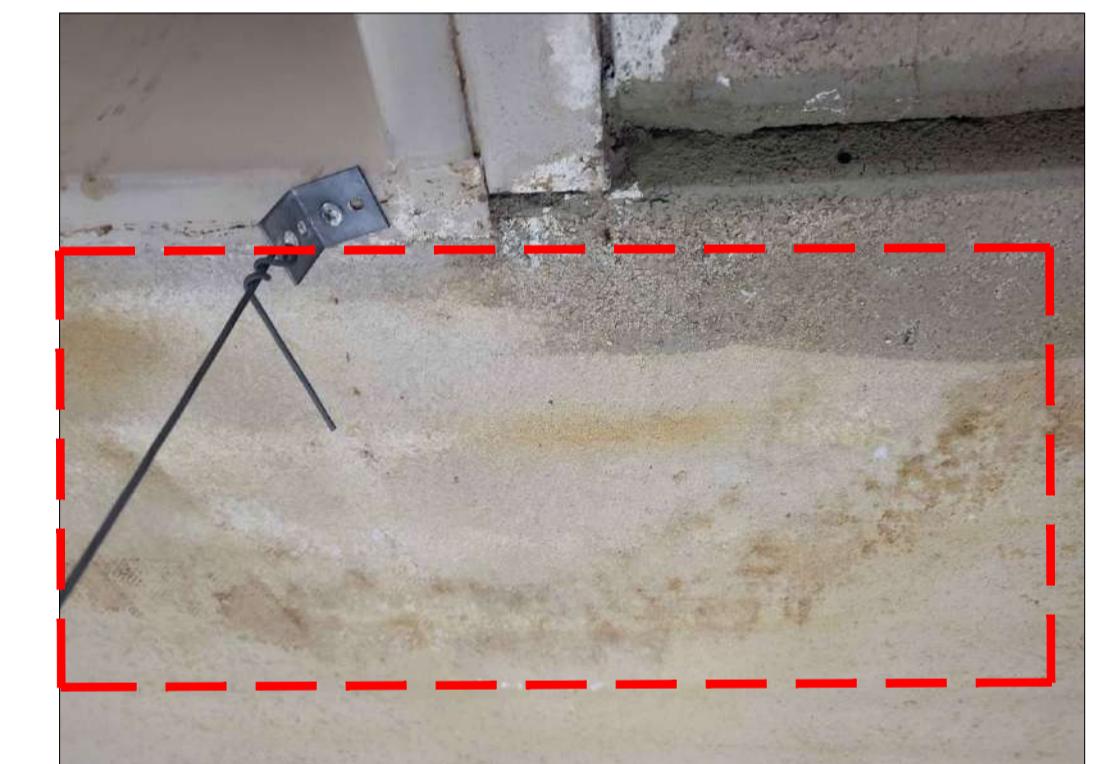
PHOTO 70 - PLANK No. 184

DELAMINATION
WATER STAIN

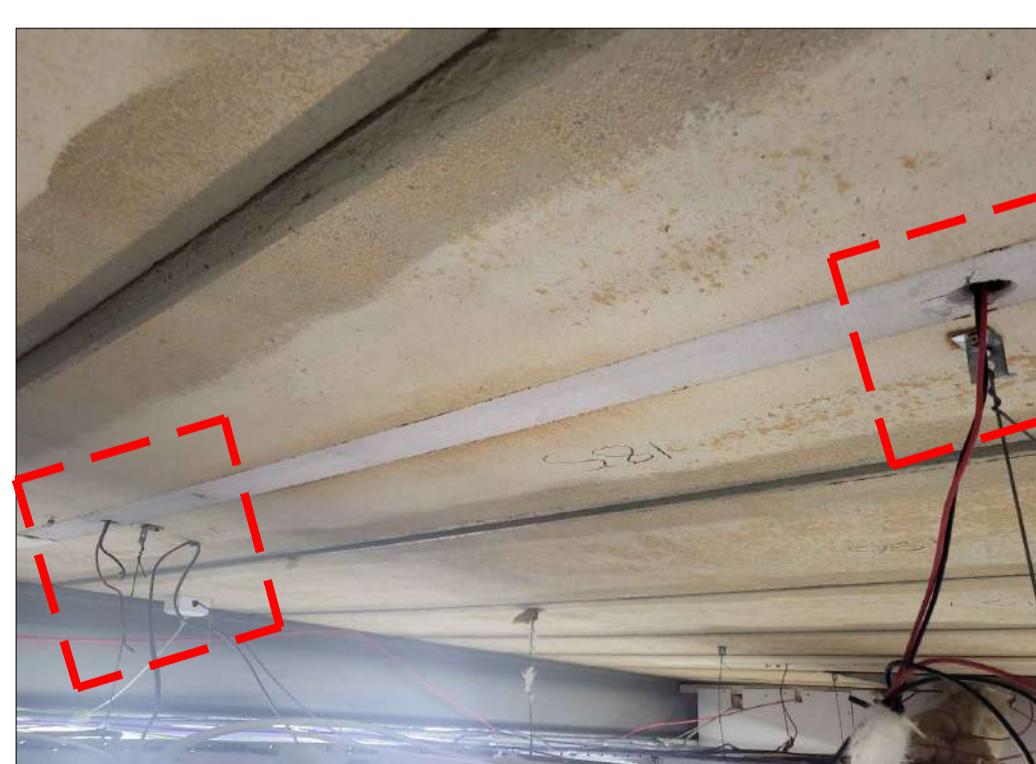
PHOTO 71 - PLANK No. 185

2No. SERVICE HOLES

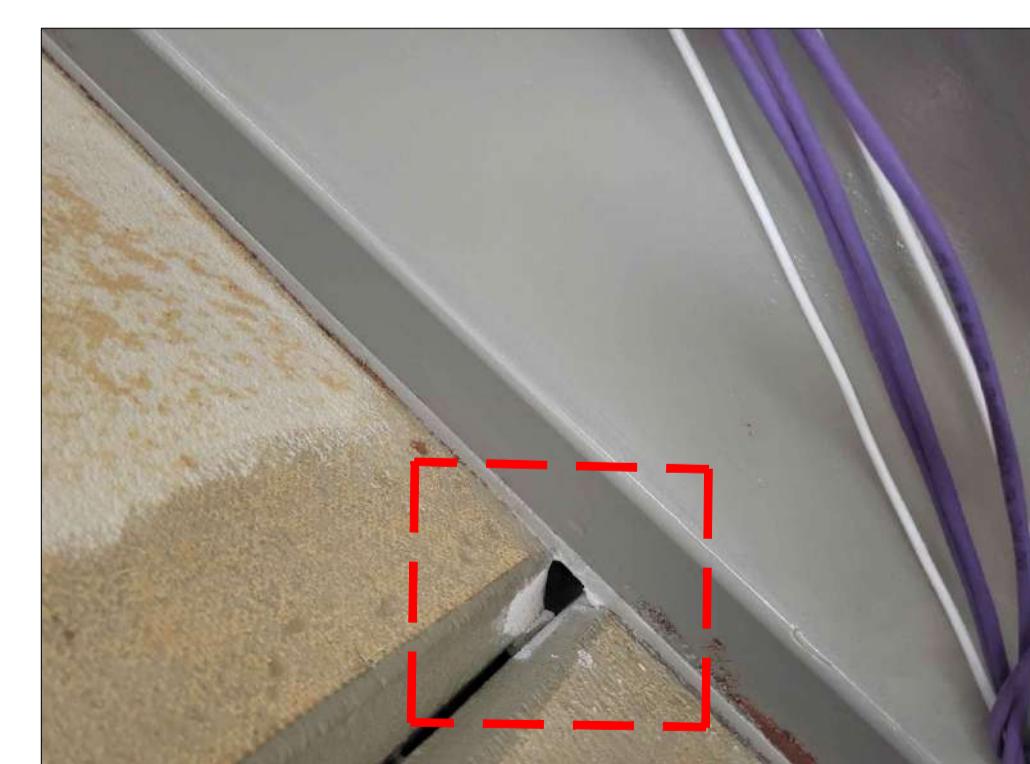
PHOTO 72 - PLANK No. 188

BROKEN EDGE AT END 1

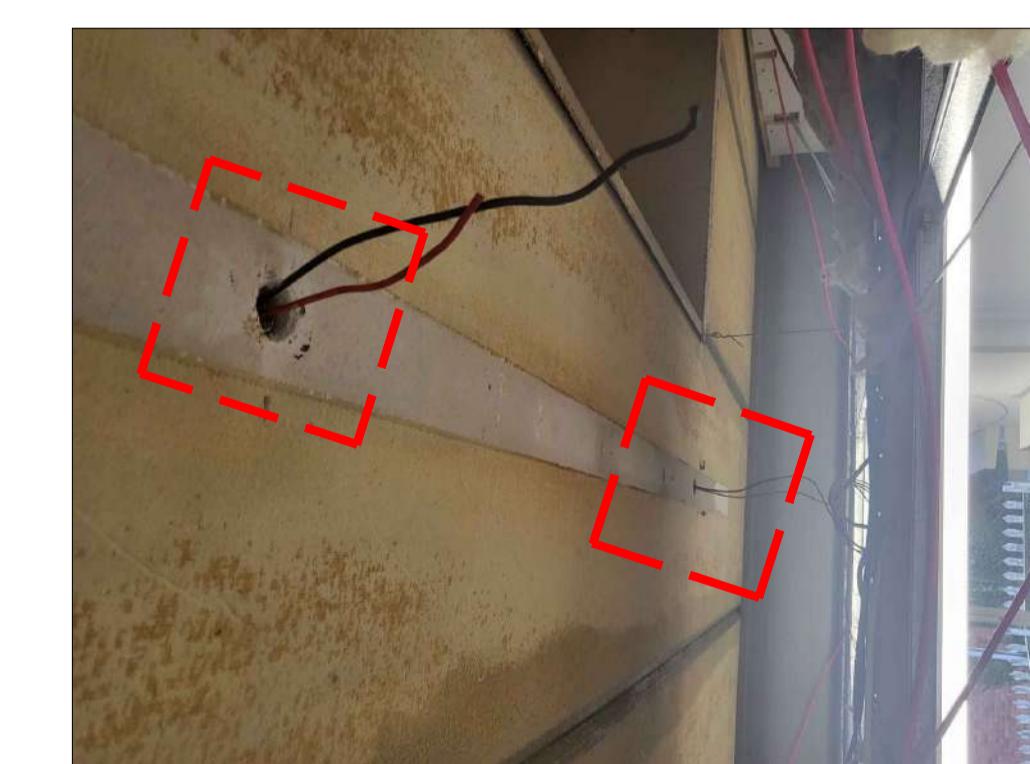
PHOTO 73 - PLANK No. 189

2No. SERVICE HOLES

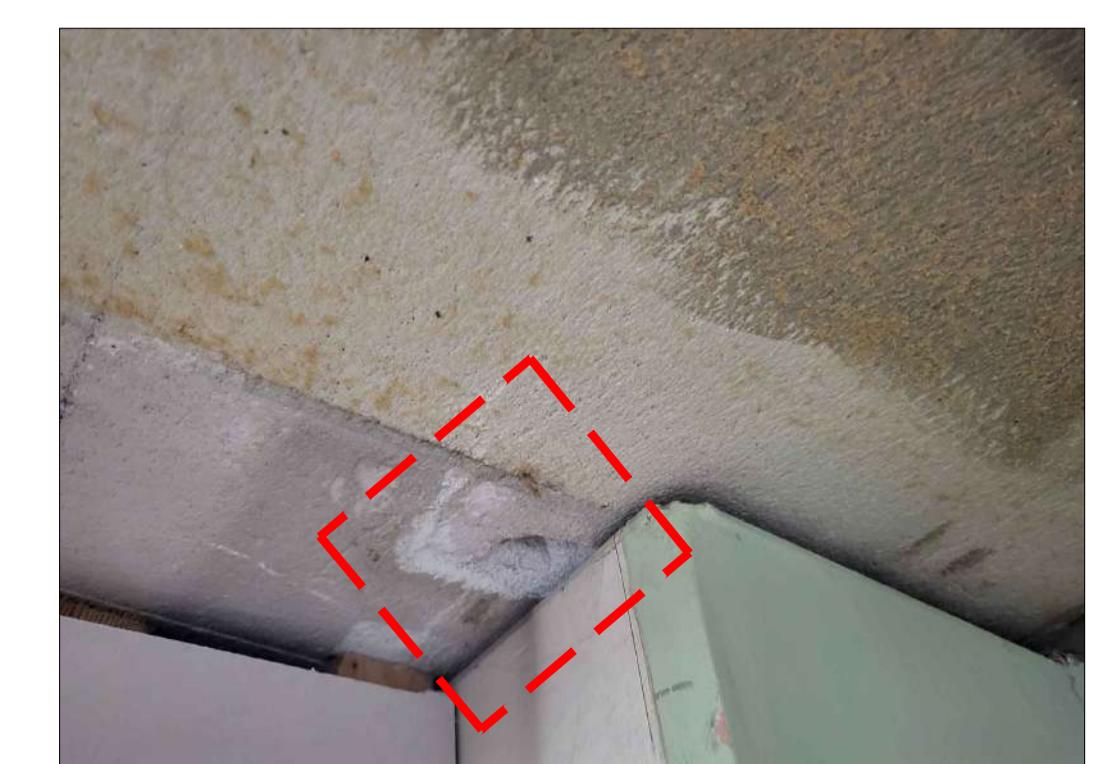
PHOTO 75 - PLANK No. 191

HOLE AT END 1

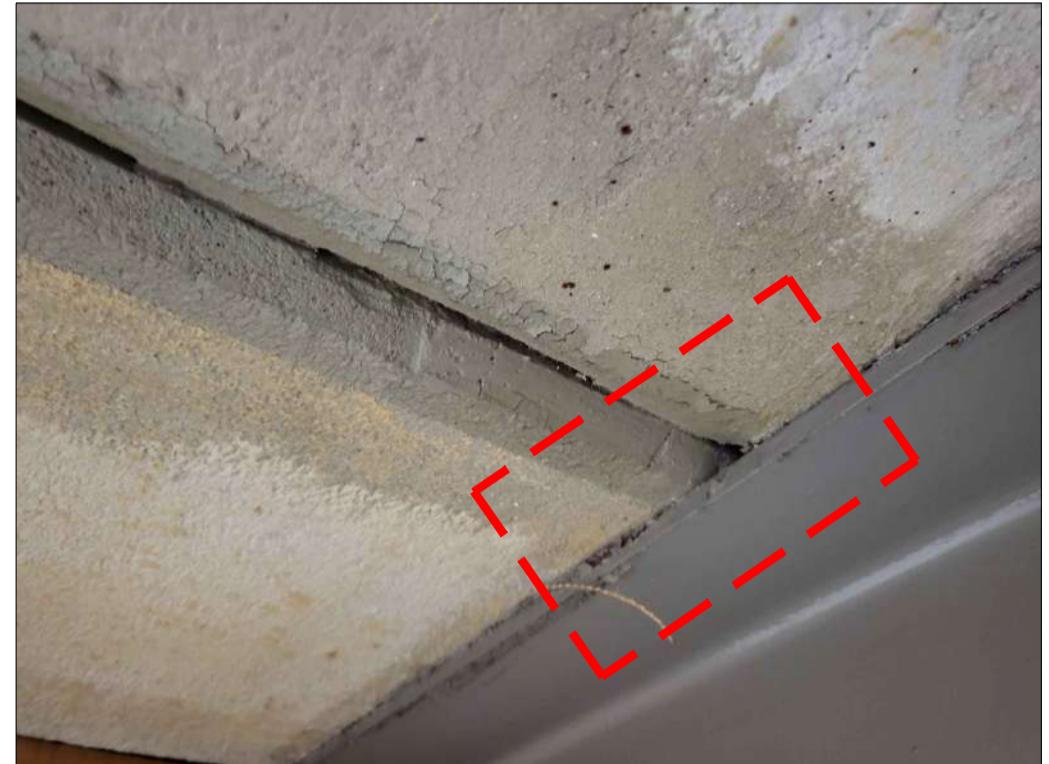
PHOTO 76 - PLANK No. 174
CRACK AT END 2

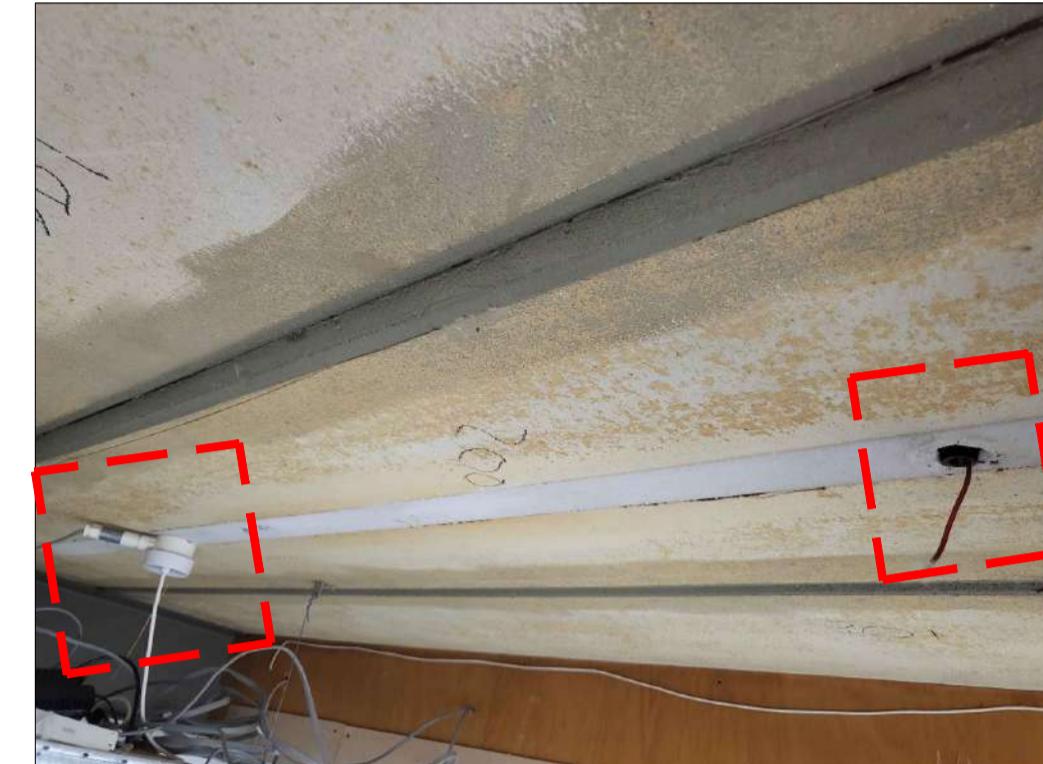
PHOTO 77 - PLANK No. 200
2No. SERVICE HOLES

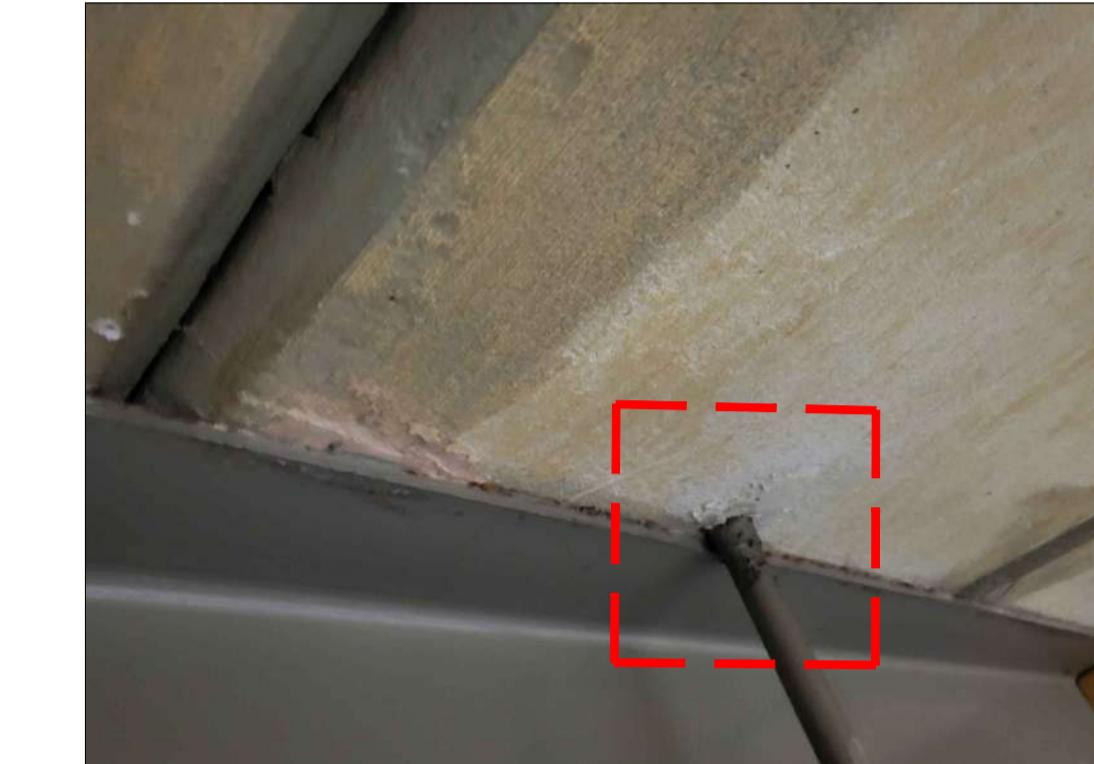
PHOTO 79 - PLANK No. 200
HOLE AT BEARING END 2

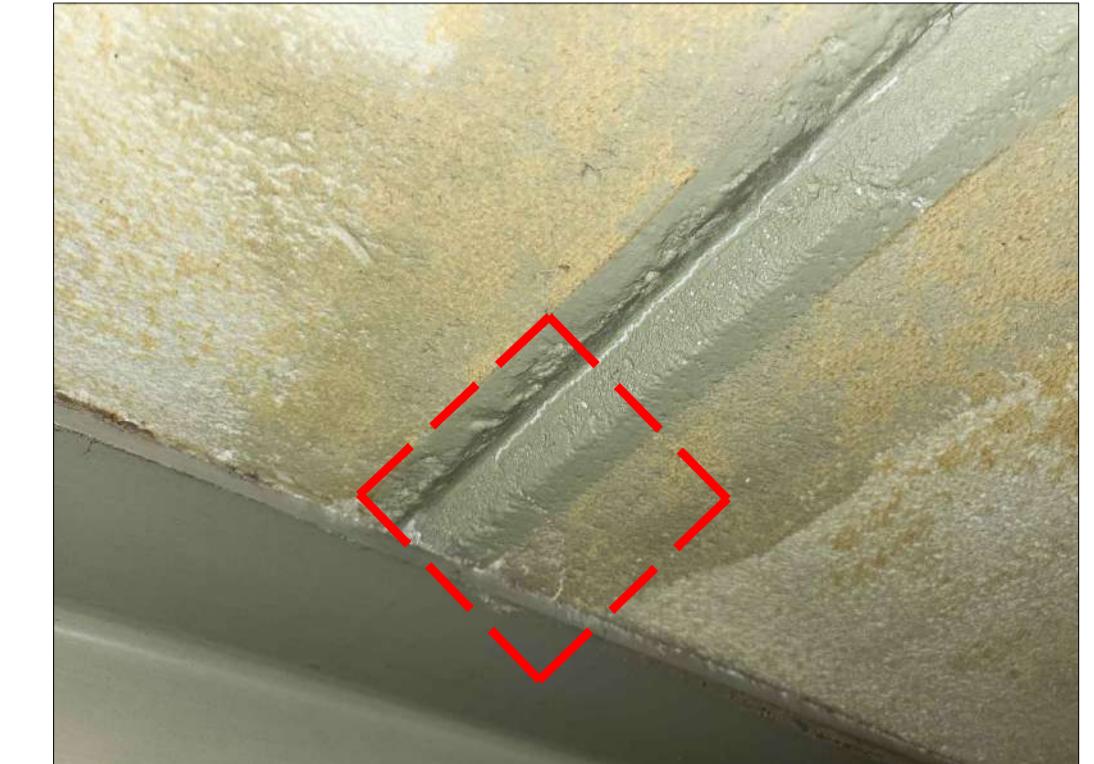
PHOTO 80 - PLANK No. 201
CRACK AT END 2

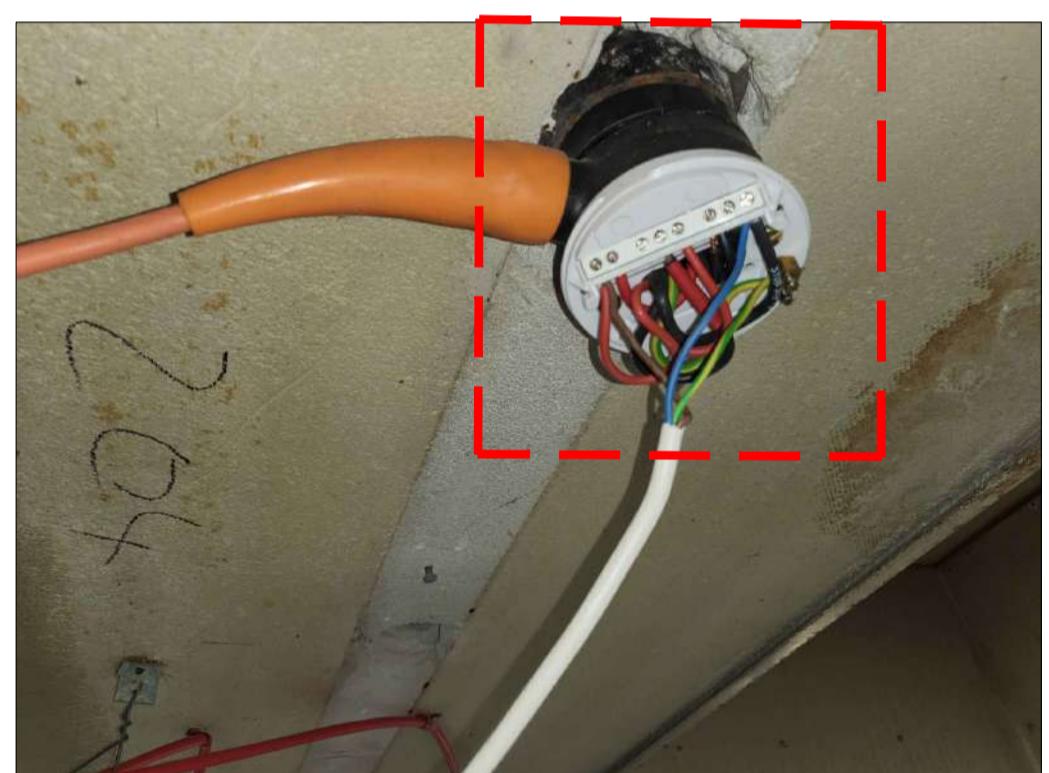
PHOTO 81 - PLANK No. 204
2No. SERVICE HOLES

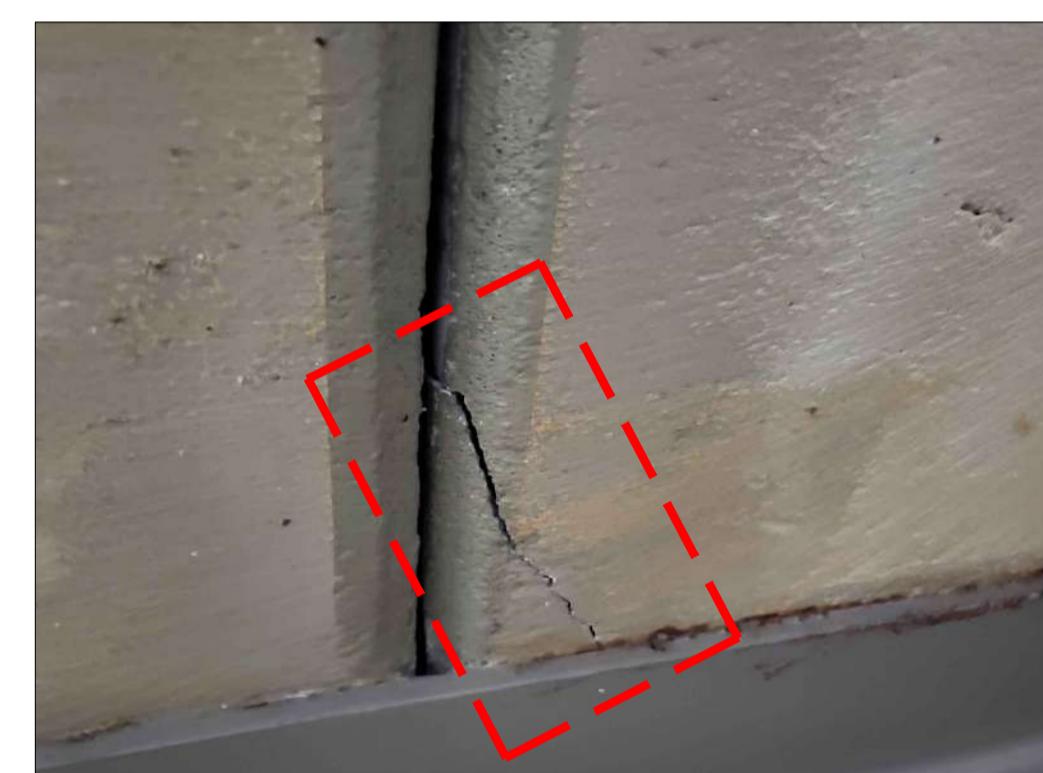
PHOTO 82 - PLANK No. 204
CRACK AT END 2

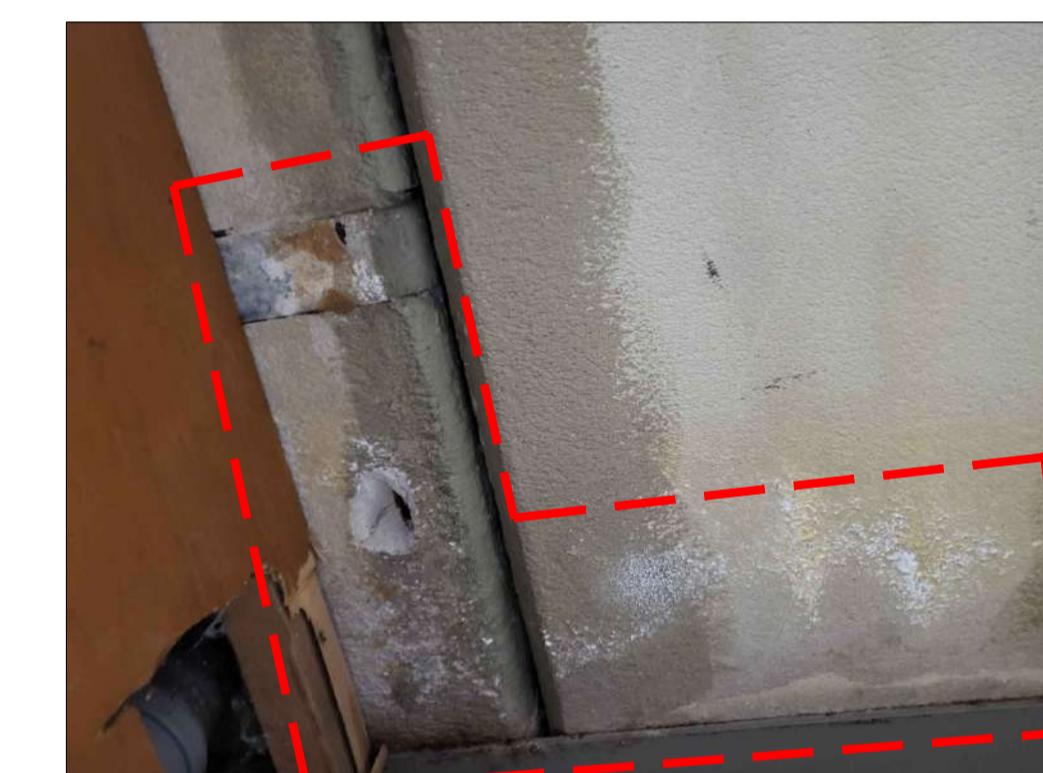
PHOTO 83 - PLANK No. 209 & 175
BRACKET & HOLE AT END 1
EFFLORESCENCE AT BOTH ENDS

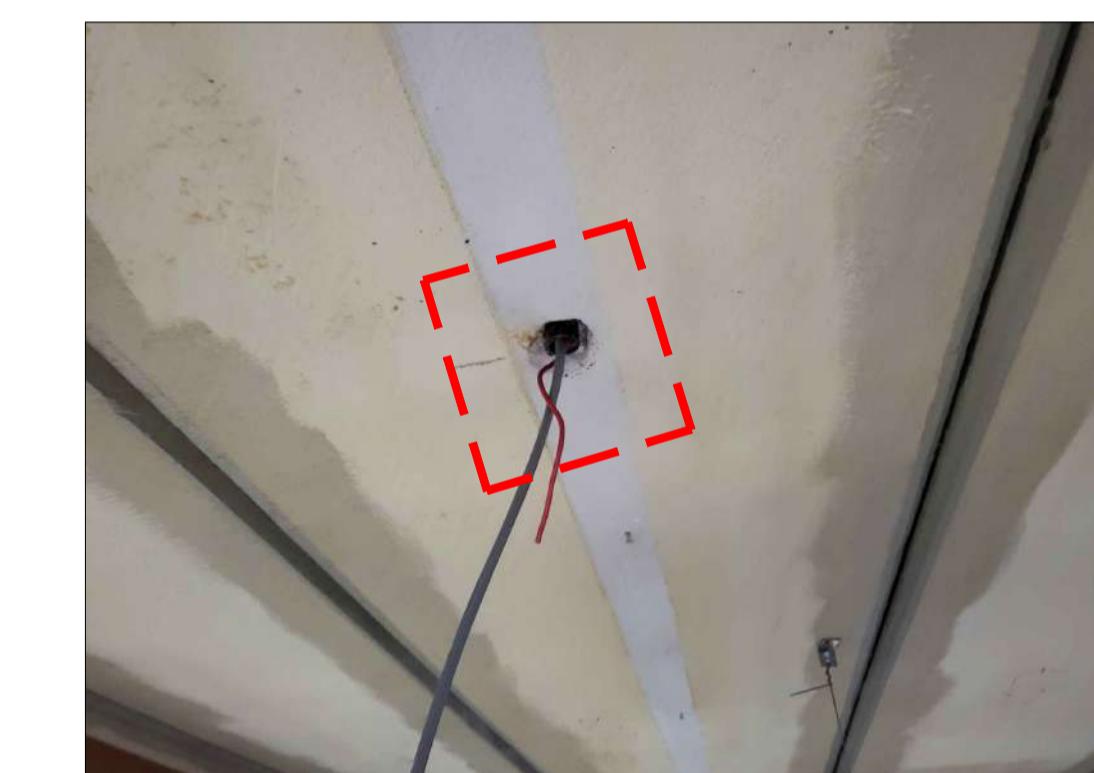
PHOTO 84 - PLANK No. 208
SERVICE HOLE

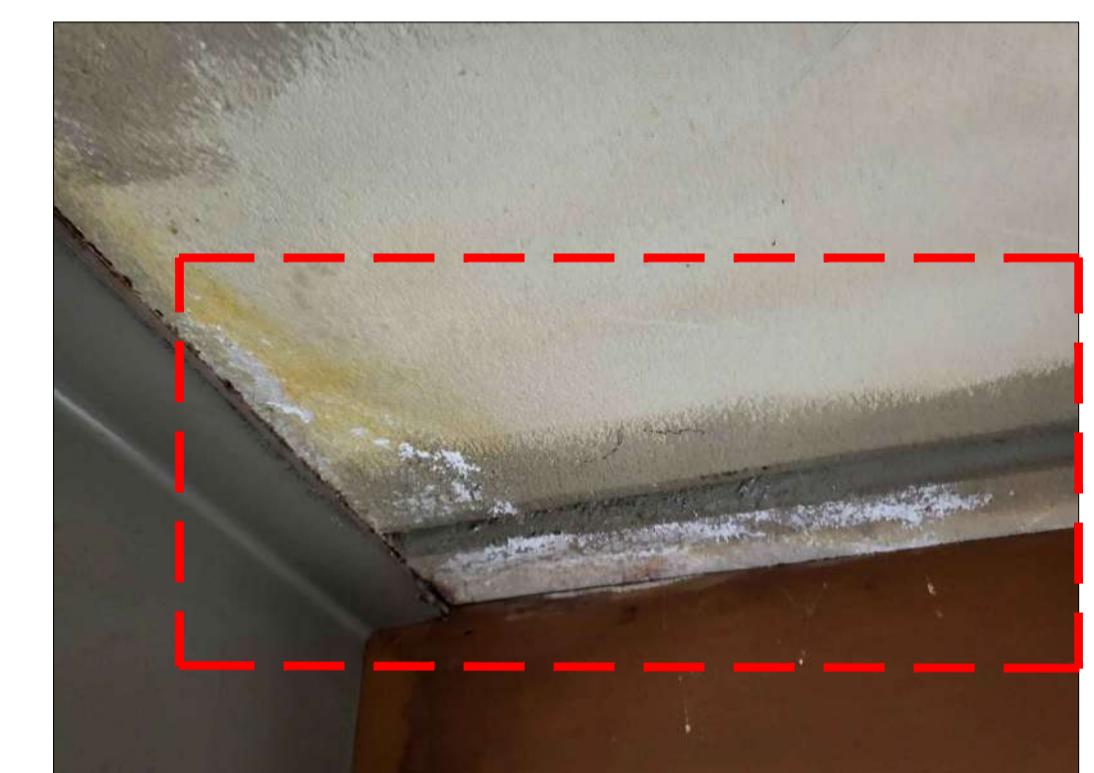
PHOTO 85 - PLANK No. 175 & 209
EFFLORESCENCE AT BOTH ENDS

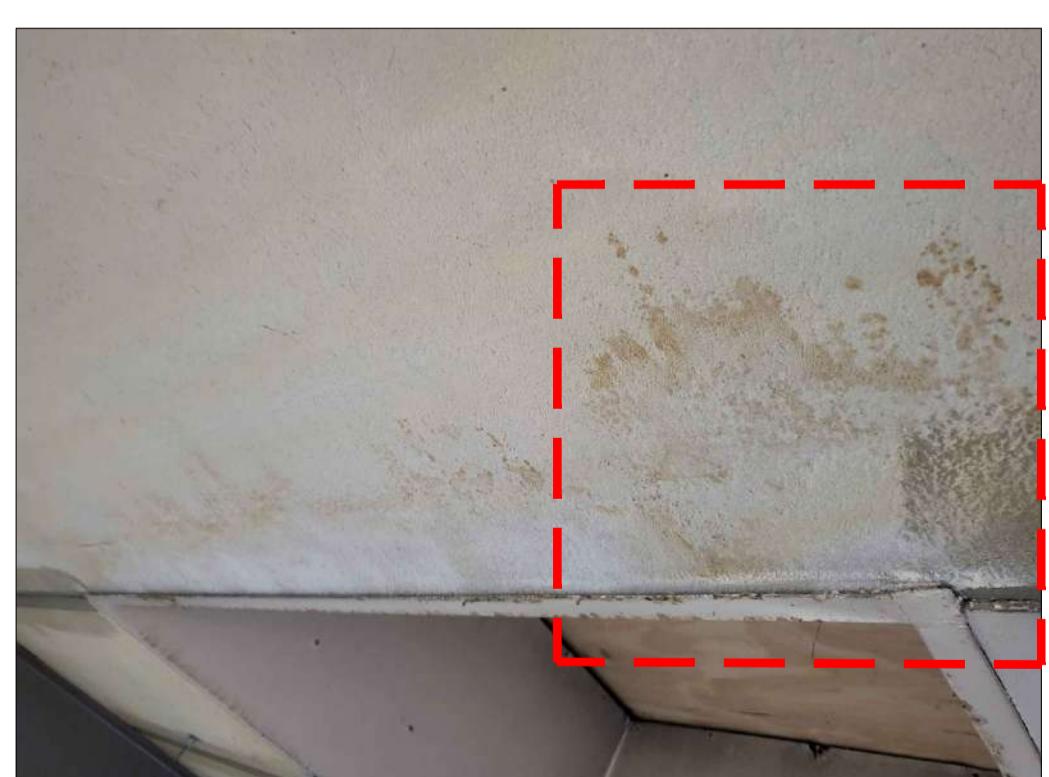
PHOTO 86 - PLANK No. 207
WATER STAIN

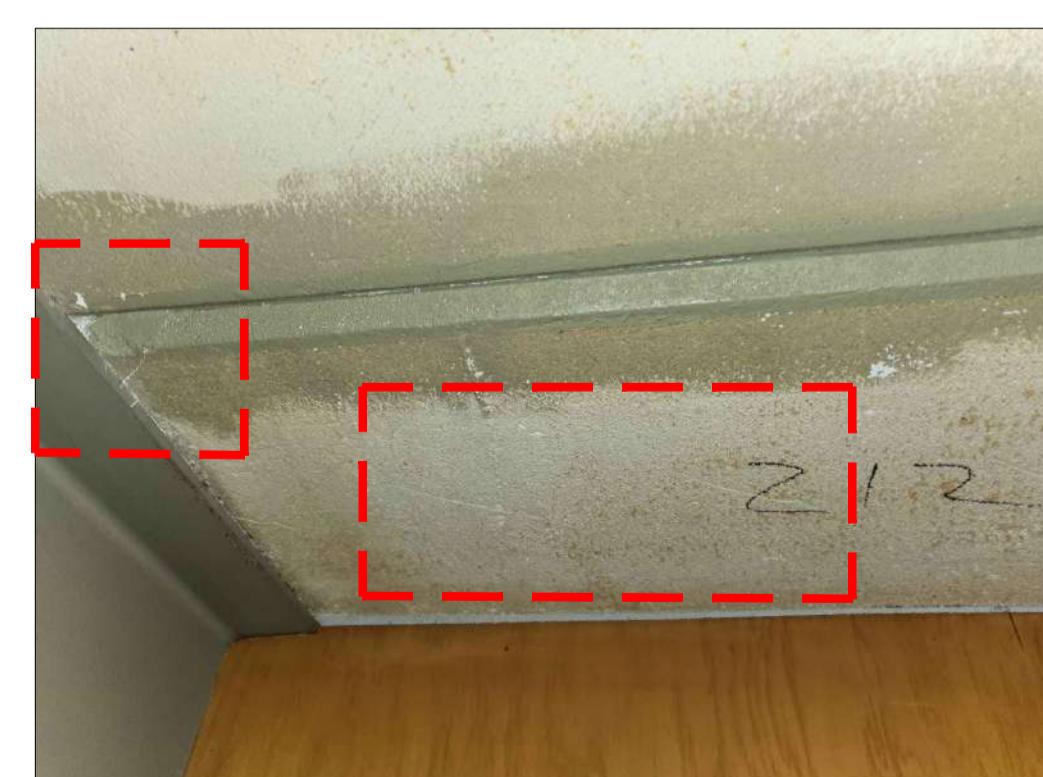
PHOTO 87 - PLANK No. 212
SCAR AT END 1
CRACK AT END 1

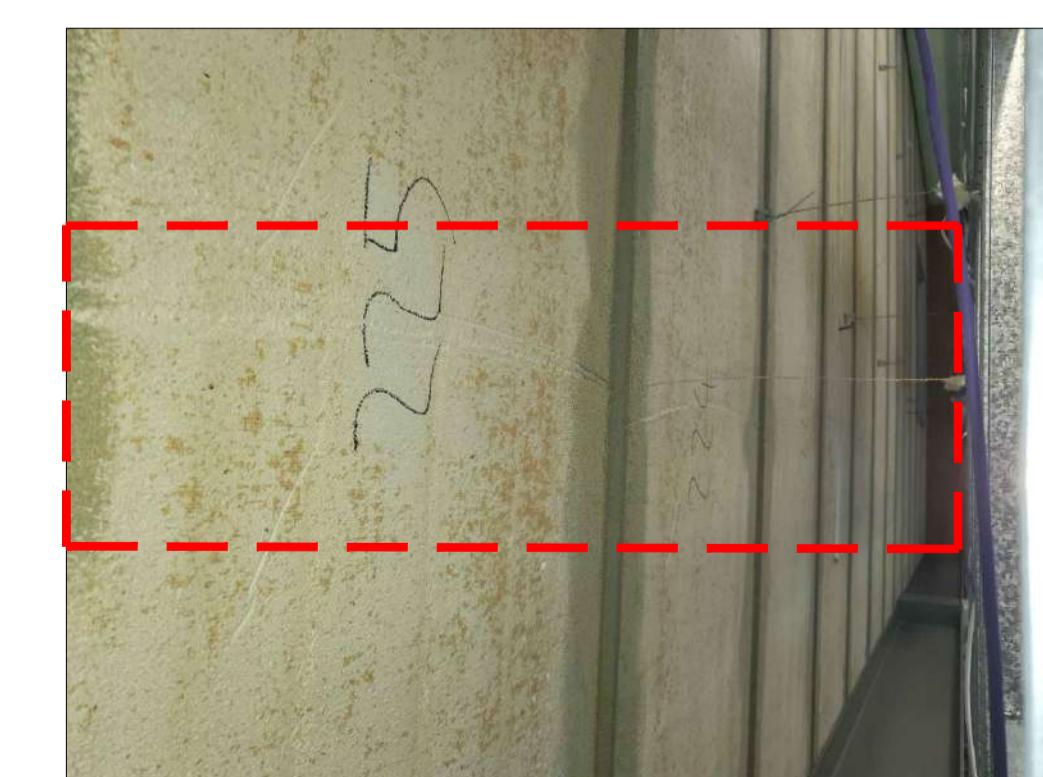
PHOTO 88 - PLANK No. 223, 224 & 225
SCAR

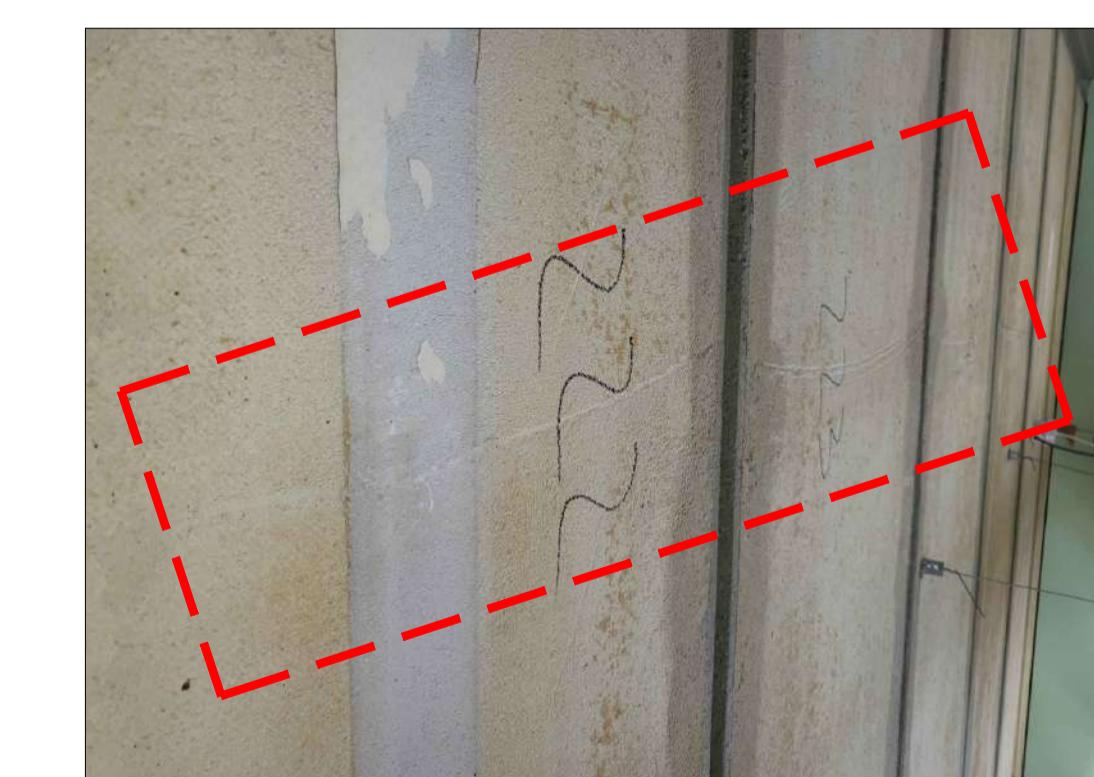
PHOTO 89 - PLANK No. 222, 223 & 224
SCAR

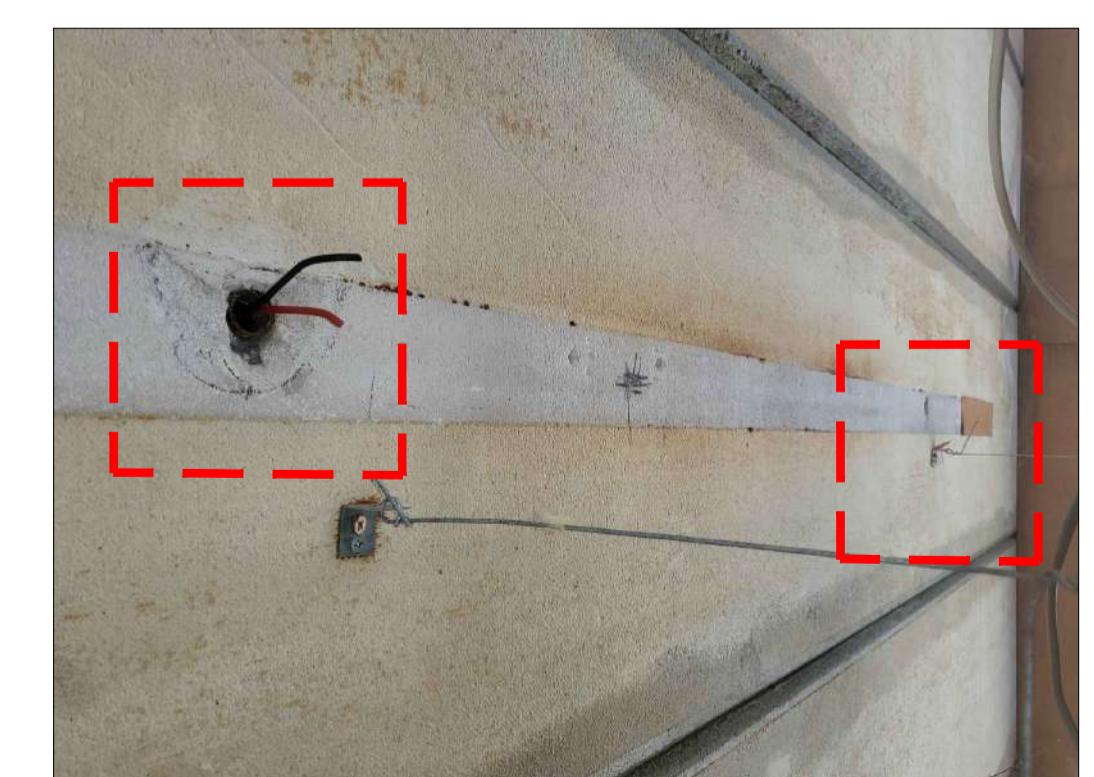
PHOTO 90 - PLANK No. 222
2No. SERVICE HOLES
