REPORT ON
CONDITION OF RAAC CONCRETE
AT
STROUD LIBRARY, LANSDOWN, STROUD

DATE: 15th March 2024

CONTRACT NO: 13827

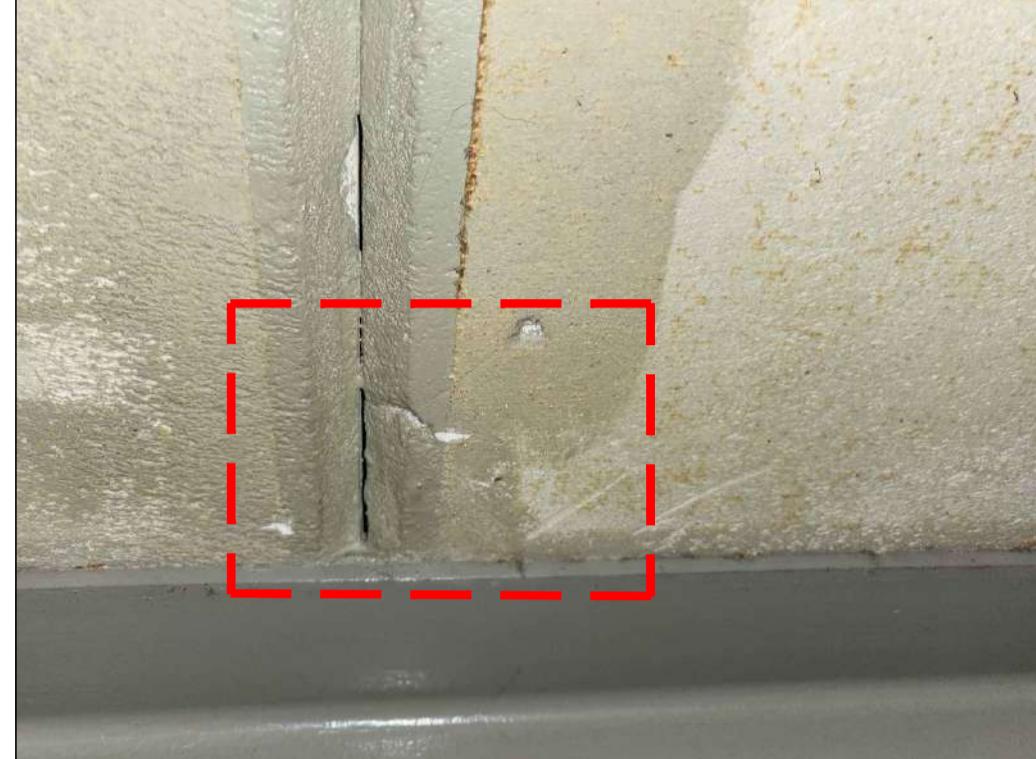
PHOTO 91 - PLANK No. 220
CRACK AT END 1

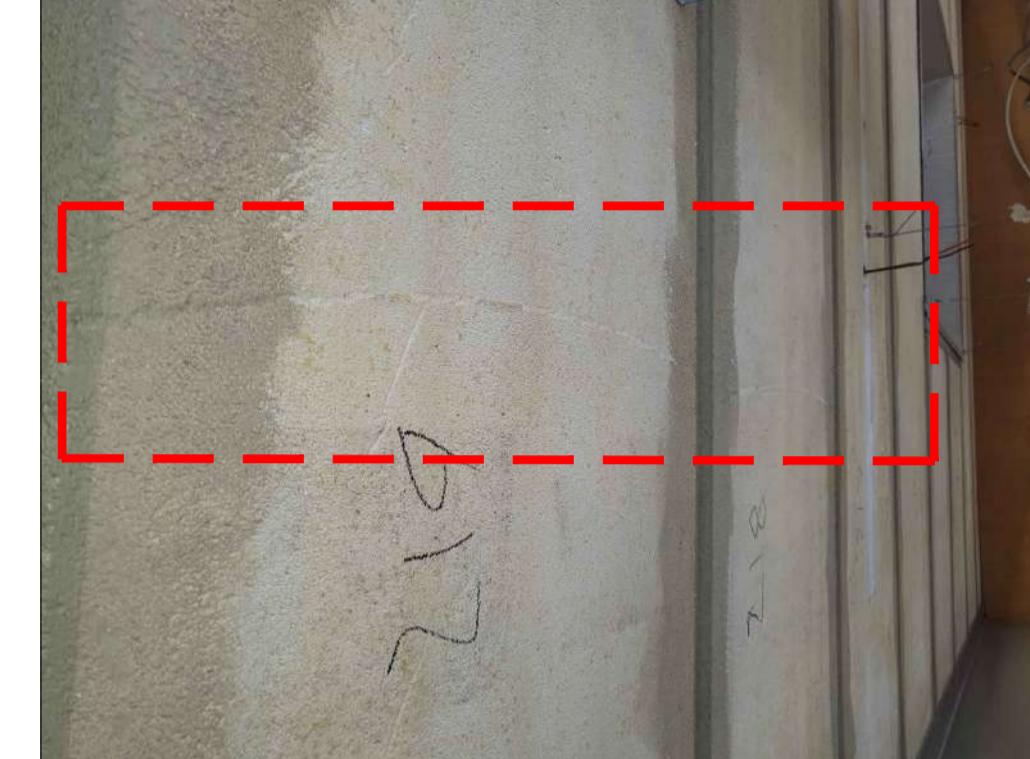
PHOTO 92 - PLANK No. 218 & 219
SCAR AT END 1

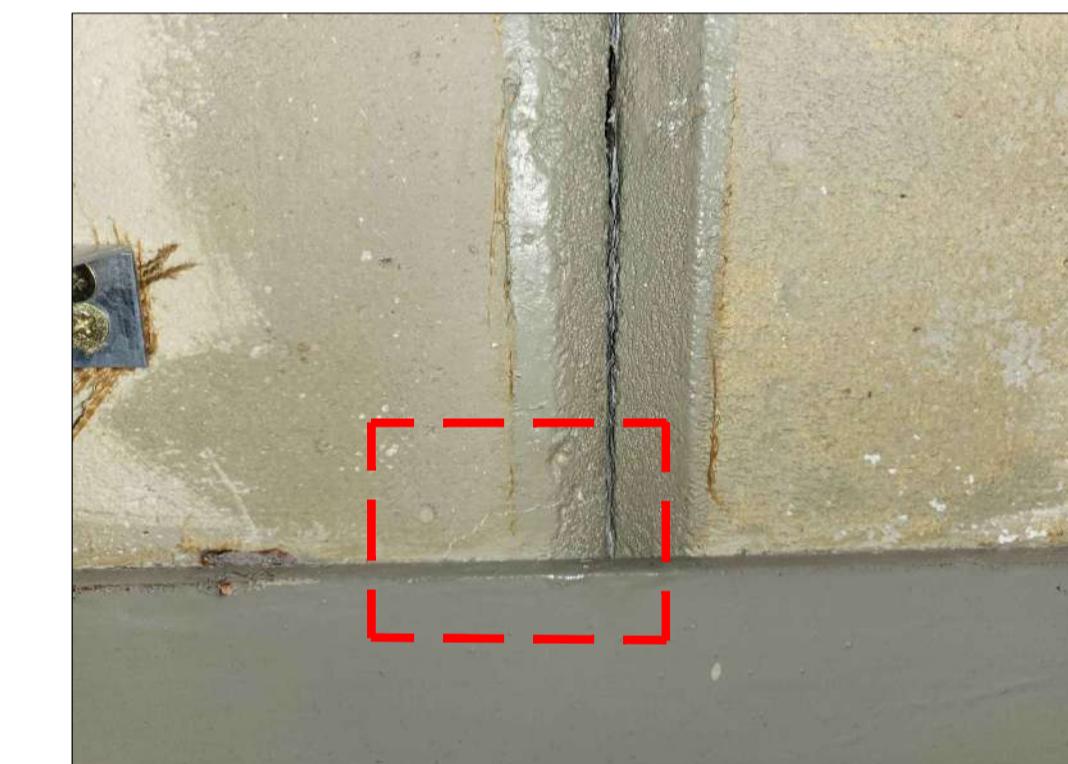
PHOTO 99 - PLANK No. 234
CRACK AT END 1

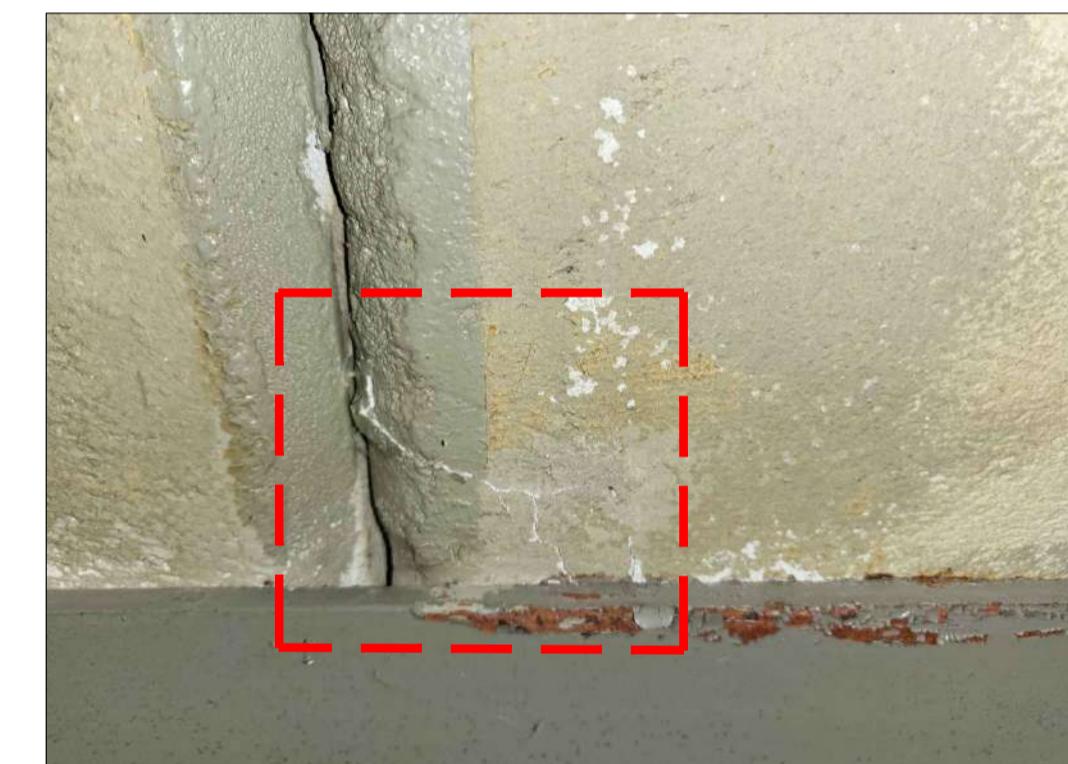
PHOTO 100 - PLANK No. 236
CRACK AT END 1

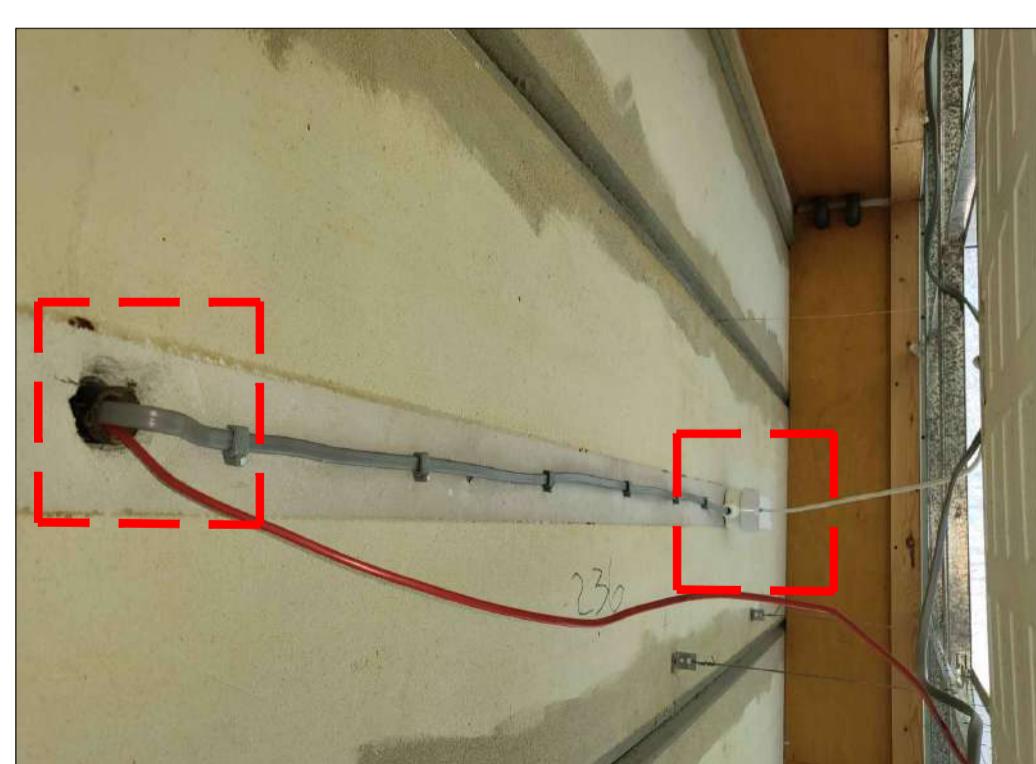
PHOTO 101 - PLANK No. 236
2No. SERVICE HOLES

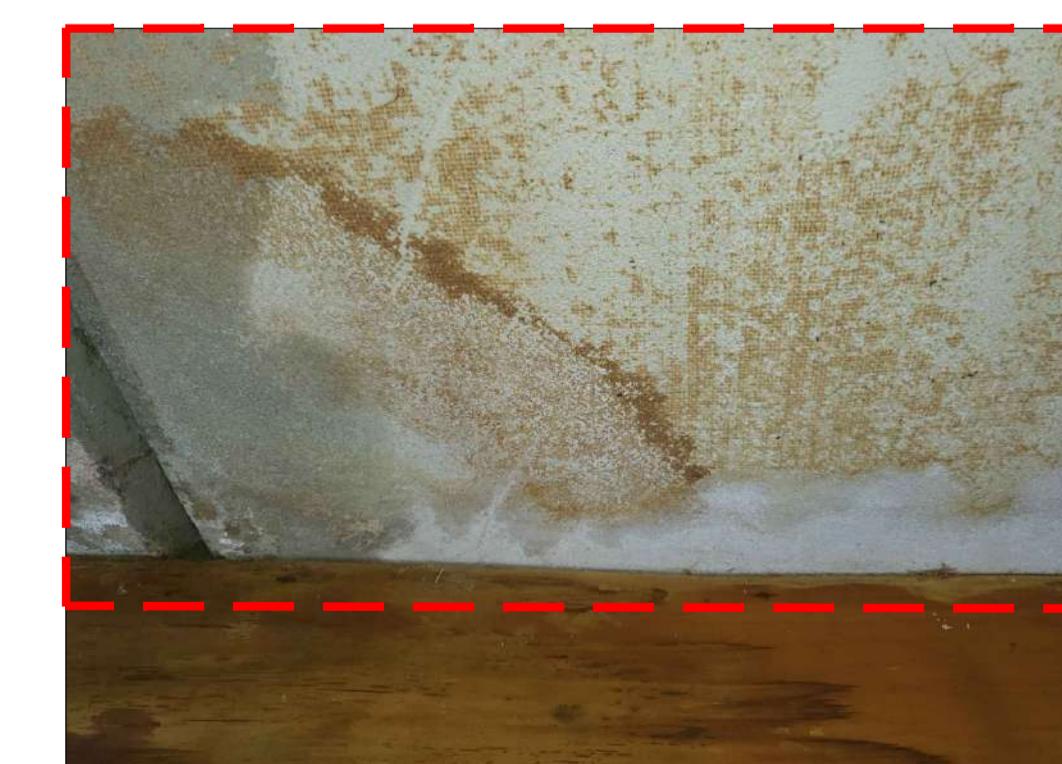
PHOTO 103 - PLANK No. 232
WATER STAIN AT END 2 BY OLD COLLAPSED CEILING TILE

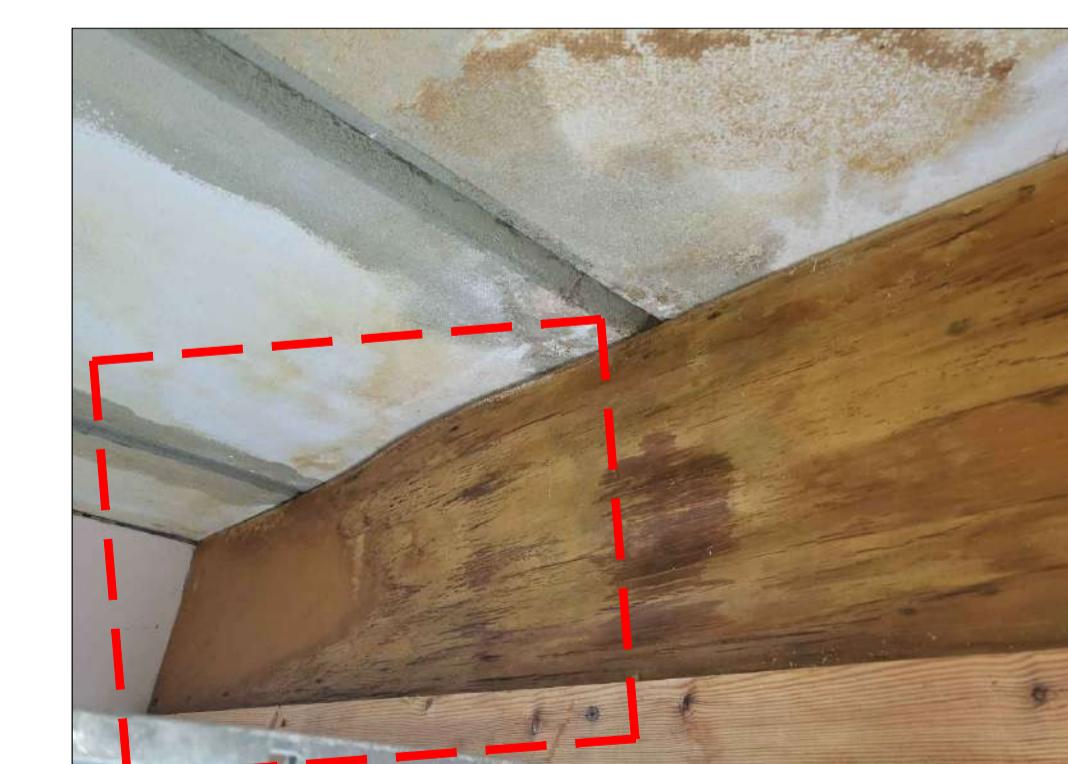
PHOTO 104 - PLANK No. 231
WARPED WOOD AT END 2

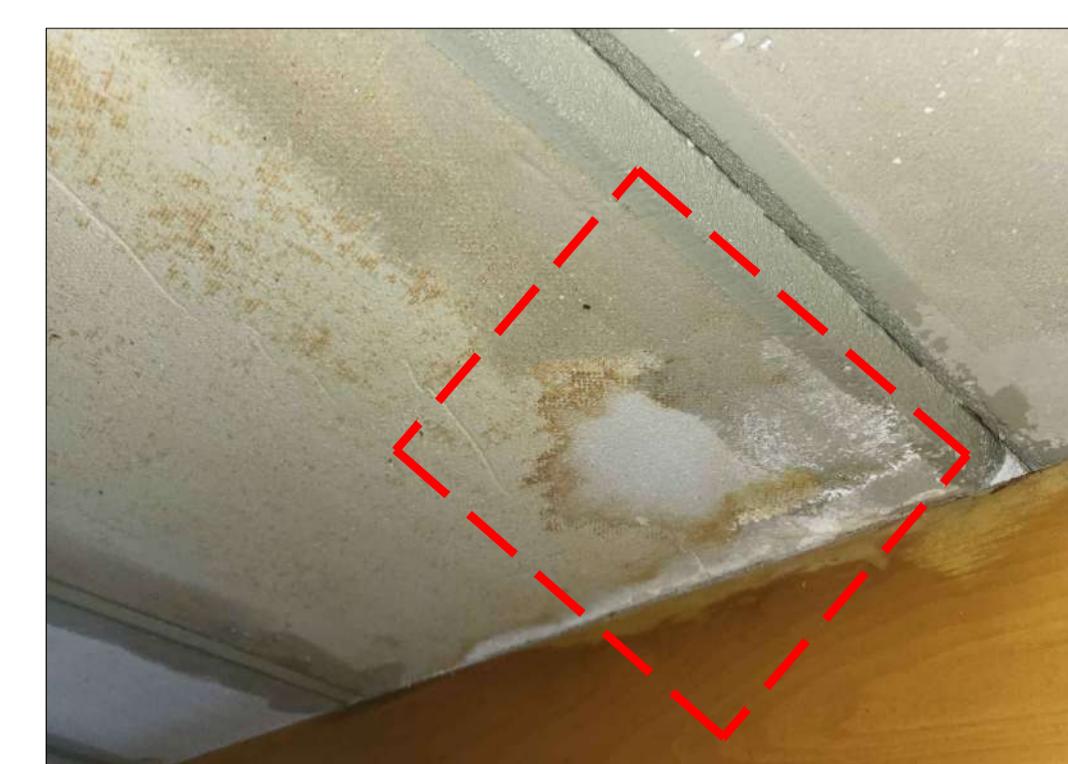
PHOTO 105 - PLANK No. 234
WATER STAIN AT END 2

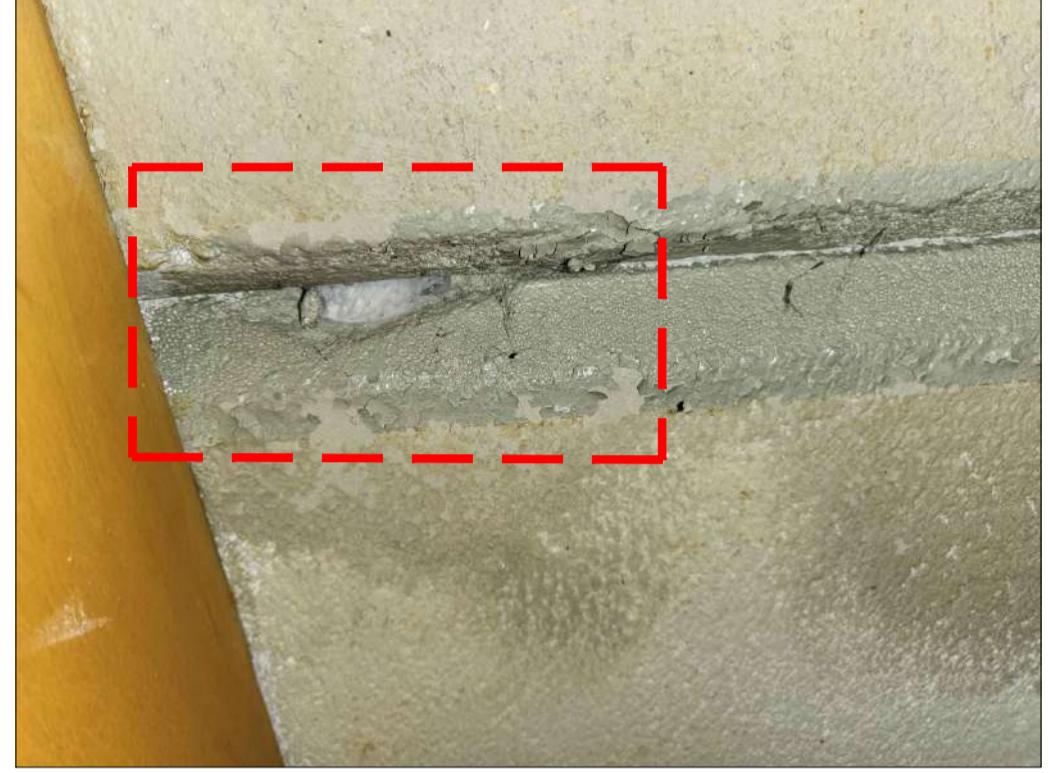
**PHOTO 106 - PLANK No. 237**

SIDE DAMAGE AT END 2
