Asbestos Survey Report

Client	Gloucestershire County Council
Site Ref	Specific Areas
Site Address	Stroud Library Lansdown Stroud SL6 1BB
Survey Date	20 June 2014
Report Issue Date	27 June 2014
Report Reference	GCC0348
Survey Type	Refurbishment Survey to Specific Areas

✓ Refurbishment Survey to Specific Areas	<p>This type of survey is required before any refurbishment or demolition work is carried out and is used to locate and describe, as far as reasonably practicable, all ACMs in the area where the refurbishment work will take place or in the whole building if demolition is planned. The survey is fully intrusive and involves destructive inspections, as necessary, to gain access to all areas, including those that may be difficult to reach and may need to penetrate all parts of the building structure. Material assessments (although not required for this type of survey) of the various ACMs and their ability to release fibres into the air if they are disturbed in some way are provided on the individual item inspections. Sampling procedures are as described above. Any areas not accessed are listed on page 17 and must be presumed to contain asbestos. These will be required to be acces

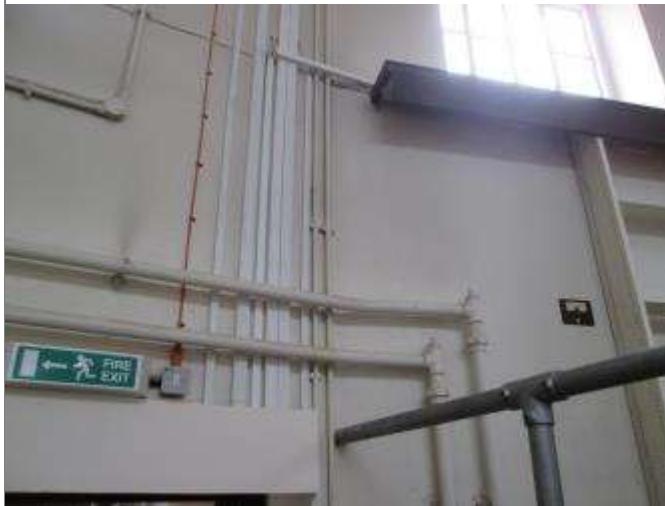
Item	Level	Location / Room number	Survey Type	Sample Reference	Quantity							
3	First	Rear Office and Store Wall adjacent entrance door	Refurbishment	Visual Inspection	-							
Material Description				Material Risk

No suspect materials observed to wall adjacent entrance door								
Additional Information				Timber skylight cheeks at high level								
				- - - -								
Recommendations				Accessibility								
				- - - -								
Review Date				- - - -								
Ceiling		Ceiling Soffit	Wall	Flooring	Other							
-		Plastered / Block work	-	-

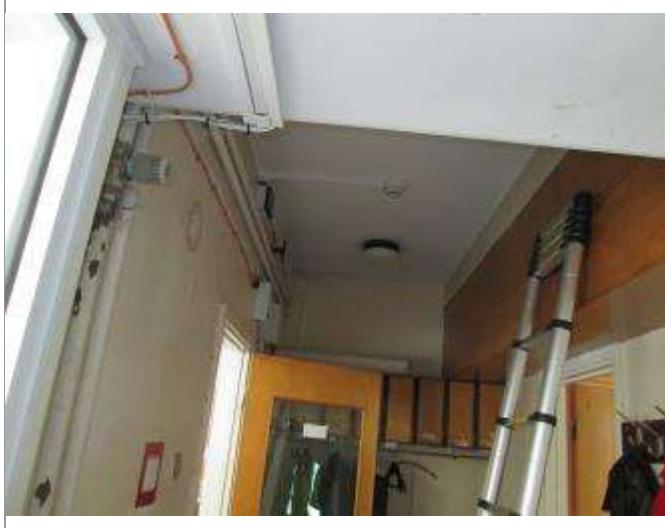
Item	Level	Location / Room number	Survey Type	Sample Reference	Quantity							
4	First	Rear Entrance Walls and Ceiling	Refurbishment	Visual Inspection	-							
Material Description				Material Risk

No suspect materials observed to walls and ceiling								
Additional Information				Access above plasterboard panel above entrance door was limited – would cause irreparable damage								
				- - - -								
Recommendations				Accessibility								
				- - - -								
Review Date				- - - -								
Ceiling		Ceiling Soffit	Wall	Flooring	Other							
Plasterboard panels	Concrete	Plastered / Plasterboard / Block work	-	-

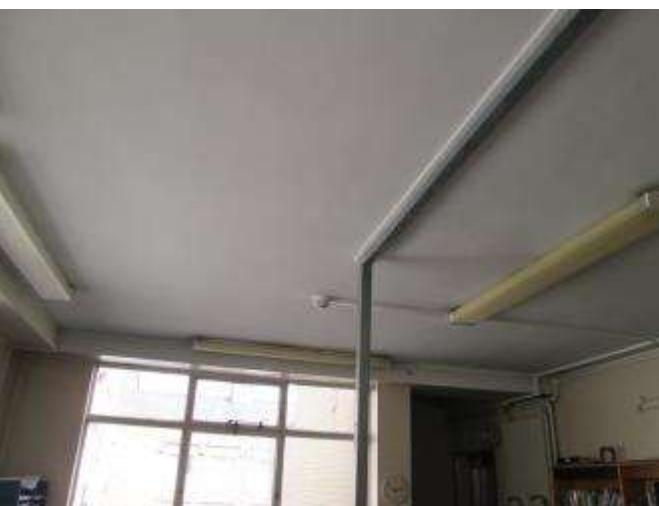
Item	Level	Location / Room number	Survey Type	Sample Reference	Quantity							
5	First	Office Ceiling	Refurbishment	Visual Inspection	-							
Material Description				Material Risk

No suspect materials observed to ceiling								
Additional Information				-								
				-								
Score - Material Risk				-								
				-								
Recommendations				Accessibility								
				-								
Review Date				-								
				-								
Ceiling	Ceiling Soffit	Wall	Flooring	Other								
-	Concrete	-	-	-

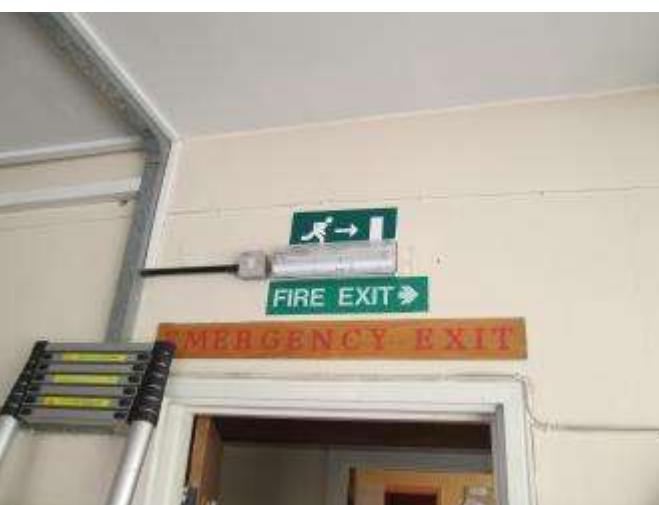
Item	Level	Location / Room number	Survey Type	Sample Reference	Quantity							
6	First	Office Walls	Refurbishment	Visual Inspection	-							
Material Description				Material Risk

No suspect materials observed to walls								
				-								
Additional Information				-								
				To walls for switches and luminaries only								
Score - Material Risk				-								
				-								
Recommendations				Accessibility								
				-								
Review Date				-								
				-								
Ceiling	Ceiling Soffit	Wall	Flooring	Other								
-	-	Plastered / Block work	-	-

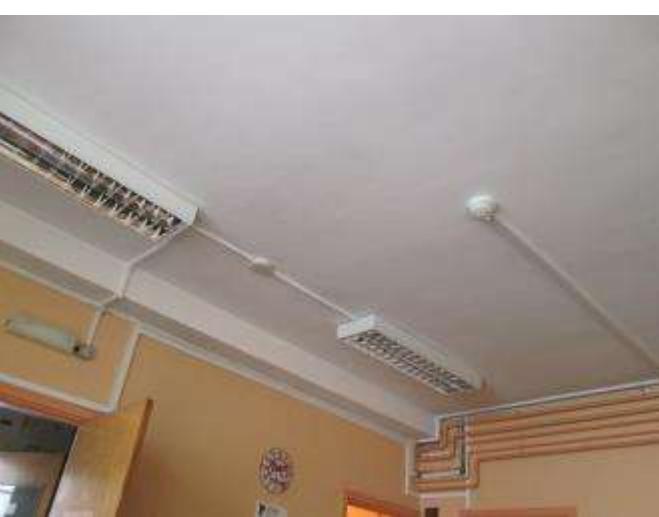
Item	Level	Location / Room number	Survey Type	Sample Reference	Quantity													
7	First	Staff Room and Kitchen Walls and Ceiling	Refurbishment	Visual Inspection	-													
Material Description				Material Risk

No suspect materials observed to walls and ceiling Additional Information To ceiling and walls for switches and luminaries only -														
				Score - Material Risk - - - - -														
Recommendations				Accessibility														
Review Date																		
<table border="1" style="width: 100%; border-collapse: collapse;"> <thead> <tr> <th>Ceiling</th> <th>Ceiling Soffit</th> <th>Wall</th> <th>Flooring</th> <th>Other</th> </tr> </thead> <tbody> <tr> <td>-</td> <td>Concrete</td> <td>Plastered / Block work</td> <td>-</td> <td>-</td> </tr> </tbody> </table>									Ceiling	Ceiling Soffit	Wall	Flooring	Other	-	Concrete	Plastered / Block work	-	-
Ceiling	Ceiling Soffit	Wall	Flooring	Other														
-	Concrete	Plastered / Block work	-	-

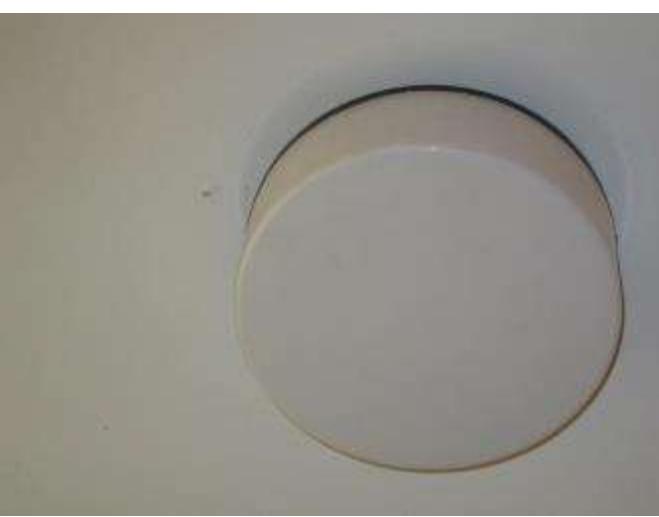
Item	Level	Location / Room number	Survey Type	Sample Reference	Quantity													
8	First	W.C's and Lobby Ceiling and Walls	Refurbishment	Visual Inspection	-													
Material Description				Material Risk

No suspect materials observed to ceiling and walls Additional Information To ceiling soffit and walls for switches and luminaries only Plasterboard panels to underside of luminaries skinned over Concrete to remainder														
				Score - Material Risk - - - - -														
Recommendations				Accessibility														
Review Date																		
<table border="1" style="width: 100%; border-collapse: collapse;"> <thead> <tr> <th>Ceiling</th> <th>Ceiling Soffit</th> <th>Wall</th> <th>Flooring</th> <th>Other</th> </tr> </thead> <tbody> <tr> <td>Plasterboard panels</td> <td>Concrete</td> <td>Plasterboard/ Block work</td> <td>-</td> <td>-</td> </tr> </tbody> </table>									Ceiling	Ceiling Soffit	Wall	Flooring	Other	Plasterboard panels	Concrete	Plasterboard/ Block work	-	-
Ceiling	Ceiling Soffit	Wall	Flooring	Other														
Plasterboard panels	Concrete	Plasterboard/ Block work	-	-

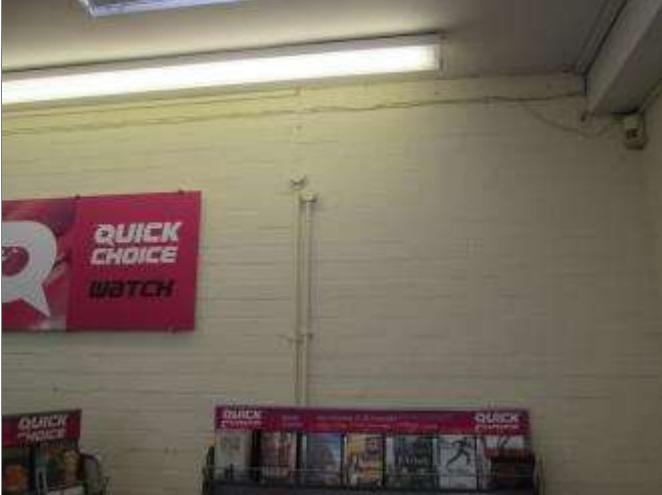
Item	Level	Location / Room number	Survey Type	Sample Reference	Quantity			
9	First	Main Library Wall	Refurbishment	Visual Inspection	-			
Material Description								Material Risk

No suspect materials observed to wall								Product Type Extent of Damage Surface Treatment Asbestos Type
Additional Information								
To wall for switches and luminaries								-
Recommendations								Accessibility
-								
Review Date								-
Ceiling Ceiling Soffit Wall Flooring Other								
-	-	Plasterboard / Block work	-	-

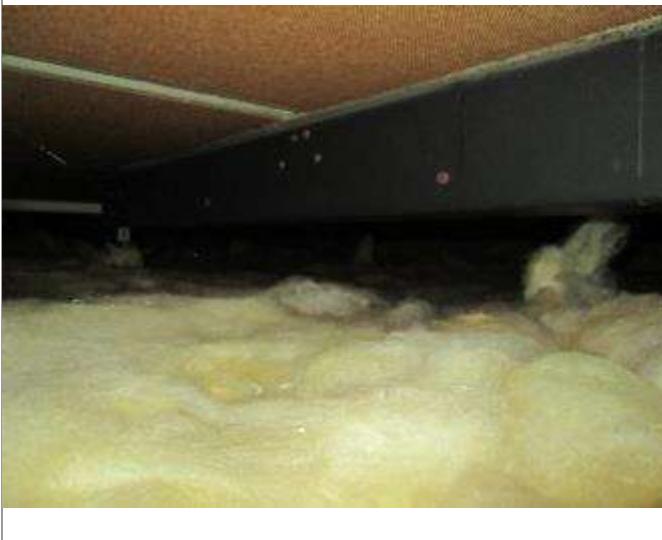
Item	Level	Location / Room number	Survey Type	Sample Reference	Quantity			
10	First	Main Library Ceiling and Void	Refurbishment	Visual Inspection	-			
Material Description								Material Risk

No suspect materials observed to ceiling and within ceiling void								Product Type Extent of Damage Surface Treatment Asbestos Type
Additional Information								
Limited access in ceiling void due to MMMF insulation on top of tiles and low soffit Old luminaries are affixed to concrete soffit and newer ones are affixed to ceiling grid Hessian wrap affixed to soffit Timber panels and plasterboard and concrete to perimeter of ceiling void								-
Recommendations								Accessibility
-								
Review Date								-
Ceiling Ceiling Soffit Wall Flooring Other								
Suspended / MMMF tiles	Concrete	-	-	-

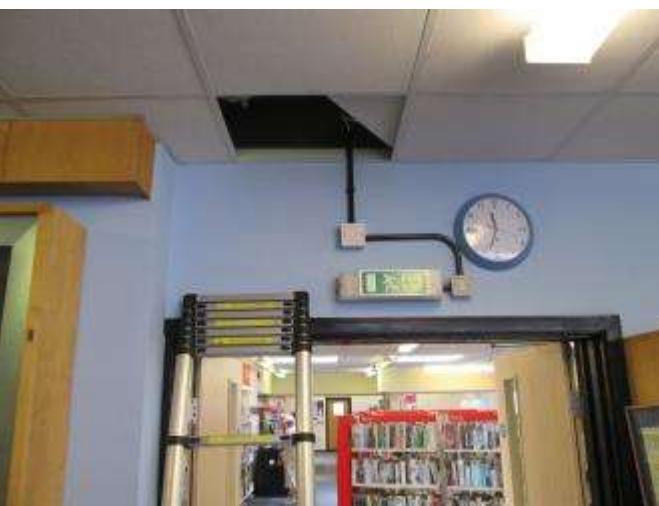
Item	Level	Location / Room number	Survey Type	Sample Reference	Quantity			
11	First	Local Study Info Walls	Refurbishment	Visual Inspection	-			
Material Description								Material Risk

No suspect materials observed to wall								Product Type Extent of Damage Surface Treatment Asbestos Type
Additional Information								
To wall for switches and luminaries only								
Recommendations								Accessibility
-								
Review Date								
-								
Ceiling	Ceiling Soffit	Wall	Flooring	Other				
-	-	Plastered / Block work	-	-

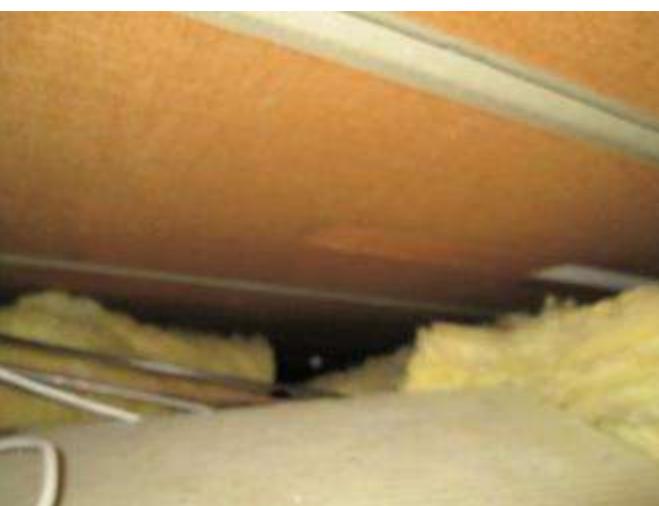
Item	Level	Location / Room number	Survey Type	Sample Reference	Quantity			
12	First	Local Study Ceiling Void and Ceiling	Refurbishment	Visual Inspection	-			
Material Description								Material Risk

No suspect materials observed to ceiling and within ceiling void								Product Type Extent of Damage Surface Treatment Asbestos Type
Additional Information								
Lights affixed to ceiling grid Hessian wrap affixed to soffit Timber boxing panels not in scope Limited access due to MMMF insulation to top of tiles Metal skylight cheeks Some timber, plasterboard and concrete panels to perimeter of ceiling void								
Recommendations								Accessibility
-								
Review Date								
-								
Ceiling	Ceiling Soffit	Wall	Flooring	Other				
Suspended / MMMF tiles	Concrete	-	-	-

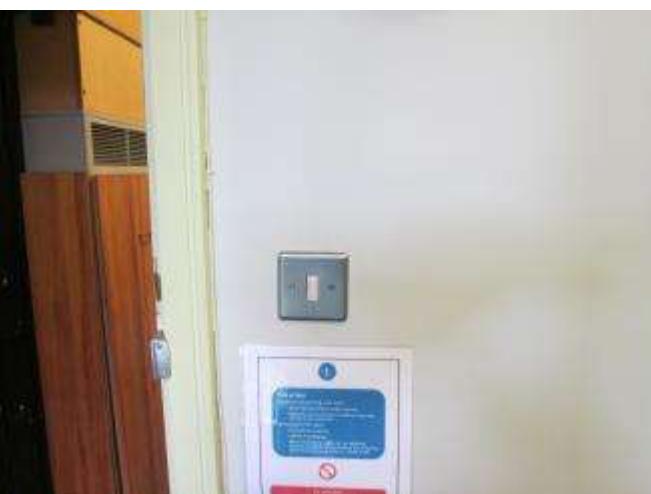
Item	Level	Location / Room number	Survey Type	Sample Reference	Quantity			
13	First	Group Librarian Wall	Refurbishment	Visual Inspection	-			
				Material Description	Material Risk

No suspect materials observed to wall	Product Type	Extent of Damage	Surface Treatment	Asbestos Type
				Additional Information	-	-	-	-
				To wall for switch only	-	-	-	-
				Recommendations	Accessibility			
				-	-			
				Review Date	-			
				-	-			
Ceiling	Ceiling Soffit	Wall	Flooring	Other				
-	-	Plastered / Block work	-	-

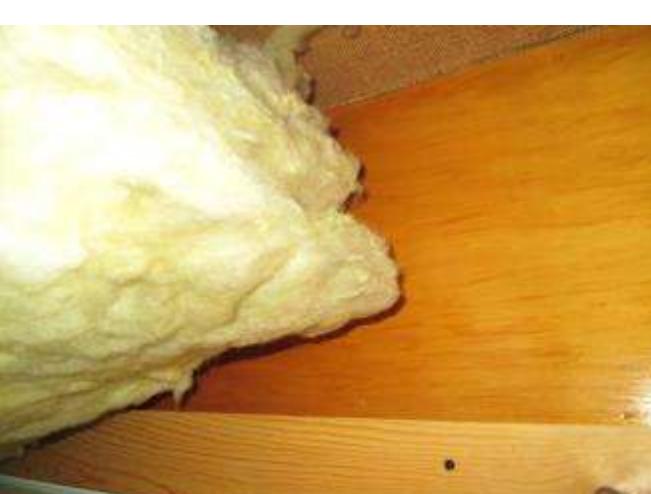
Item	Level	Location / Room number	Survey Type	Sample Reference	Quantity			
14	First	Group Librarian Ceiling Void	Refurbishment	Visual Inspection	-			
				Material Description	Material Risk

No suspect materials observed to ceiling and within ceiling void	Product Type	Extent of Damage	Surface Treatment	Asbestos Type
				Additional Information	-	-	-	-
				Light affixed to ceiling grid Limited access into void due to MMMF insulation Timber panel above window Hessian wrap to concrete soffit	-	-	-	-
				Recommendations	Accessibility			
				-	-			
				Review Date	-			
				-	-			
Ceiling	Ceiling Soffit	Wall	Flooring	Other				
Suspended / MMMF	Concrete	-	-	-

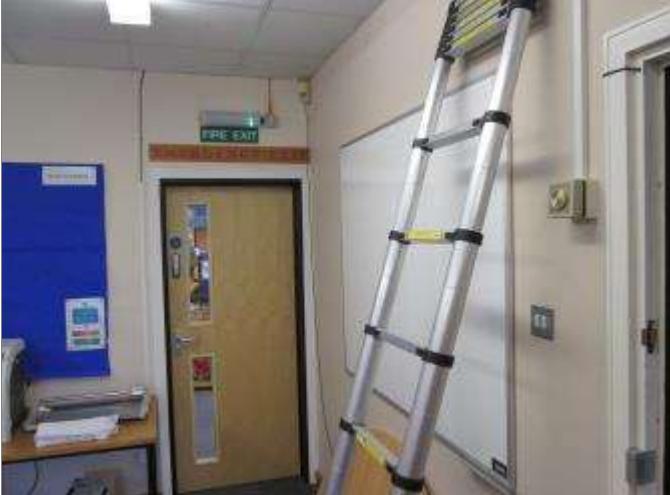
Item	Level	Location / Room number	Survey Type	Sample Reference	Quantity			
15	First	Group Office Wall	Refurbishment	Visual Inspection	-			
Material Description								Material Risk

No suspect materials observed to wall								
Additional Information								
For switches and luminaries only								
Recommendations								Accessibility
Review Date								
Ceiling	Ceiling Soffit	Wall	Flooring	Other				
-	-	-	-	-

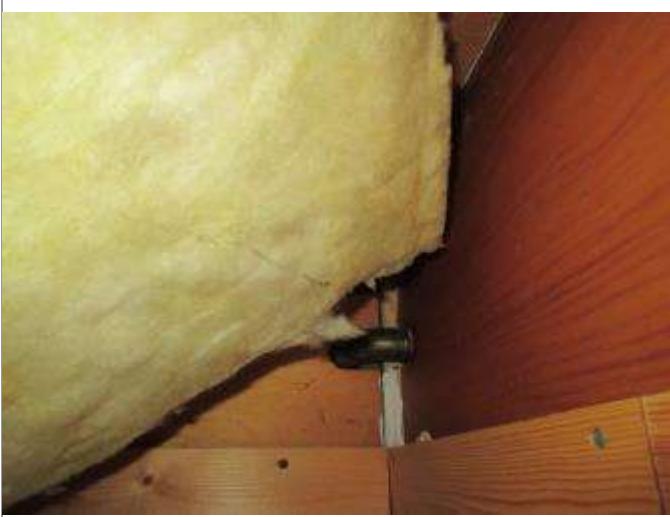
Item	Level	Location / Room number	Survey Type	Sample Reference	Quantity			
16	First	Group Office Ceiling Void and Ceiling	Refurbishment	Visual Inspection	-			
Material Description								Material Risk

No suspect materials observed to ceiling or within ceiling void								
Additional Information								
Lights affixed to ceiling grid Limited access into void due to MMMF insulation Timber panels above windows Hessian wrap to concrete soffit								
Recommendations								Accessibility
Review Date								
Ceiling	Ceiling Soffit	Wall	Flooring	Other				
Suspended / MMMF tiles	Concrete	-	-	-
