Asbestos Survey Report

Client **Gloucestershire County Council**
Site Ref **N/A**
Site Address **Stroud Branch Library
Stroud
GL5 1JR**
Survey Date **24 September 2012**
Report Issue Date **19 October 2012**
Report Reference **GCC0170**
Survey Type **Management Survey**

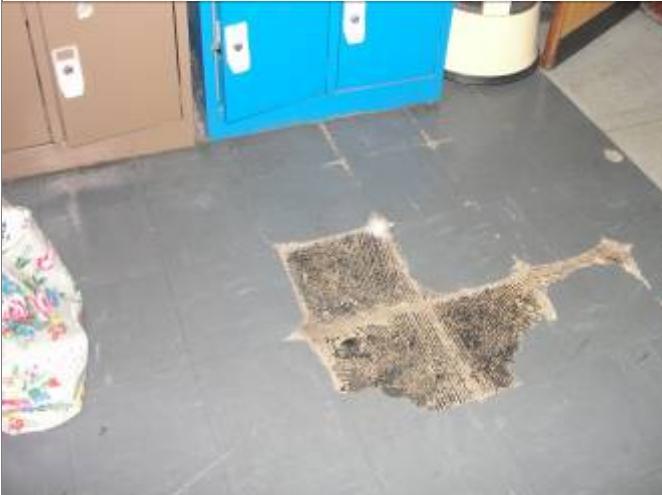
Item	Level	Location / Room number	Survey Type	Sample Reference	Quantity					
3	First	Link Corridor	Management	GCC0170/02	10 m ²					
Material Description				Material Risk

Asbestos bonded floor tiles (Grey)						
Additional Information				1	2	0	1			
Cast iron soil pipe Timber framed exit door No access within boxing No suspect materials observed to remainder of surveyed area				Score - Material Risk						
				4	Very Low					
Recommendations				Accessibility						
Repair and manage in accordance with current asbestos legislation				Low						
				Review Date						
				September 2013						
Ceiling	Ceiling Soffit	Wall	Flooring	Other						
Plastered/ Plasterboard panels	No access	Plastered/ Block work	Tiles/ Screed	Pipe work – Unlagged Riser covers – Plasterboard/ Timber

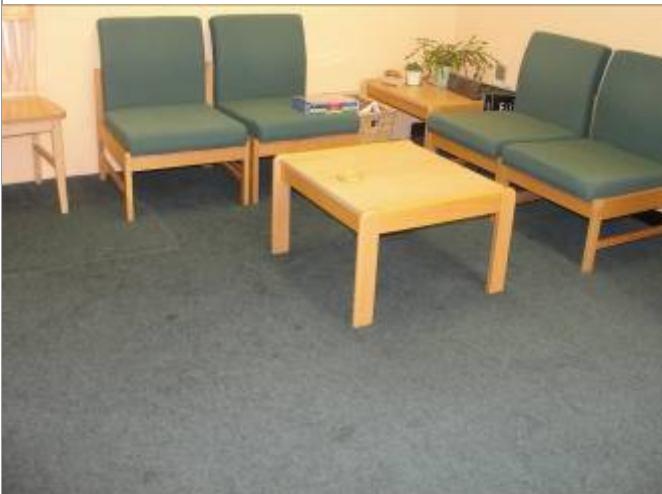
Item	Level	Location / Room number	Survey Type	Sample Reference	Quantity					
4	First	Store Room	Management	Visual Inspection	-					
Material Description				Material Risk

No suspect materials observed within surveyed area						
Additional Information				-	-	-	-			
Metal framed windows				Score - Material Risk						
				-	-					
Recommendations				Accessibility						
				-						
Review Date				-						
Ceiling	Ceiling Soffit	Wall	Flooring	Other						
Plastered	Concrete	Plastered/ Block work	Carpet/ Screed	Pipe work - Unlagged
