ASBESTOS SURVEY REPORT

Client : **Gloucestershire County Council**
Site Ref : **All Accessible Areas**
Site Address : **Winchcombe Youth and Community Centre
8 Gretton Road
Winchcombe
Cheltenham
Gloucestershire
GL54 5EE**
Survey Date : **23rd October 2024**
Report Issue Date : **29th October 2024**
Report Reference : **J052241**
Survey Type : **Management Survey**

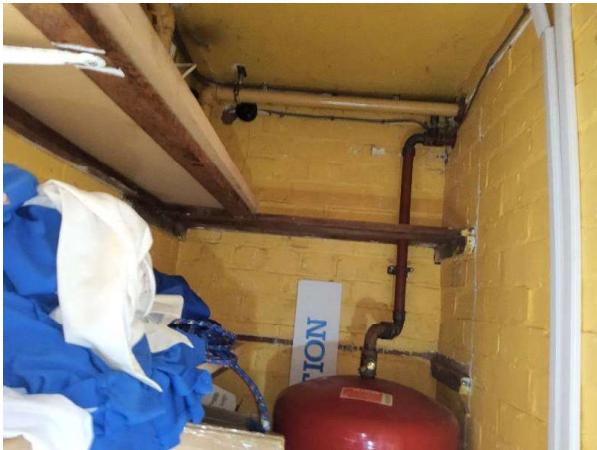
Item	Level	Building Name / Location / Room Number	Survey Type	Sample Reference	Quantity		
1	Ground Floor	01-0F-007 Store	Management	Visual Inspection	-

Material Description / Location		Material Risk		
			No suspect materials observed within surveyed area		Product Type	Extent of Damage	Surface Treatment
			Additional Information		-	-	-
					Score - Material Risk		
					-	-	
			Recommendations		Accessibility		
					Review Period		
Inspection Level	Analysis Result	Product Type	Licensed / Non-Licensed				
-	-	-	-

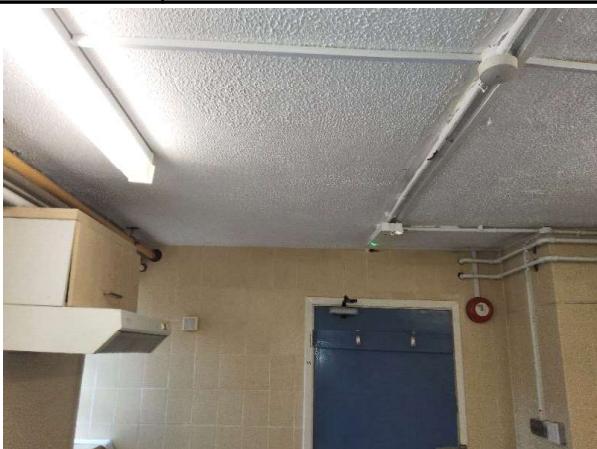
Item	Level	Building Name / Location / Room Number	Survey Type	Sample Reference	Quantity		
2	Ground Floor	01-0F-008 Kitchen	Management	CW003359	-

Material Description / Location		Material Risk		
			Textured coating (stipple effect) to plastered concrete soffit		Product Type	Extent of Damage	Surface Treatment
			Additional Information		-	-	-
			Treat as uniform throughout.		Score - Material Risk		
					-	-	
			Recommendations		Accessibility		
			No asbestos detected in sample		Review Period		
Inspection Level	Analysis Result	Product Type	Licensed / Non-Licensed				
-	No asbestos detected in sample	-	-

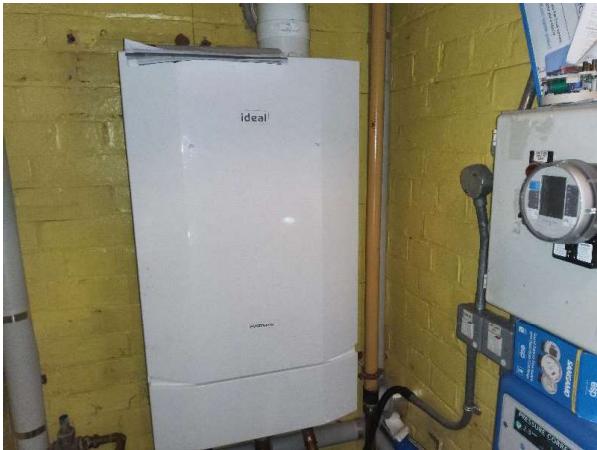
Item	Level	Building Name / Location / Room Number	Survey Type	Sample Reference	Quantity										
3	Ground Floor	01-0F-009 Boiler Cupboard	Management	Visual Inspection	-

Material Description / Location No suspect materials observed within surveyed area		Material Risk <table border="1" style="display: inline-table; vertical-align: middle;"> <tr> <td>Product Type</td> <td>Extent of Damage</td> <td>Surface Treatment</td> <td>Asbestos Type</td> </tr> <tr> <td>-</td> <td>-</td> <td>-</td> <td>-</td> </tr> </table>			Product Type	Extent of Damage	Surface Treatment	Asbestos Type	-	-	-	-
Product Type	Extent of Damage	Surface Treatment	Asbestos Type												
-	-	-	-												
			Additional Information -		Score - Material Risk - - -										
			Recommendations -		Accessibility -										
			Review Period -												
Inspection Level	Analysis Result	Product Type	Licensed / Non-Licensed												
-	-	-	-

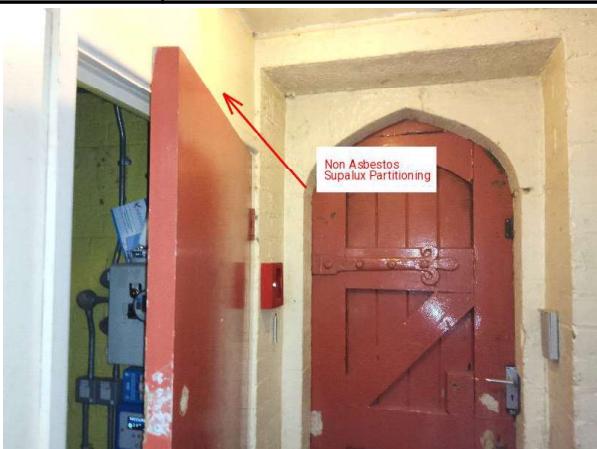
Item	Level	Building Name / Location / Room Number	Survey Type	Sample Reference	Quantity										
4	Ground Floor	01-0F-010 Lobby	Management	Visual Inspection	-

Material Description / Location No suspect materials observed within surveyed area		Material Risk <table border="1" style="display: inline-table; vertical-align: middle;"> <tr> <td>Product Type</td> <td>Extent of Damage</td> <td>Surface Treatment</td> <td>Asbestos Type</td> </tr> <tr> <td>-</td> <td>-</td> <td>-</td> <td>-</td> </tr> </table>			Product Type	Extent of Damage	Surface Treatment	Asbestos Type	-	-	-	-
Product Type	Extent of Damage	Surface Treatment	Asbestos Type												
-	-	-	-												
			Additional Information -		Score - Material Risk - - -										
			Recommendations -		Accessibility -										
			Review Period -												
Inspection Level	Analysis Result	Product Type	Licensed / Non-Licensed												
-	-	-	-

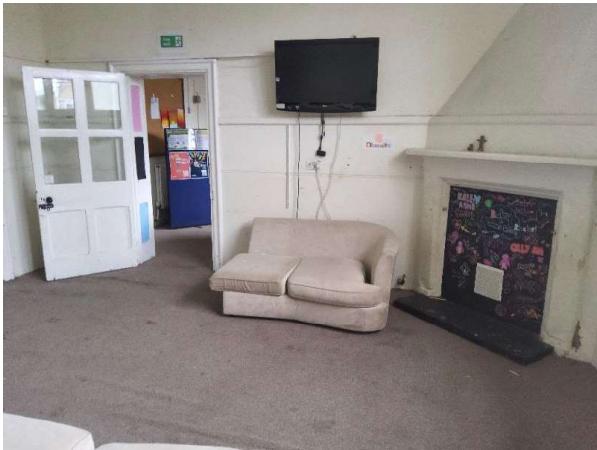
Item	Level	Building Name / Location / Room Number	Survey Type	Sample Reference	Quantity		
5	Ground Floor	01-0F-03 Coffee Lounge	Management	Visual Inspection	-

Material Description / Location		Material Risk		
			No suspect materials observed within surveyed area		Product Type	Extent of Damage	Surface Treatment
			Additional Information		-	-	-
			Limited inspection within suspended ceiling void due to heavy volume of insulation upon suspended ceiling tiles and general inaccessibility - apply caution.		Score - Material Risk		-
			Recommendations		Accessibility		
					-		
					Review Period		
					-		
Inspection Level	Analysis Result	Product Type	Licensed / Non-Licensed				
-	-	-	-

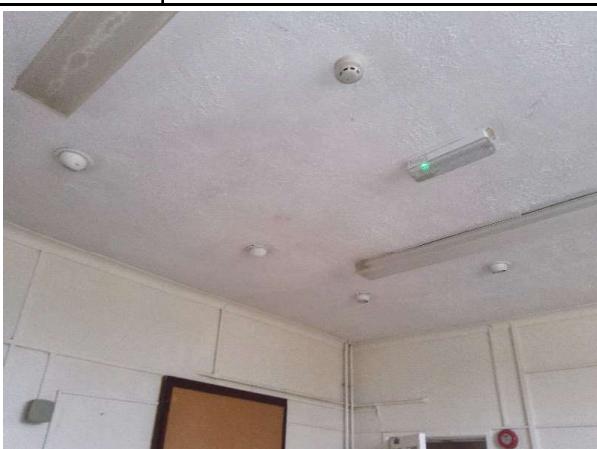
Item	Level	Building Name / Location / Room Number	Survey Type	Sample Reference	Quantity		
6	Ground Floor	01-0F-02 Computer Room	Management	CW003360	-

Material Description / Location		Material Risk		
			Textured coating (stipple effect) to plastered plasterboard ceiling		Product Type	Extent of Damage	Surface Treatment
			Additional Information		-	-	-
			Treat as uniform throughout. Limited inspection within ceiling void due to heavy volume of insulation upon and general inaccessibility - apply caution.		Score - Material Risk		-
			Recommendations		Accessibility		
					-		
			No asbestos detected in sample		Review Period		
					-		
Inspection Level	Analysis Result	Product Type	Licensed / Non-Licensed				
-	No asbestos detected in sample	-	-

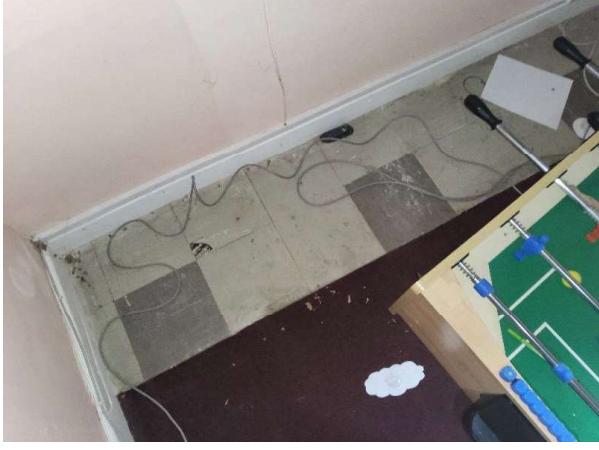
Item	Level	Building Name / Location / Room Number	Survey Type	Sample Reference	Quantity				
7	Ground Floor	01-0F-020 Circulation	Management	CW003361	2lm

Material Description / Location Asbestos bonded vinyl tiles (grey) and adhesive laid to floor below the window		Material Risk			
						Product Type	Extent of Damage		
						Surface Treatment	Asbestos Type		
				Additional Information		1	1		
				Score - Material Risk		0	1		
						3	Very Low		
				Recommendations Manage in accordance with current asbestos legislation		Accessibility Low			
				Review Period Annual					
Inspection Level	Analysis Result		Product Type	Licensed / Non-Licensed					
Identified	Chrysotile		Reinforced Composite	Non-Licensable

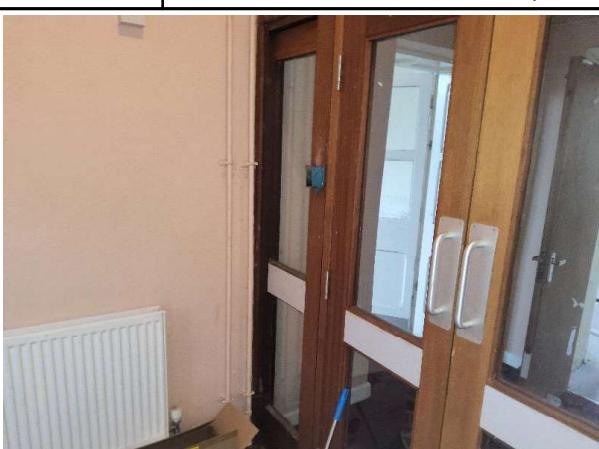
Item	Level	Building Name / Location / Room Number	Survey Type	Sample Reference	Quantity				
8	Ground Floor	01-0F-001 Entrance Lobby	Management	Visual Inspection	-

Material Description / Location No suspect materials observed within surveyed area		Material Risk			
						Product Type	Extent of Damage		
						Surface Treatment	Asbestos Type		
				Additional Information		-	-		
				Score - Material Risk		-	-		
				Recommendations		Accessibility -			
				Review Period		-			
Inspection Level	Analysis Result		Product Type	Licensed / Non-Licensed					
-	-		-	-

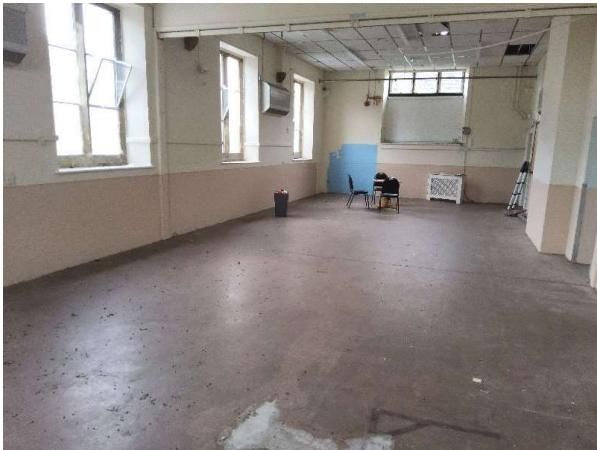
Item	Level	Building Name / Location / Room Number	Survey Type	Sample Reference	Quantity		
9	Ground Floor	01-0F-011 Main Hall	Management	Visual Inspection	-

Material Description / Location		Material Risk		
			No suspect materials observed within surveyed area		Product Type	Extent of Damage	Surface Treatment
			Additional Information		-	-	-
			Limited inspection within suspended ceiling void due to height and general inaccessibility - apply caution.		Score - Material Risk		-
			Recommendations		Accessibility		
			-		-		
					Review Period		
Inspection Level	Analysis Result	Product Type	Licensed / Non-Licensed				
-	-	-	-

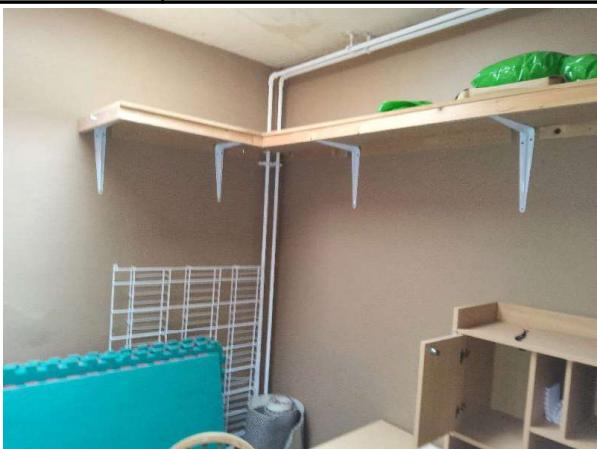
Item	Level	Building Name / Location / Room Number	Survey Type	Sample Reference	Quantity		
10	Ground Floor	01-0F-015 Store	Management	Visual Inspection	-

Material Description / Location		Material Risk		
			No suspect materials observed within surveyed area		Product Type	Extent of Damage	Surface Treatment
			Additional Information		-	-	-
					Score - Material Risk		-
					-		-
			Recommendations		Accessibility		
			-		-		
					Review Period		
Inspection Level	Analysis Result	Product Type	Licensed / Non-Licensed				
-	-	-	-

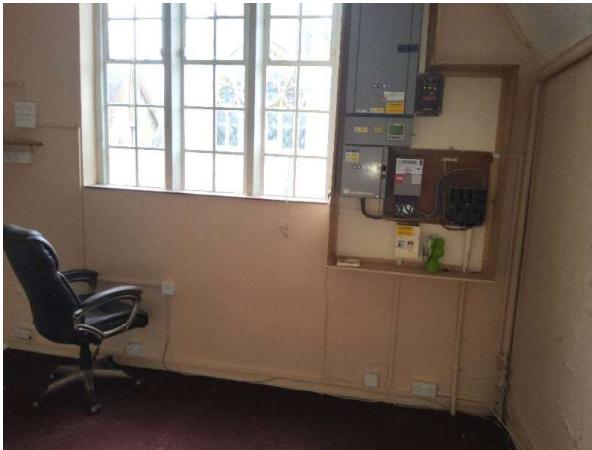
Item	Level	Building Name / Location / Room Number	Survey Type	Sample Reference	Quantity		
11	Ground Floor	01-0F-019 Office	Management	Visual Inspection	-

Material Description / Location No suspect materials observed within surveyed area		Material Risk		
			Product Type		Product Type	Extent of Damage	Surface Treatment
			Additional Information		-	-	-
			Limited inspection within suspended ceiling void - apply caution.		Score - Material Risk		-
			Recommendations		Accessibility		
			-		-		
			Review Period		-		
			-		-		
			Inspection Level		Analysis Result		
			-		-		
			Product Type		Licensed / Non-Licensed		
			-		-

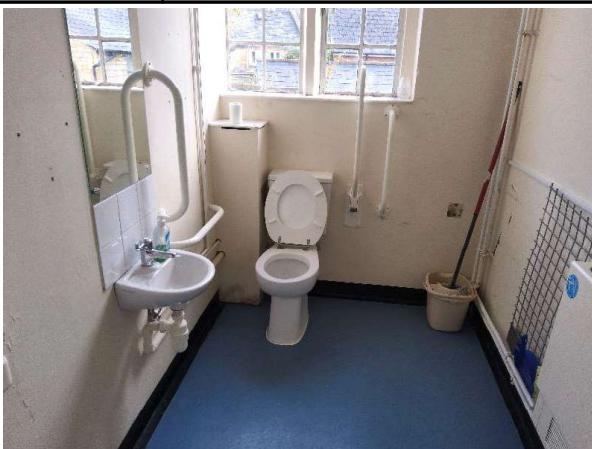
Item	Level	Building Name / Location / Room Number	Survey Type	Sample Reference	Quantity		
12	Ground Floor	01-0F-018 Toilet	Management	Visual Inspection	-

Material Description / Location No suspect materials observed within surveyed area		Material Risk		
			Product Type		Product Type	Extent of Damage	Surface Treatment
			Additional Information		-	-	-
			-		Score - Material Risk		-
			Recommendations		Accessibility		
			-		-		
			Review Period		-		
			-		-		
			Inspection Level		Analysis Result		
			-		-		
			Product Type		Licensed / Non-Licensed		
			-		-

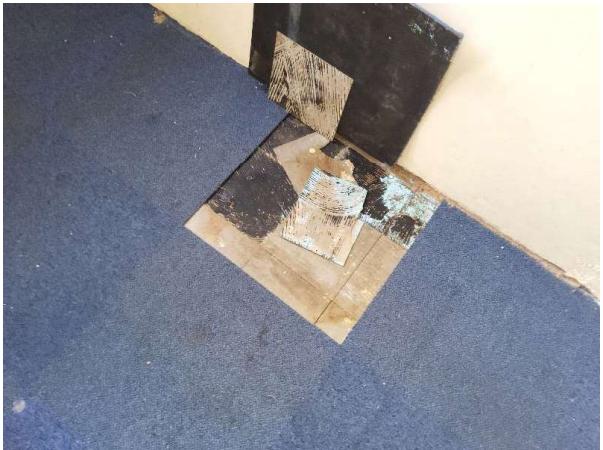
Item	Level	Building Name / Location / Room Number	Survey Type	Sample Reference	Quantity			
13	Ground Floor	01-0F-017 Office	Management	As CW003361	9m ²

Material Description / Location		Material Risk			
			Asbestos bonded vinyl floor tiles (grey) and adhesive laid below carpet		Product Type	Extent of Damage	Surface Treatment	Asbestos Type
			Additional Information		1	1	0	1
			Treat as uniform throughout below fixed floorings.		Score - Material Risk		3	Very Low
			Recommendations		Accessibility			
			Manage in accordance with current asbestos legislation		Low			
			Review Period		Annual			
			Inspection Level		Analysis Result			
			Strongly Presumed		Chrysotile			
			Product Type		Licensed / Non-Licensed			
			Reinforced Composite		Non-Licensable

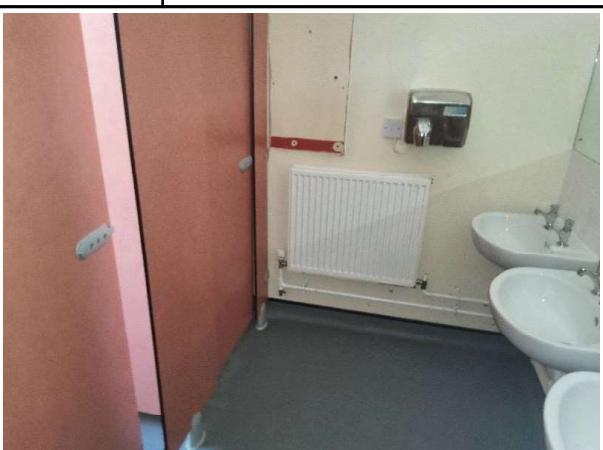
Item	Level	Building Name / Location / Room Number	Survey Type	Sample Reference	Quantity			
14	Ground Floor	01-0F-014 Female Toilet	Management	Visual Inspection	-

Material Description / Location		Material Risk			
			No suspect materials observed within surveyed area		Product Type	Extent of Damage	Surface Treatment	Asbestos Type
			Additional Information		-	-	-	-
			Score - Material Risk		-	-		
			Recommendations		Accessibility			
			Review Period		-			
			Inspection Level		Analysis Result			
			-		Product Type			
			-		Licensed / Non-Licensed			
			-		-

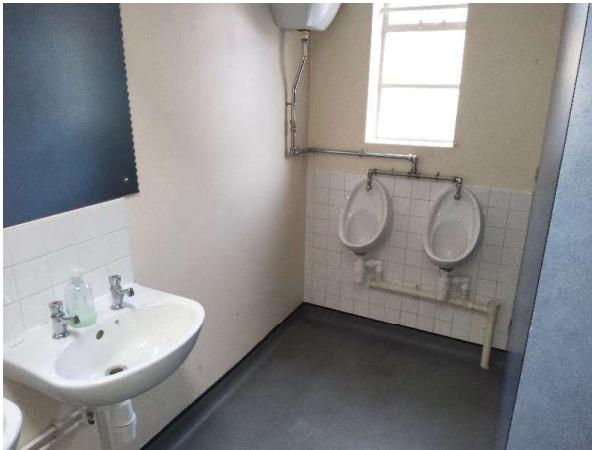
Item	Level	Building Name / Location / Room Number	Survey Type	Sample Reference	Quantity					
15	Ground Floor	01-0F-013 Male Toilet	Management	Visual Inspection	-

Material Description / Location No suspect materials observed within surveyed area		Material Risk					
			Additional Information -		Product Type	Extent of Damage	Surface Treatment			
			Score - Material Risk -							
			Recommendations -		Accessibility -					
			Review Period -							
Inspection Level	Analysis Result	Product Type	Licensed / Non-Licensed							
-	-	-	-

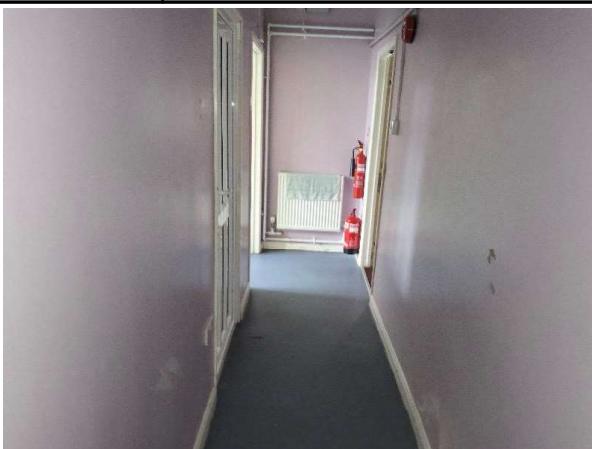
Item	Level	Building Name / Location / Room Number	Survey Type	Sample Reference	Quantity					
16	Ground Floor	01-0F-016 Circulation	Management	Visual Inspection	-

Material Description / Location No suspect materials observed within surveyed area		Material Risk					
			Additional Information -		Product Type	Extent of Damage	Surface Treatment			
			Score - Material Risk -							
			Recommendations -		Accessibility -					
			Review Period -							
Inspection Level	Analysis Result	Product Type	Licensed / Non-Licensed							
-	-	-	-

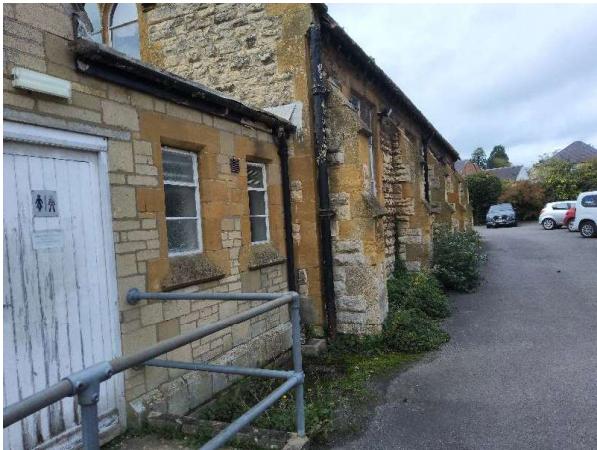
Item	Level	Building Name / Location / Room Number	Survey Type	Sample Reference	Quantity					
17	External	External Elevations	Management	Visual Inspection	-

Material Description / Location		Material Risk					
			No suspect materials observed within surveyed area		Product Type	Extent of Damage	Surface Treatment			
			Additional Information		-	-	-			
					Score - Material Risk					
					-	-				
			Recommendations		Accessibility					
					Review Period					
Inspection Level	Analysis Result	Product Type		Licensed / Non-Licensed						
-	-
