## **Waste Core Strategy Site Options Consultation**

### **Waste Site Assessment**

#### **Appendix C.32: Site 291 - Drybrook**

**October 2009**

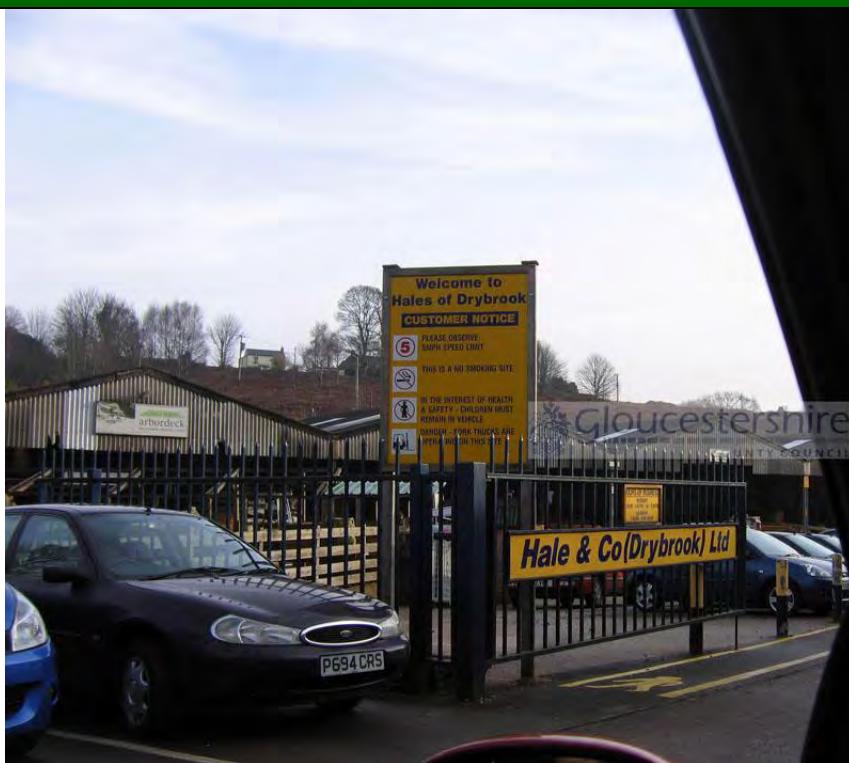
### Site Images

District	Forest		
Parish	Drybrook		
Easting	364519	Northing	216436
Approximate Site Area (hectares)	3		
Reasons for inclusion <i>NB: Slight anomalies in site boundaries may have arisen from 'clustering' of sites from more than one source and/or the absence of detailed site plans in source documents.</i>	The site was identified in the Forest of Dean Local Plan.		
Date of WPA officer visit	15th December 2008		
Broad Description of Site (including current activities on site, location and neighbouring uses)	<p>This is a small site which runs alongside Morse Road. The whole site is used by Hales &amp; Co (Drybrook) Ltd. The site is lower than the surrounding roads due to a fall in the land. The south area of the site is used for the storage of building materials. Some housing in proximity.</p> <p>Additional Sensitive Receptors: A school and 2 churches.</p>

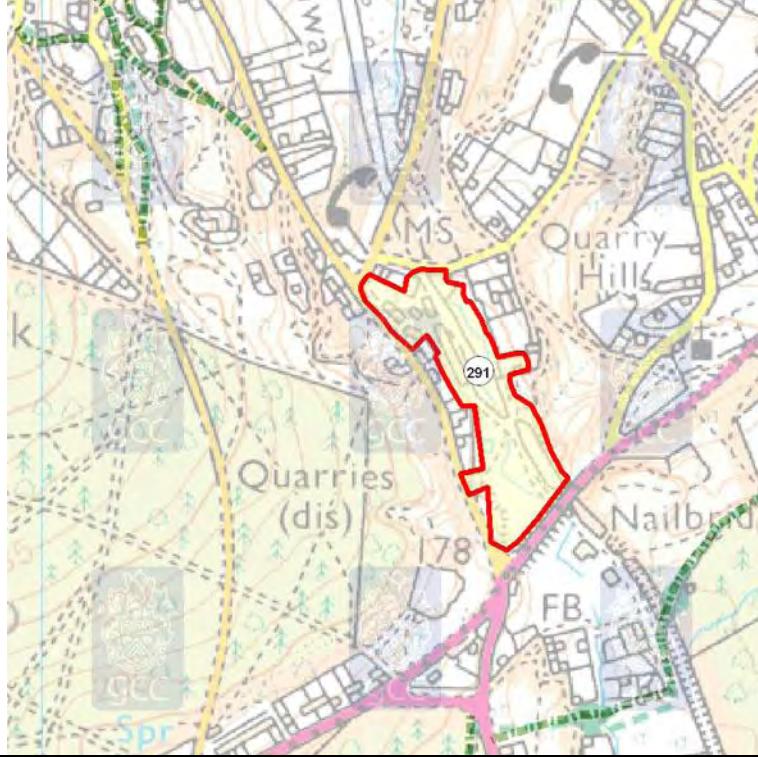
<b>Public Right of Way</b>
PRoW Map

Public Rights of Way (Based on information provided by Gloucestershire County Council's Public Rights of Way (PRoW) team)	
Score	+
Score Definition	No Public Rights of Way network present on site; or Presence of Public Rights of Way network with opportunity for existing route to be enhanced.
Additional Comments	No Path.
Map Legend

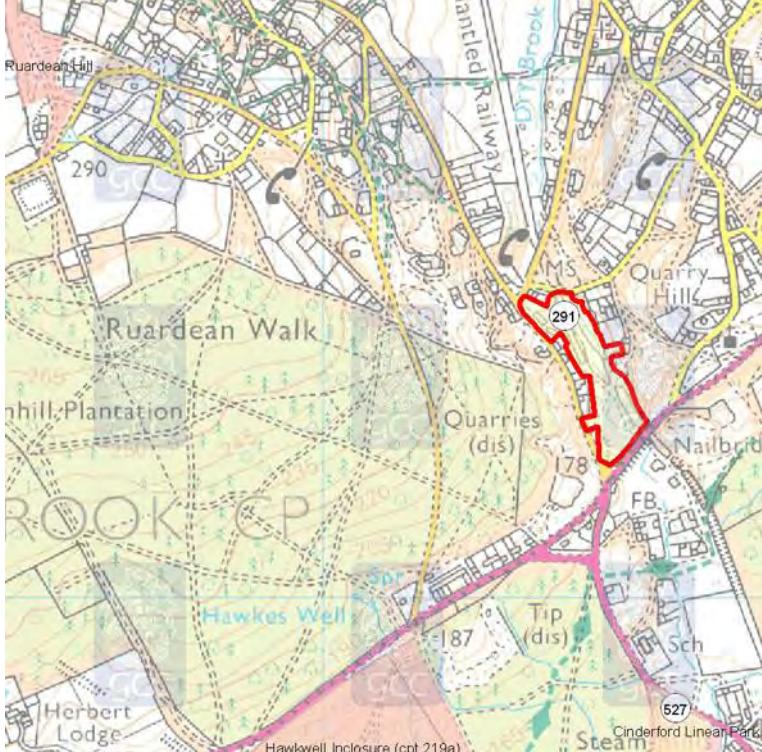
Constraints Map

Ecology/Biodiversity (Based on information provided by Gloucestershire County Council's Ecologist and the Gloucestershire Centre for Environmental Records (GCER))	
Score	0
Score Definition	Overall impact on biodiversity could be potentially negative, uncertain or positive. Identified important ecological constraint up to and including 250 metres distant.
Additional Comments	Scores with * indicate designated aquifer fed/surface water/flood water dependent site(s) over 1km distant which may be affected, site as named above.
Nearby Internationally & Nationally Designated Sites Recorded	None
Other Internationally & Nationally Designated Sites (wetlands)	None
Ecology Legend	<ul style="list-style-type: none"> <li><span style="display: inline-block; width: 15px; height: 15px; background-color: green; border: 1px solid black; margin-right: 5px;"></span> SSSI Site of Special Scientific Interest</li> <li><span style="display: inline-block; width: 15px; height: 15px; background-color: pink; border: 1px solid black; margin-right: 5px;"></span> Key Wildlife Site - area</li> <li><span style="display: inline-block; width: 15px; height: 15px; background: repeating-linear-gradient(45deg, transparent, transparent 2px, black 2px, black 4px); border: 1px solid black; margin-right: 5px;"></span> SAC Site</li> <li><span style="display: inline-block; width: 15px; height: 15px; background: repeating-linear-gradient(45deg, transparent, transparent 2px, blue 2px, blue 4px); border: 1px solid black; margin-right: 5px;"></span> Ramsar Site</li> <li><span style="display: inline-block; width: 15px; height: 15px; background: repeating-linear-gradient(45deg, transparent, transparent 2px, black 2px, black 4px); border: 1px solid black; margin-right: 5px;"></span> SPA Site</li> </ul>
