Asbestos Survey Report

Client **Gloucestershire County Council**
Site Ref **Ceiling Tiles Only**
Address **Stroud Library
Spiritualist Church
Nursery Room
Lansdown
Stroud
Gloucestershire**
Report Date **3 November 2005**
Report Issue Date **23 November 2005**
Report Reference **CWE/KT/GCC/SCN/031105**
Survey Type **2**

Client	Gloucestershire County Council
Site Ref	N/A
Address	Stroud Library, Spiritualist Church Nursery Room, Lansdown, Stroud, Gloucestershire
Report Date	3 November 2005
Report Reference	CWE/KT/GCC/SCN/031105

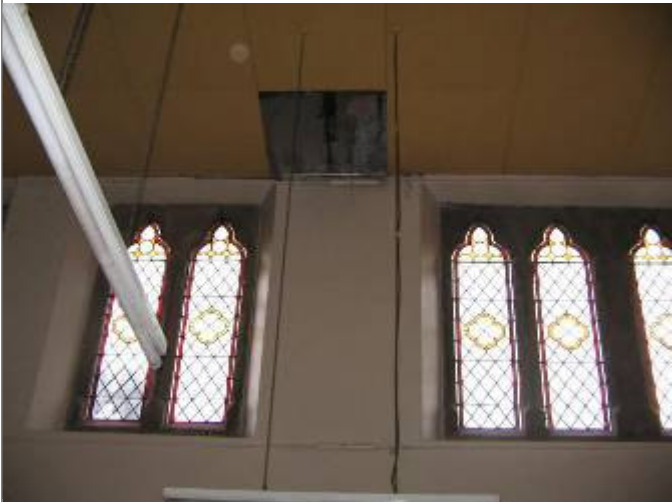
Item	Level	Location / Room number	Survey Type	Sample Reference	Quantity			
1	First	Hall Ceiling Area	2	SCN/01	-

Material Description		Material Risk			
			Decorative coating to ceiling panel		Product Type	Extent of Damage	Surface Treatment	Asbestos Type
			Additional Information		-	-	-	-
					Score - Material Risk			
					-		-	
			Recommendations		Accessibility			
			No asbestos detected in sample No further action is required		-			
					Review Date			
					-			
Ceiling	Ceiling Soffit	Wall	Flooring	Other				
Suspended / MMMF tiles	Lath & Plaster / Plasterboard	Rendered / Block work	Carpet	-

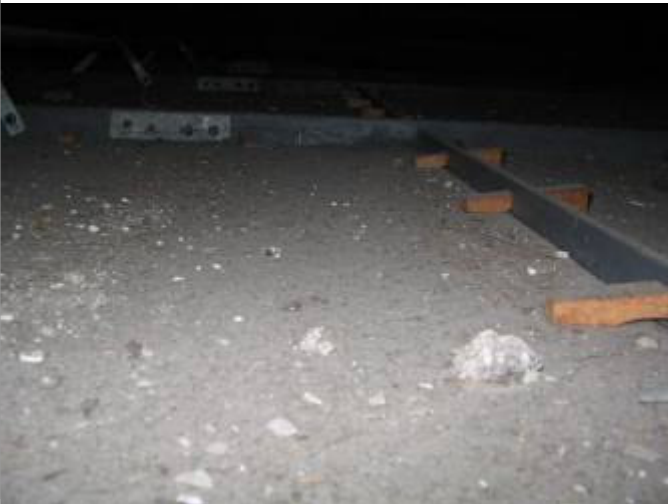
Item	Level	Location / Room number	Survey Type	Sample Reference	Quantity			
2	First	Hall Ceiling Area	2	SCN/02	-

Material Description		Material Risk			
			Debris to ceiling panels		Product Type	Extent of Damage	Surface Treatment	Asbestos Type
			Additional Information		-	-	-	-
					Score - Material Risk			
					-		-	
			Recommendations		Accessibility			
No asbestos detected in sample No further action is required		-						
		Review Date						
		-						
Ceiling	Ceiling Soffit	Wall	Flooring	Other				
Suspended / MMMF tiles	Lath & Plaster / Plasterboard	Rendered / Block work	Carpet	-

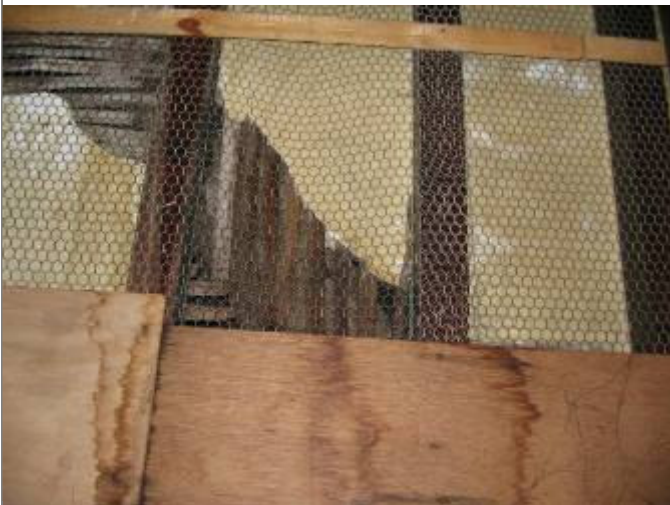
Item	Level	Location / Room number	Survey Type	Sample Reference	Quantity			
3	First	Hall Ceiling Area	2	SCN/03	-

Material Description		Material Risk			
			Material to ceiling soffit		Product Type	Extent of Damage	Surface Treatment	Asbestos Type
			Additional Information		-	-	-	-
			-		Score - Material Risk			
					-	-		
			Recommendations		Accessibility			
No asbestos detected in sample No further action is required		-						
		Review Date						
		-						
Ceiling	Ceiling Soffit	Wall	Flooring	Other				
Suspended / MMMF tiles	Lath & Plaster / Plasterboard	Rendered / Block work	Carpet	-
