Asbestos Survey Report

Stroud Library

Report Reference **CWE/AT/RLB/SL/130908**

Survey Type **3 (Specific Areas)**

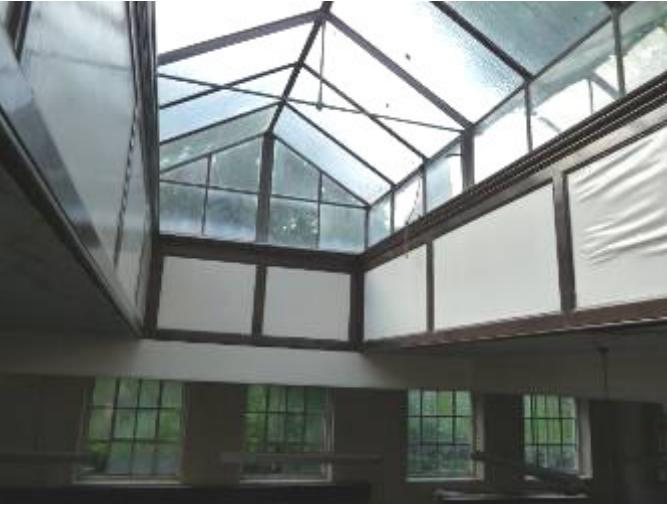
Item	Level	Location / Room number	Survey Type	Sample Reference	Quantity										
1	First	Skylight	3	Visual Inspection	-										
Material Description				Material Risk

No suspect materials observed within area											
Additional Information				-	-										
Timber panels within skylight surround				-	-										
Recommendations				Accessibility											
-				Review Date											
<table border="1" style="width: 100%; border-collapse: collapse;"> <tr> <th>Ceiling</th> <th>Ceiling Soffit</th> <th>Wall</th> <th>Flooring</th> <th>Other</th> </tr> <tr> <td>-</td> <td>-</td> <td>-</td> <td>-</td> <td>-</td> </tr> </table>						Ceiling	Ceiling Soffit	Wall	Flooring	Other	-	-	-	-	-
Ceiling	Ceiling Soffit	Wall	Flooring	Other											
-	-	-	-	-

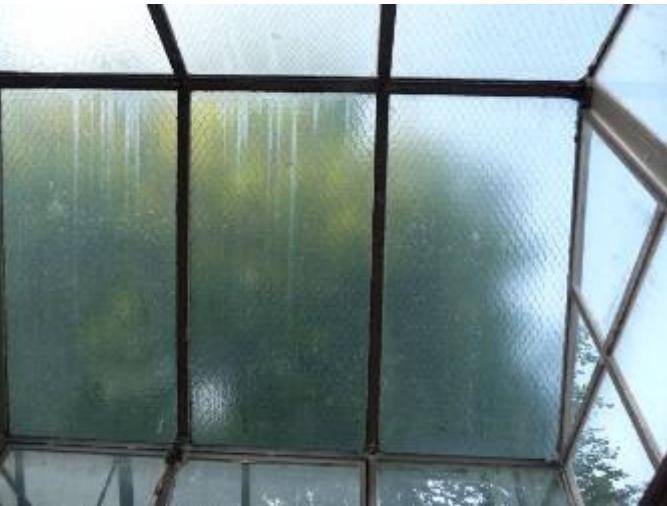
Item	Level	Location / Room number	Survey Type	Sample Reference	Quantity										
2	First	Skylight	3	Visual Inspection	-										
Material Description				Material Risk

No suspect materials observed to skylight framework											
Additional Information				-	-										
Metal frame with glazed reinforced glass				-	-										
Recommendations				Accessibility											
-				Review Date											
<table border="1" style="width: 100%; border-collapse: collapse;"> <tr> <th>Ceiling</th> <th>Ceiling Soffit</th> <th>Wall</th> <th>Flooring</th> <th>Other</th> </tr> <tr> <td>-</td> <td>-</td> <td>-</td> <td>-</td> <td>-</td> </tr> </table>						Ceiling	Ceiling Soffit	Wall	Flooring	Other	-	-	-	-	-
Ceiling	Ceiling Soffit	Wall	Flooring	Other											
-	-	-	-	-

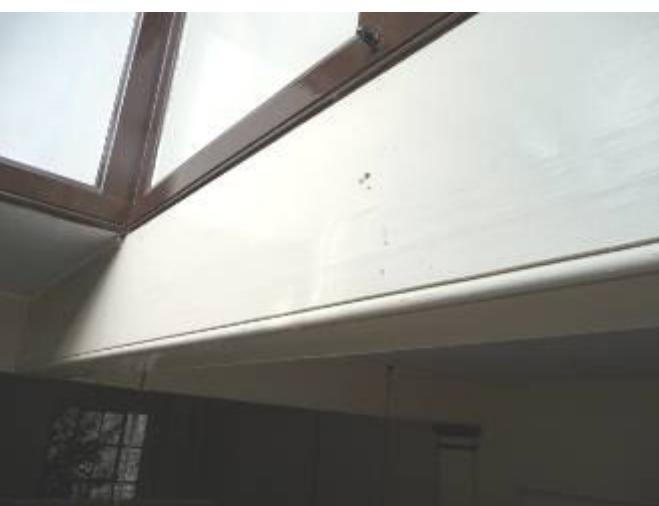
Item	Level	Location / Room number	Survey Type	Sample Reference	Quantity
3	First	Skylight	3	Visual Inspection	-
			Material Description	Material Risk

No suspect materials observed to support beams directly below timber clad skylight		
			Additional Information		
			Score - Material Risk		
			Recommendations	Accessibility	
			Review Date		
Ceiling	Ceiling Soffit	Wall	Flooring	Other	
-	-	-

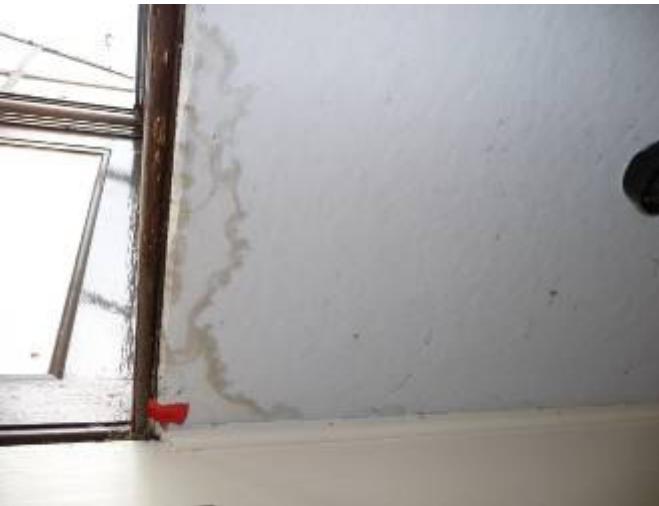
Item	Level	Location / Room number	Survey Type	Sample Reference	Quantity
4	First	Skylight	3	SL/01	-
			Material Description	Material Risk

Fibreboard ceiling panels located throughout area where skylight is to be removed		
			Additional Information		
			Score - Material Risk		
			Recommendations	Accessibility	
			No asbestos detected in sample. No further action is required		
			Review Date		
Ceiling	Ceiling Soffit	Wall	Flooring	Other	
-	-	-

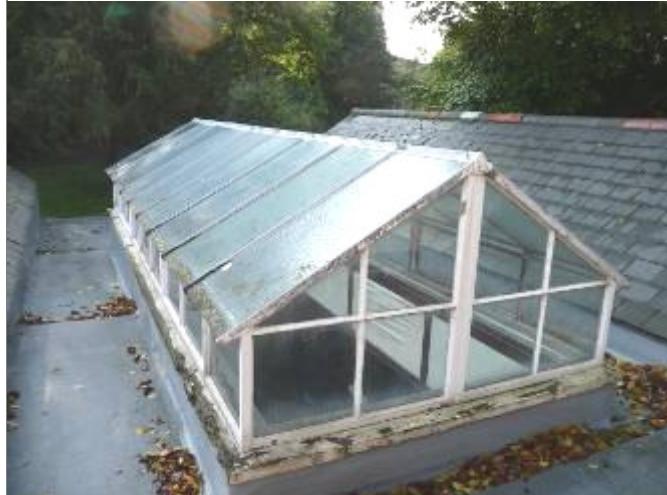
Item	Level	Location / Room number	Survey Type	Sample Reference	Quantity																					
7	Roof	Skylight	3	Visual Inspection	Material Description		Material Risk																			
							Product Type	Extent of Damage

No suspect materials observed to skylight	Surface Treatment																		
Additional Information							-	-																		
Timber sills with metal framework							-	-																		
Recommendations							Accessibility																			
							Review Date																			
<table border="1"> <thead> <tr> <th>Ceiling</th> <th>Ceiling Soffit</th> <th>Wall</th> <th>Flooring</th> <th>Other</th> <th></th> <th></th> <th></th> <th></th> </tr> </thead> <tbody> <tr> <td>-</td> <td>-</td> <td>-</td> <td>-</td> <td>-</td> <td></td> <td></td> <td></td> <td></td> </tr> </tbody> </table>									Ceiling	Ceiling Soffit	Wall	Flooring	Other					-	-	-	-	-				
Ceiling	Ceiling Soffit	Wall	Flooring	Other																						
-	-	-	-	-
