## **Waste Core Strategy Site Options Consultation**

### **Waste Site Assessment**

#### **Appendix C.47: Site 411 - Blaisdon Way**

**October 2009**

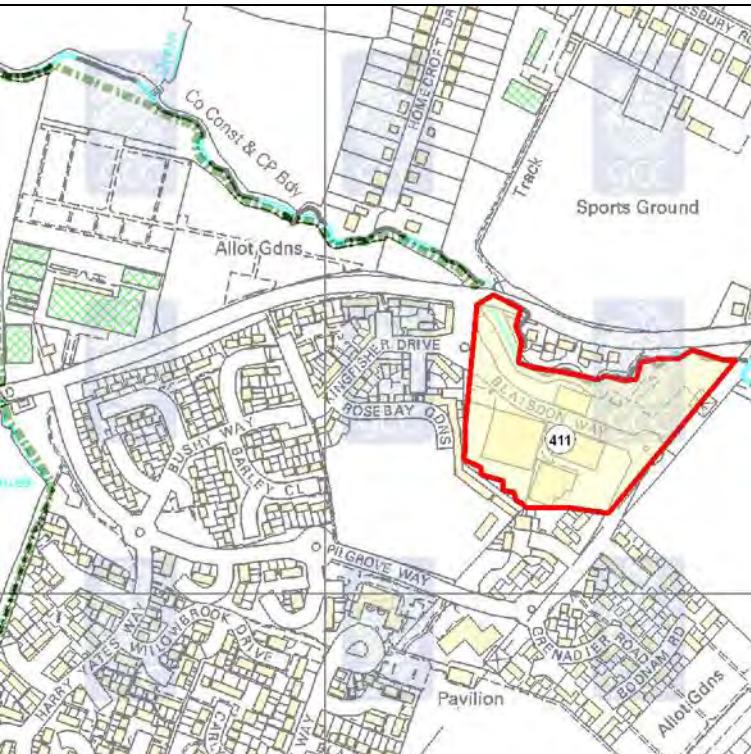
<b>Public Right of Way</b>
PRoW Map

<b>Public Rights of Way</b> <i>(Based on information provided by Gloucestershire County Council's Public Rights of Way (PRoW) team)</i>	
Score	+
Score Definition	No Public Rights of Way network present on site; or Presence of Public Rights of Way network with opportunity for existing route to be enhanced.
Additional Comments	No Path.
Map Legend
