REPORT ON
CONDITION OF RAAC CONCRETE
AT
STROUD LIBRARY, LANSDOWN, STROUD

DATE: 15th March 2024

CONTRACT NO: 13827

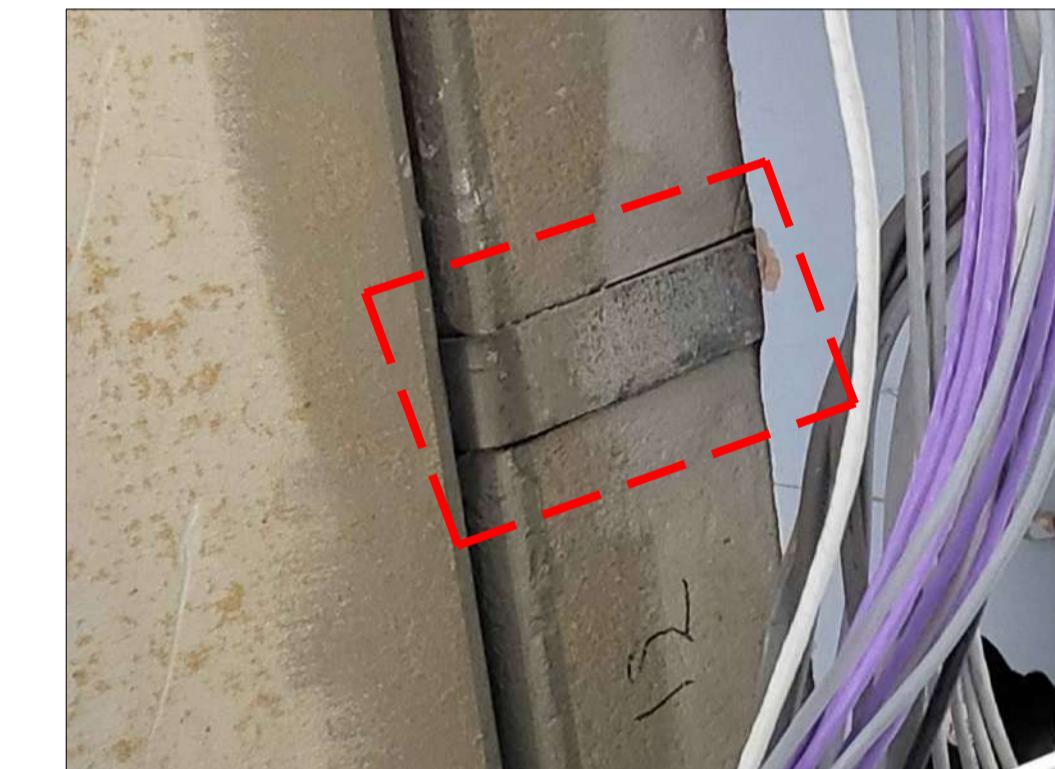
PHOTO 7 - PLANK No. 12

BRACKET AT END 1

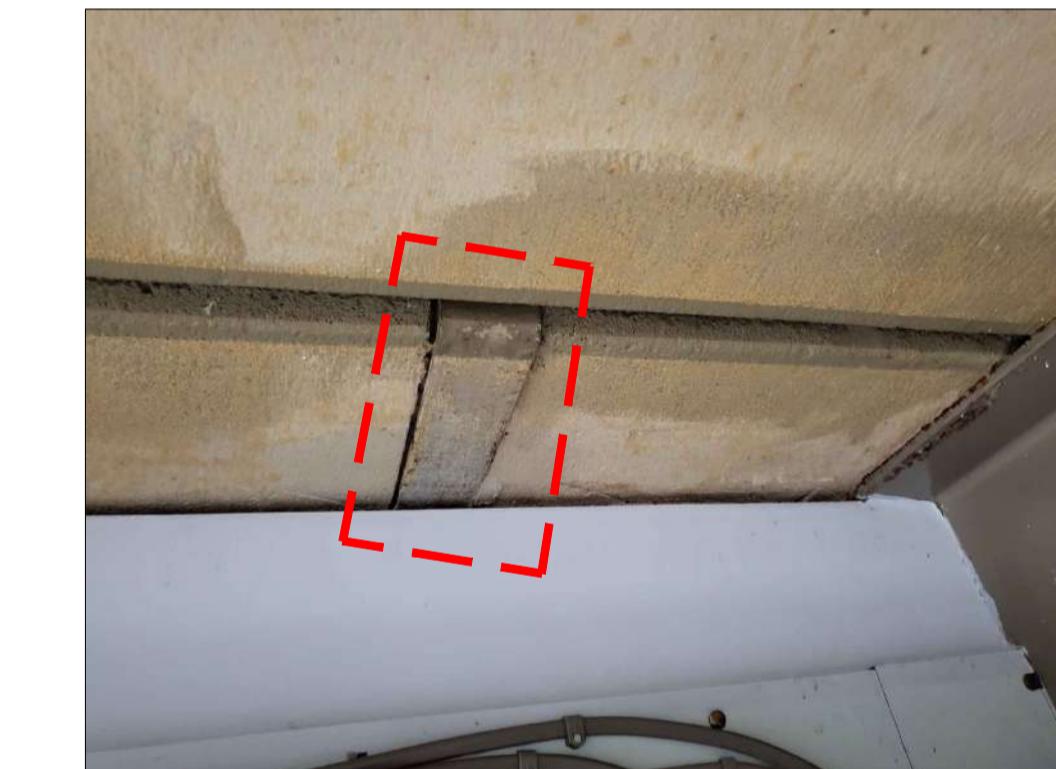
PHOTO 8 - PLANK No. 12

BRACKET AT END 1

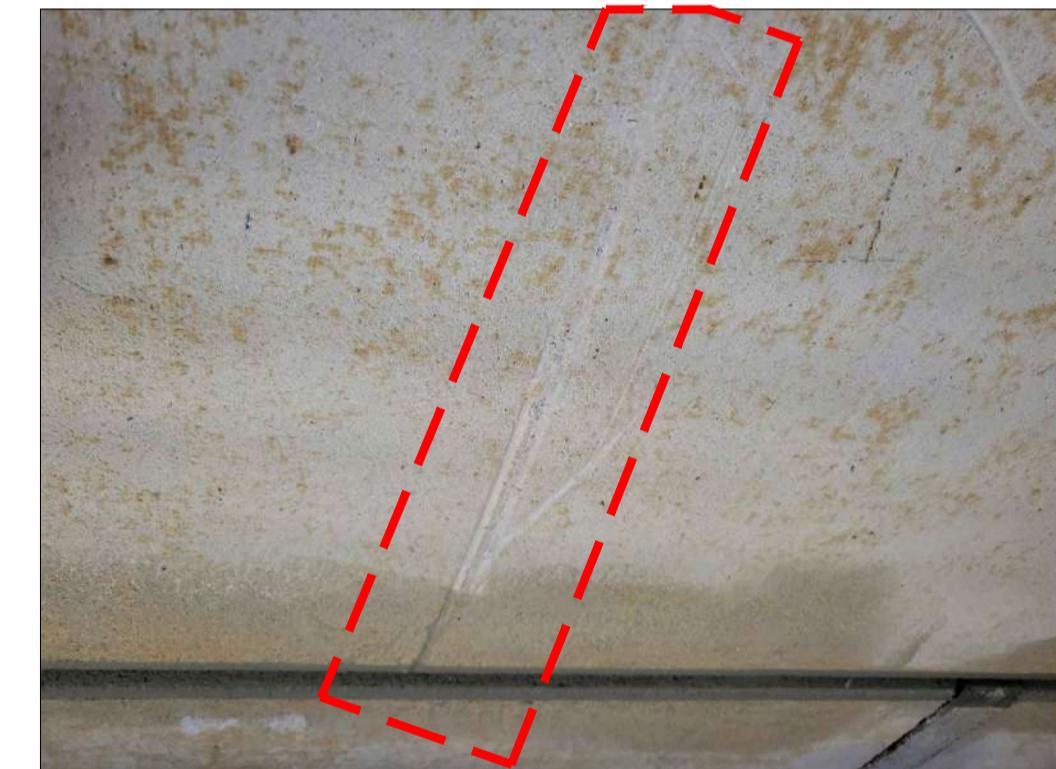
PHOTO 9 - PLANK No. 28

BRACKET AT END 2

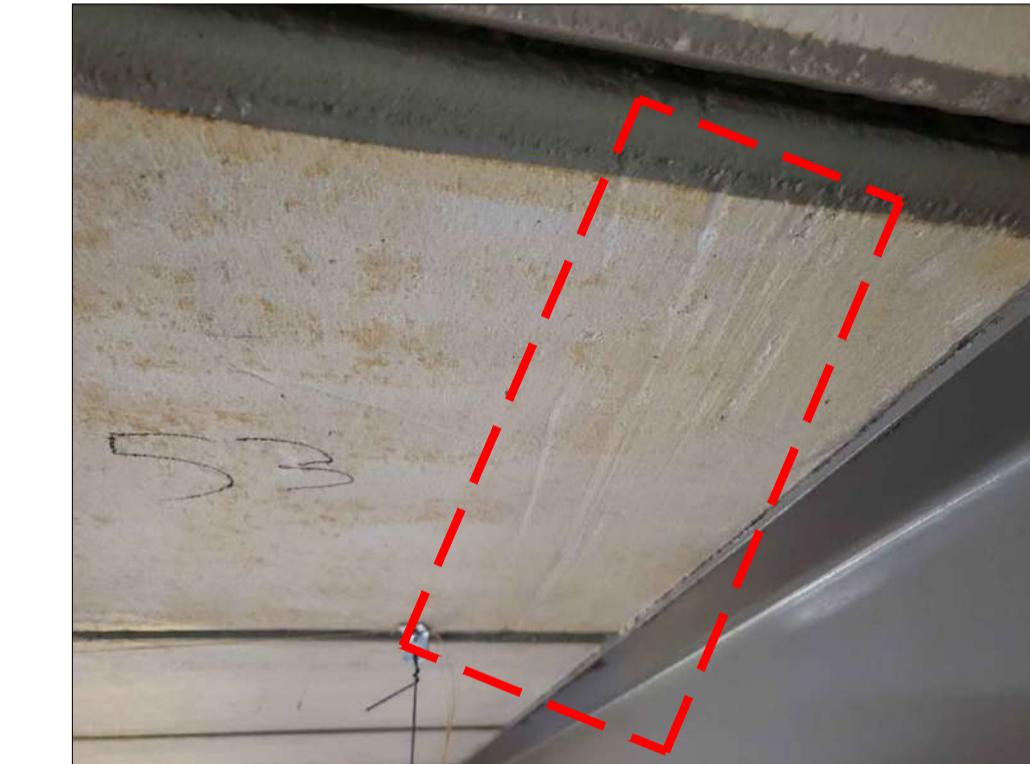
PHOTO 22 - PLANK No. 33

EFFLORESCENCE AT END 1

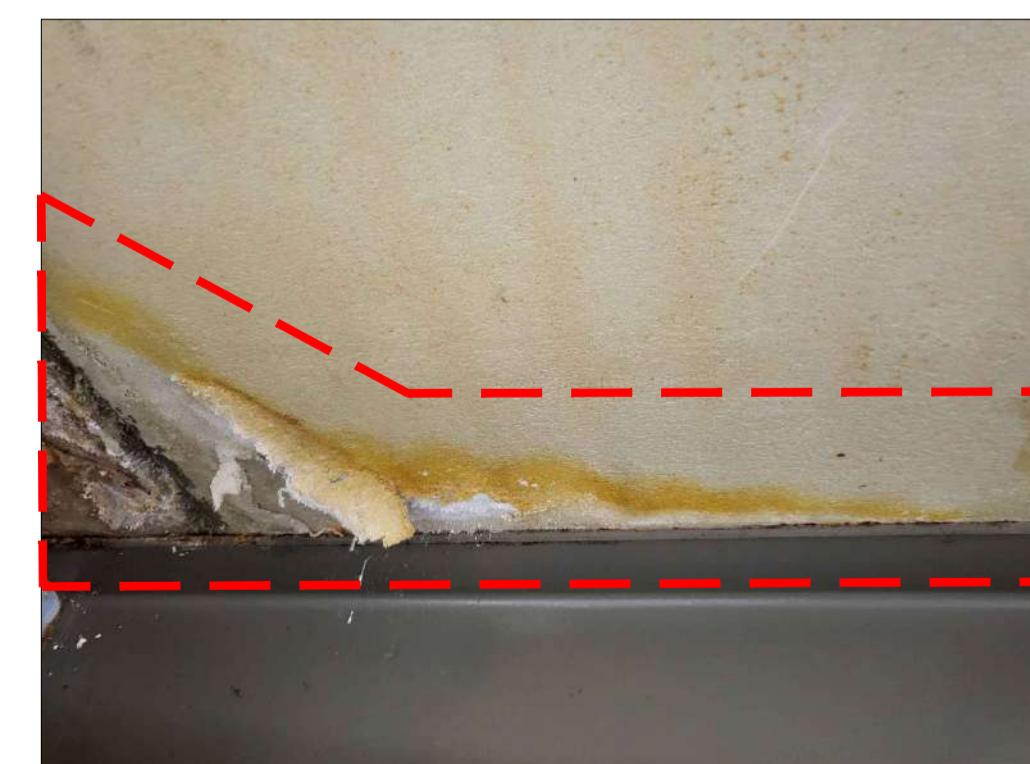
PHOTO 26 - PLANK No. 57

DELAMINATION/EFFLORESCENCE AT END 1

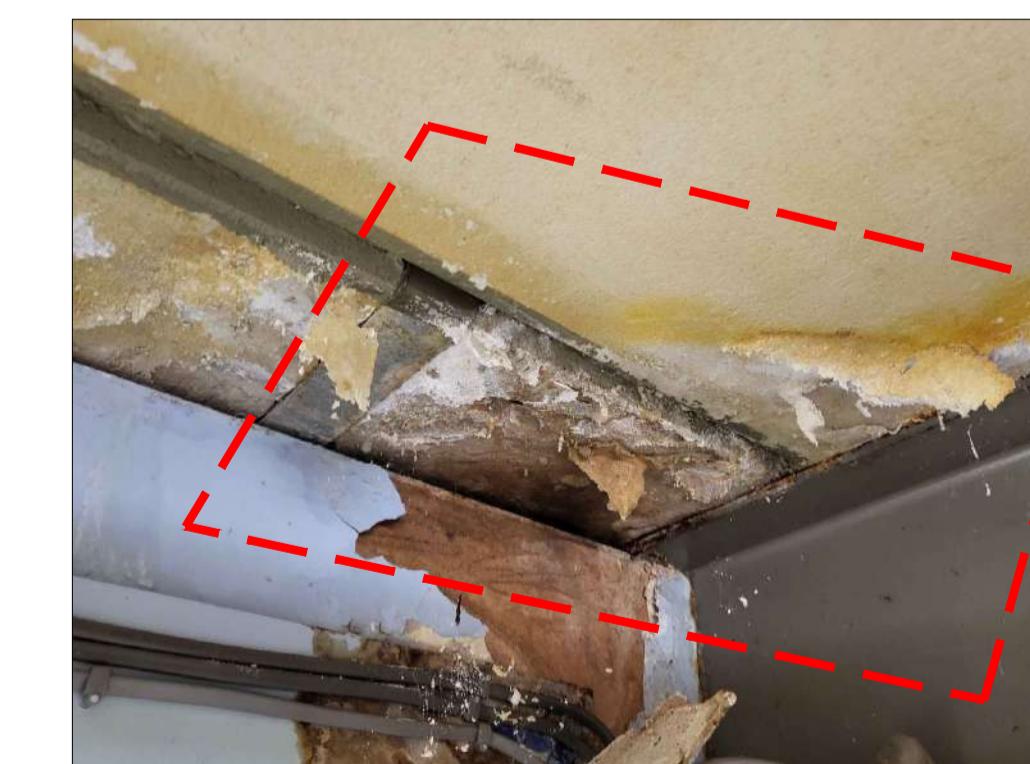
PHOTO 27 - PLANK No. 57

DELAMINATION/EFFLORESCENCE AT END 2

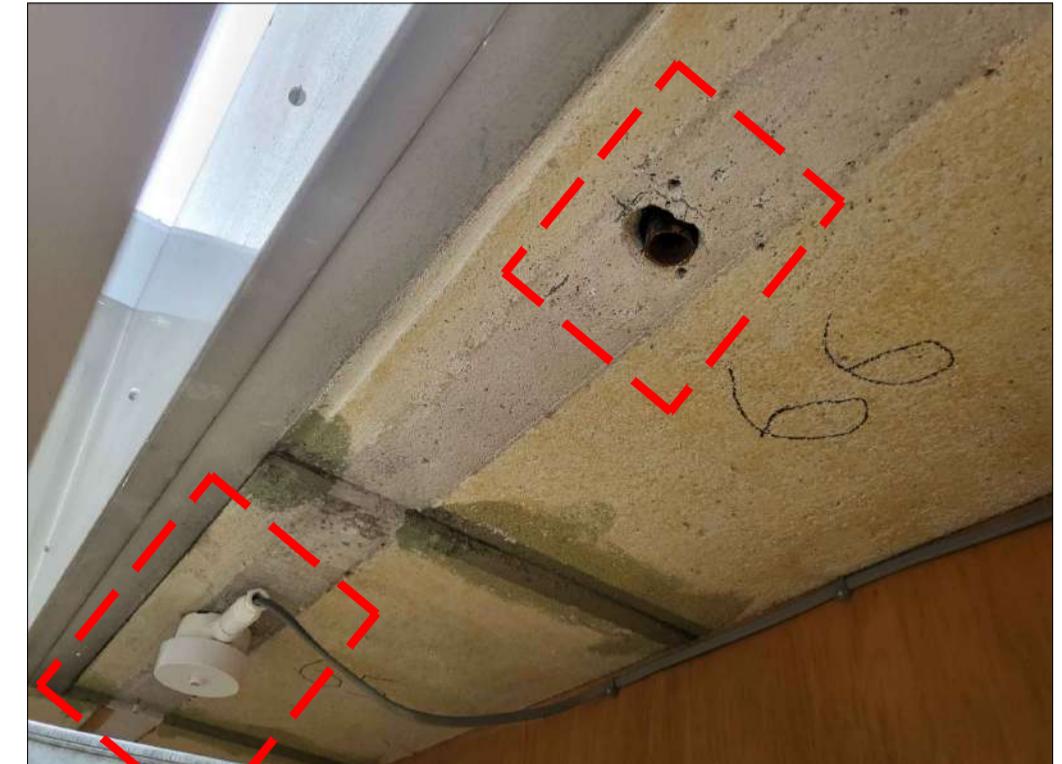
PHOTO 34 - PLANK No. 61

BRACKET

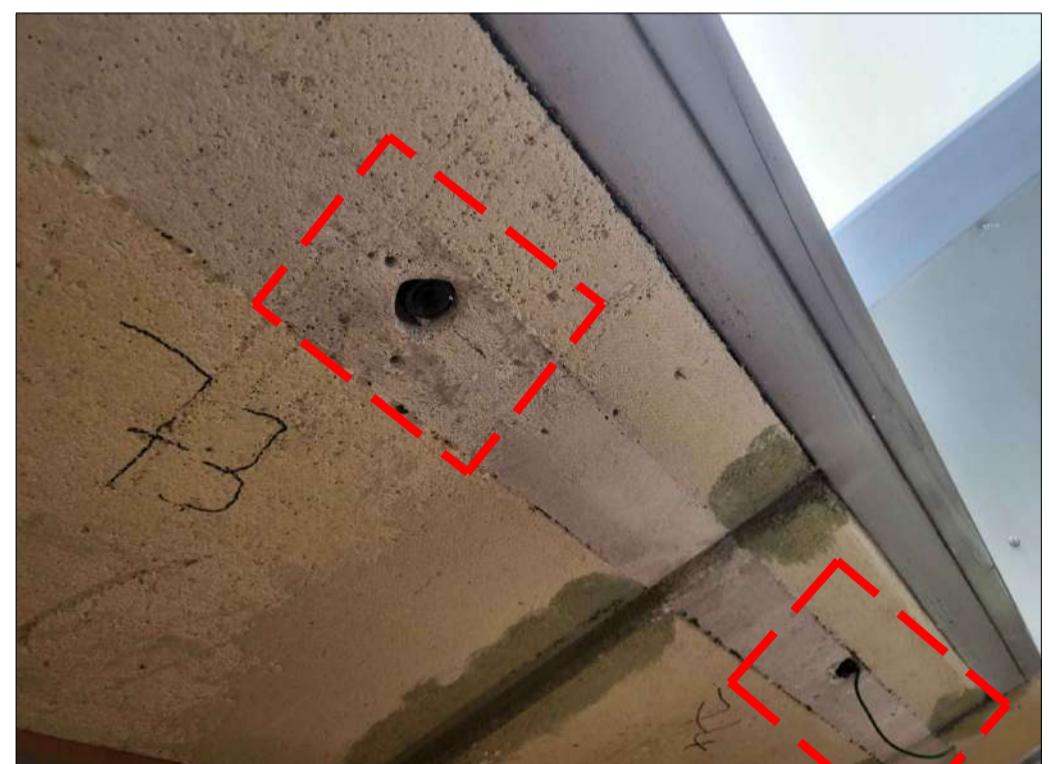
PHOTO 35 - PLANK No. 65 & 66

LIGHT FITTING
SERVICE HOLE

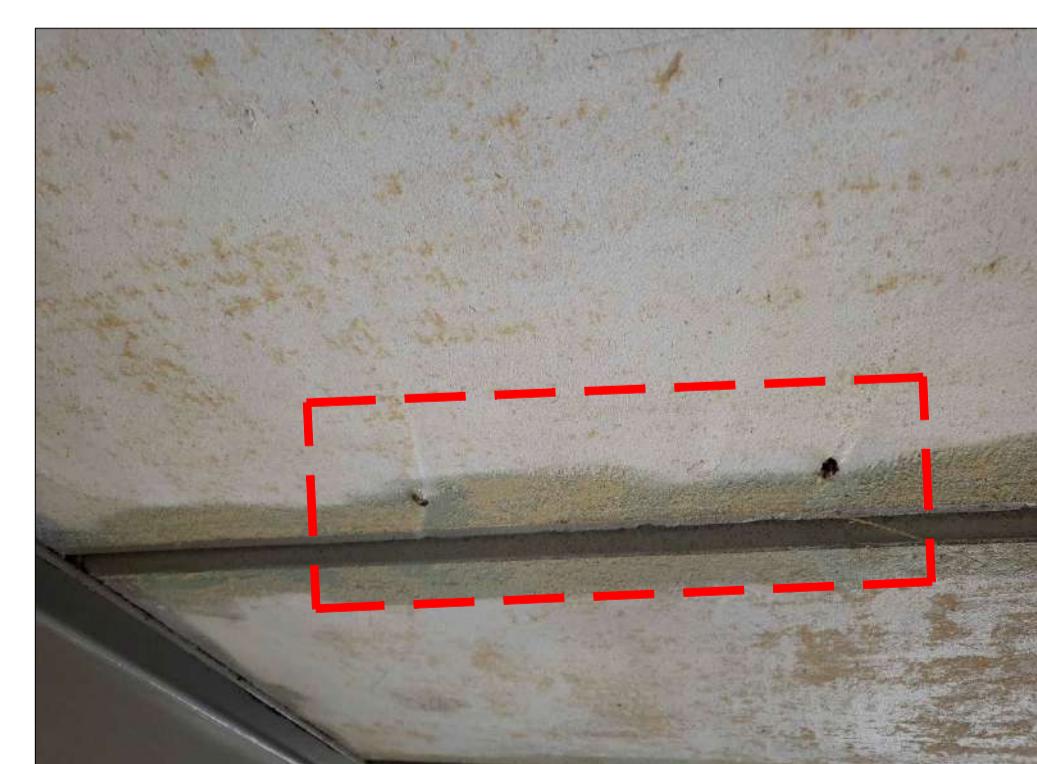
PHOTO 41 - PLANK No. 90

EXPOSED STEEL AT IRREGULAR CENTRES

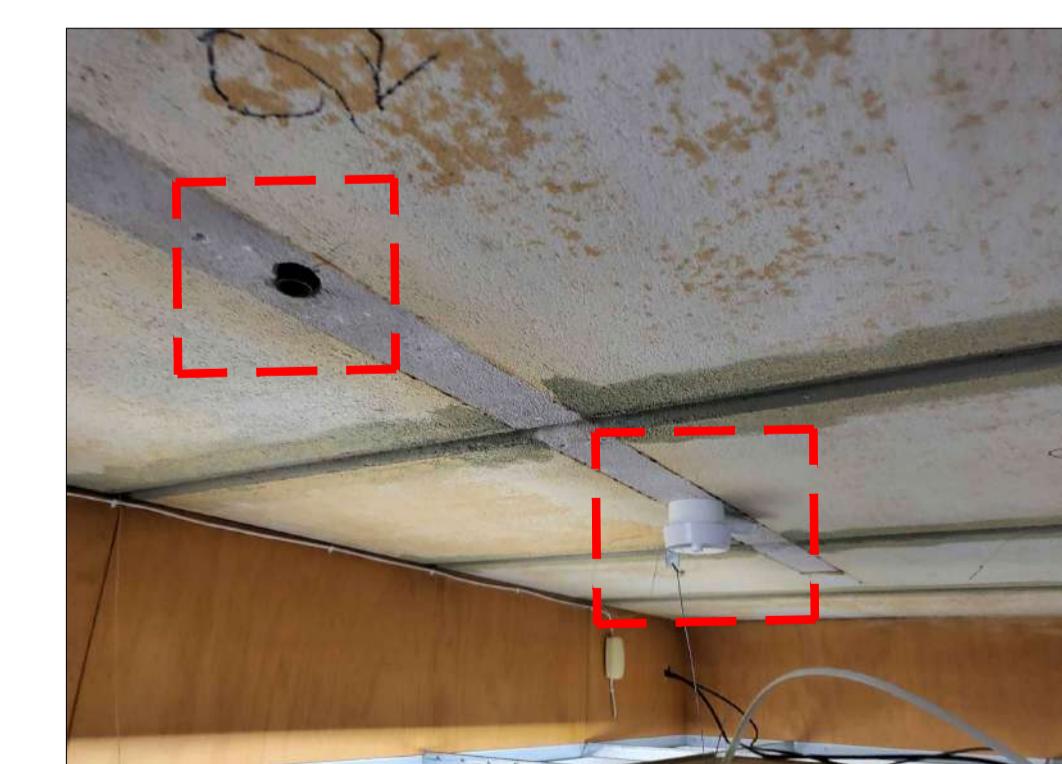
PHOTO 42 - PLANK No. 90

EXPOSED STEEL AT IRREGULAR CENTRES

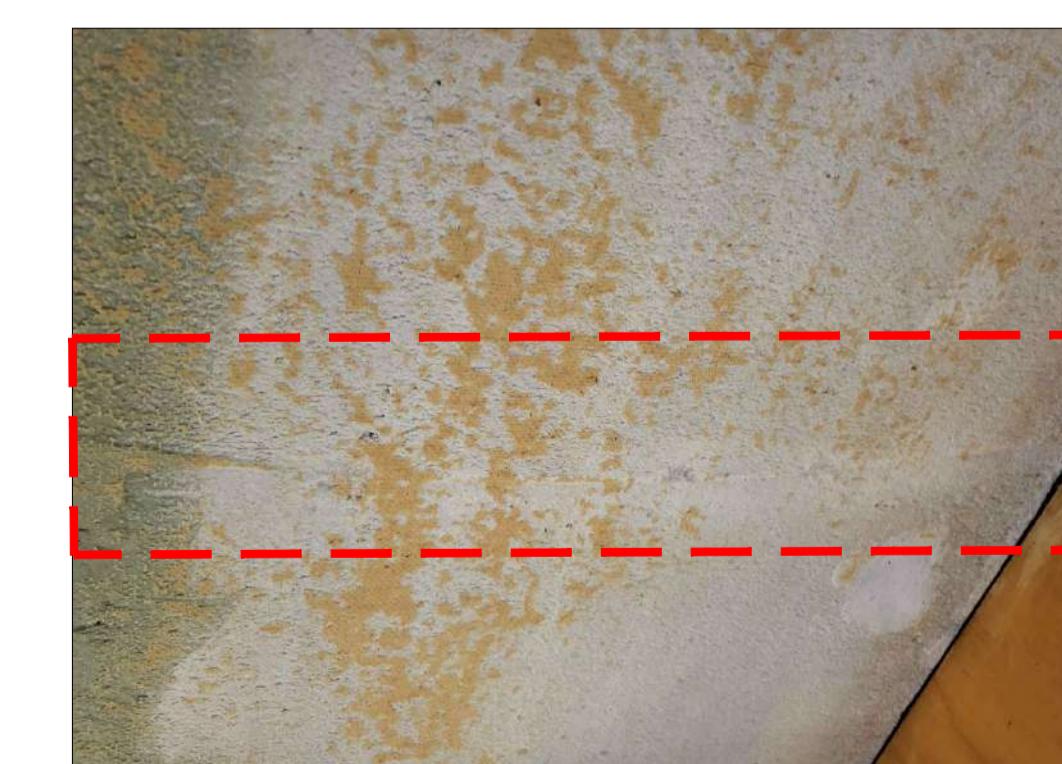
PHOTO 43 - PLANK No. 92 & 93

SERVICE HOLES

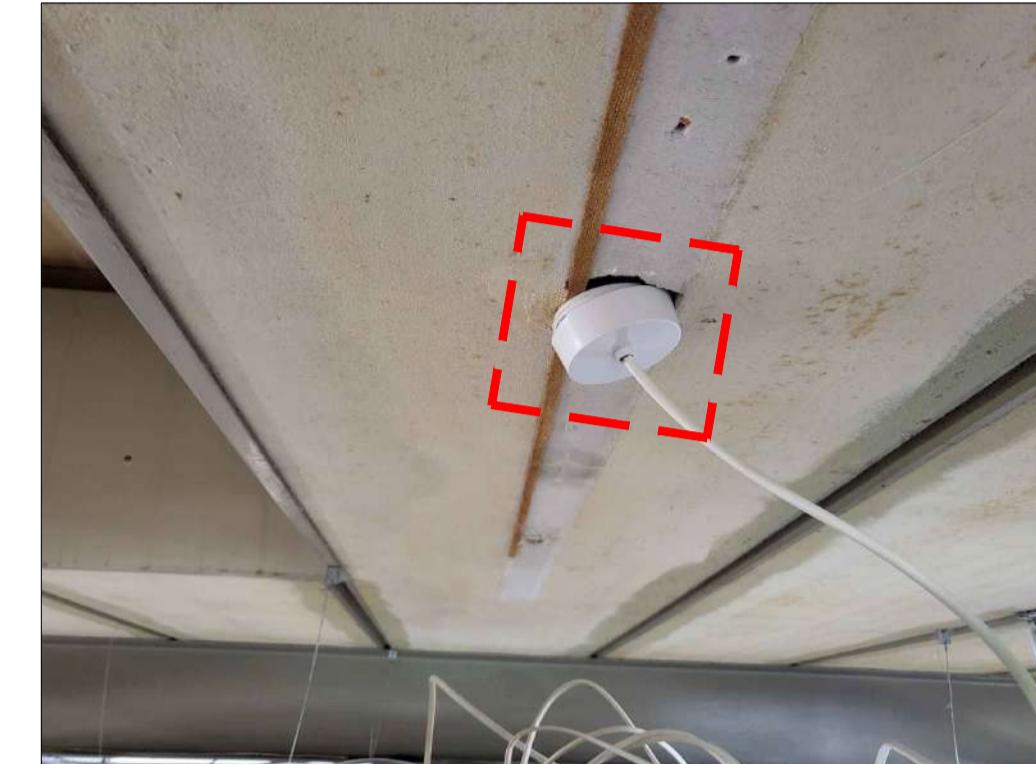
PHOTO 46 - PLANK No. 100

2No. SERVICE HOLES

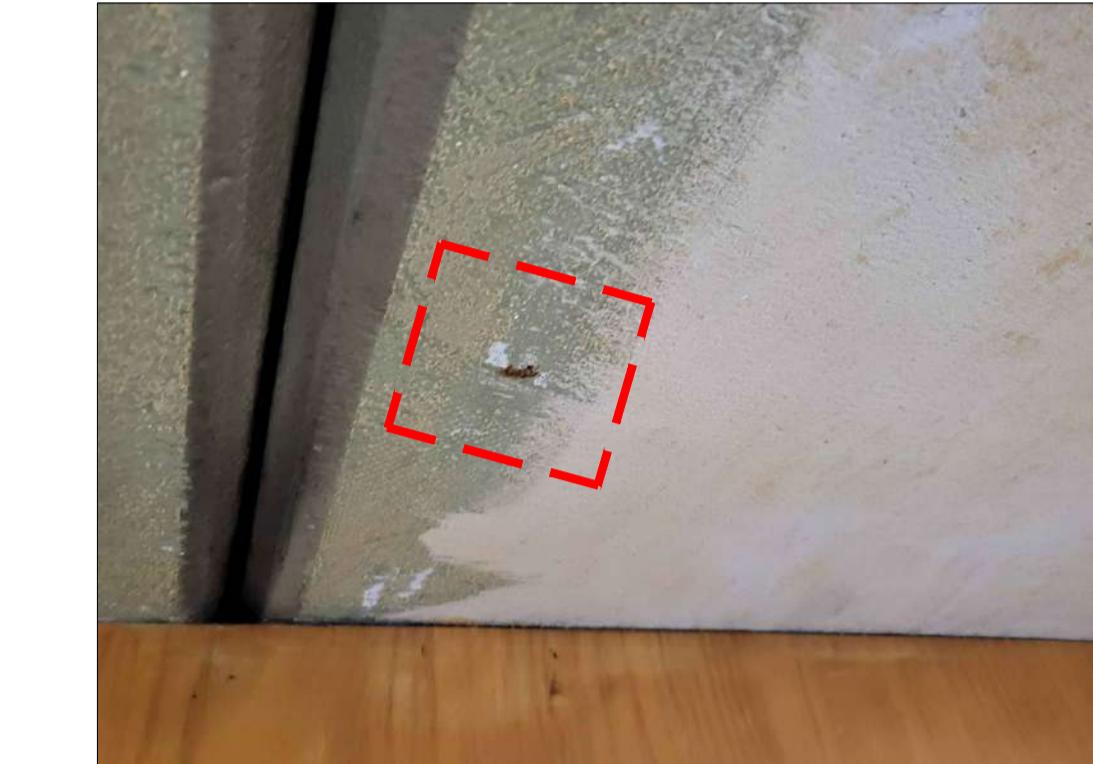
PHOTO 48 - PLANK No. 108

2No. SERVICE HOLES

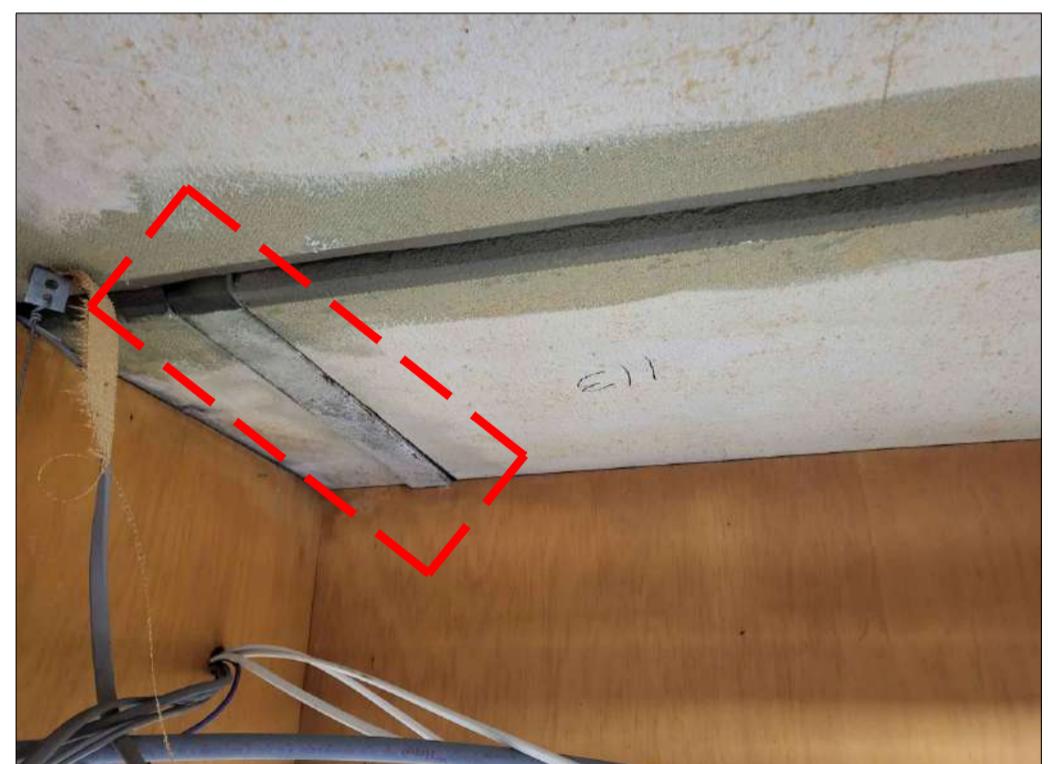
PHOTO 50 - PLANK No. 112

1No. SMALL HOLE
1No. LONG HOLE

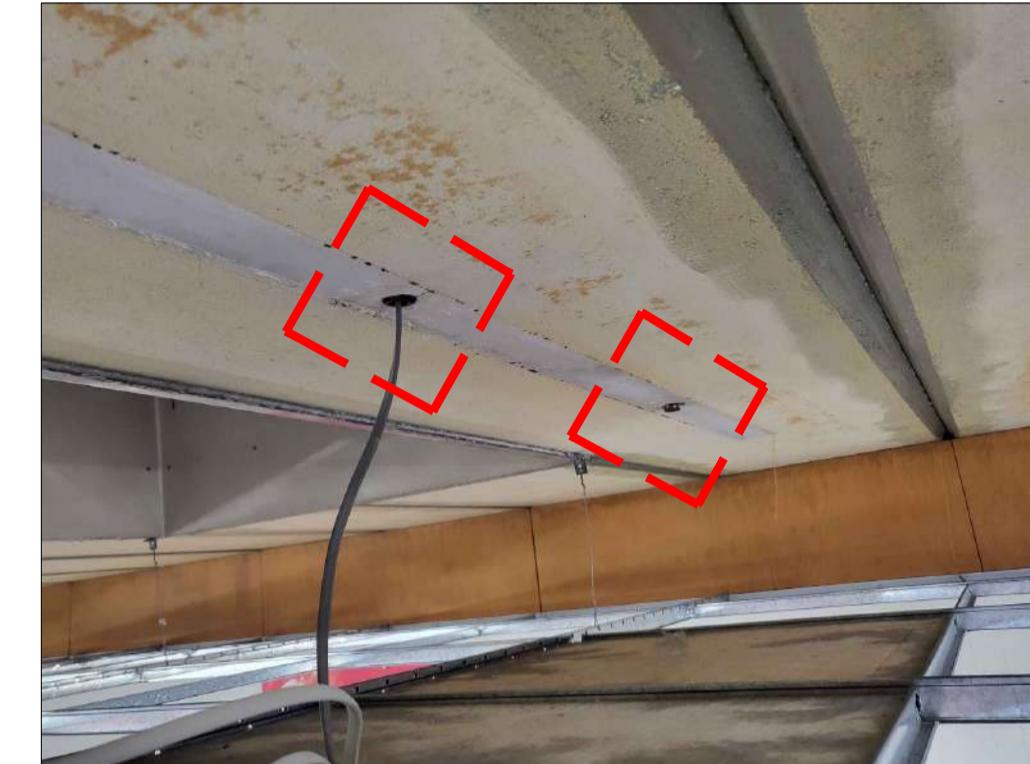
PHOTO 61 - PLANK No. 156

2No. SERVICE HOLES

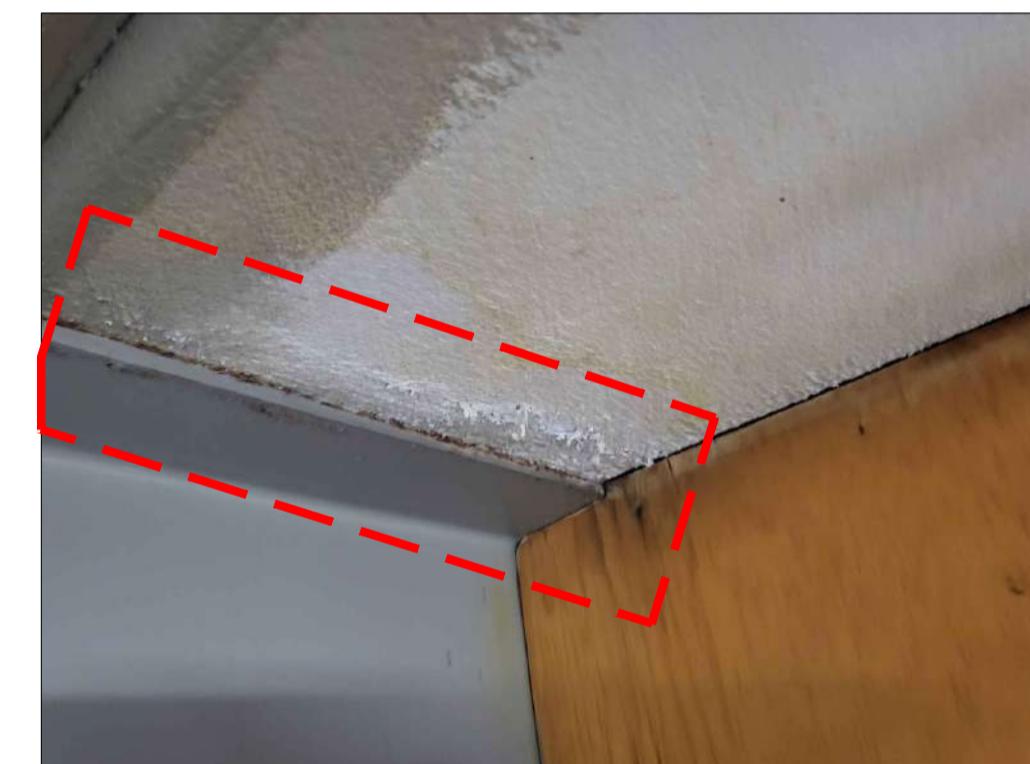
PHOTO 66 - PLANK No. 176

HOLE

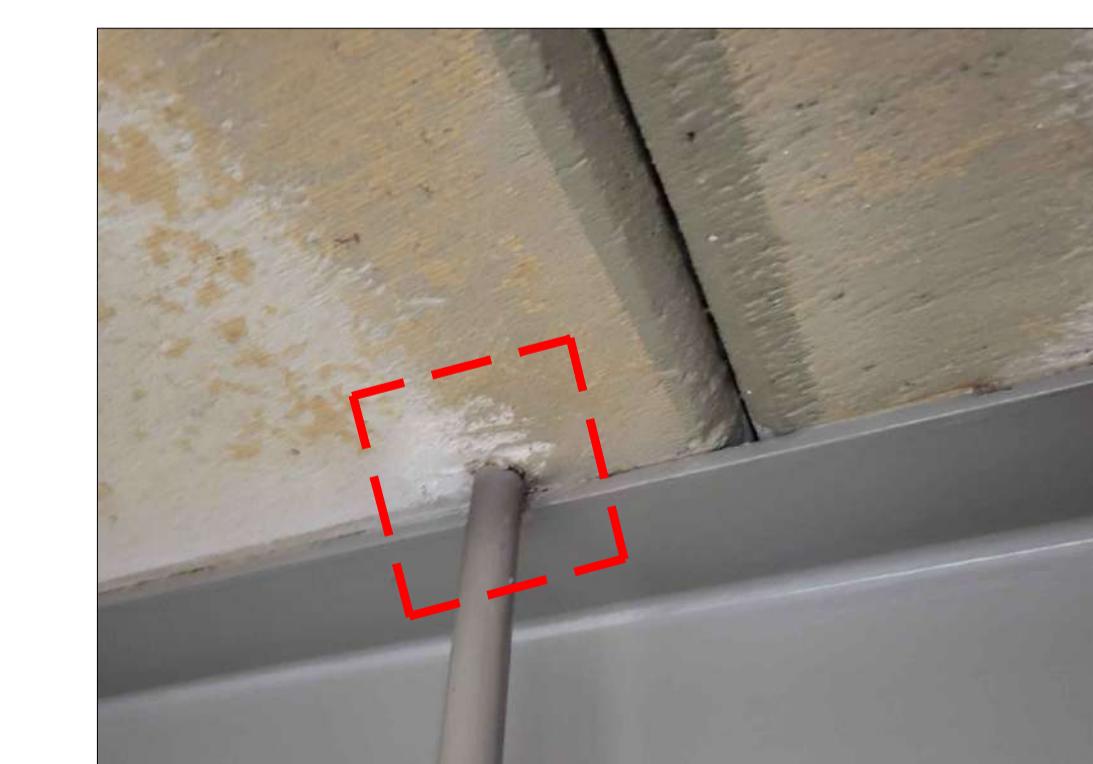
PHOTO 73 - PLANK No. 189

2No. SERVICE HOLES

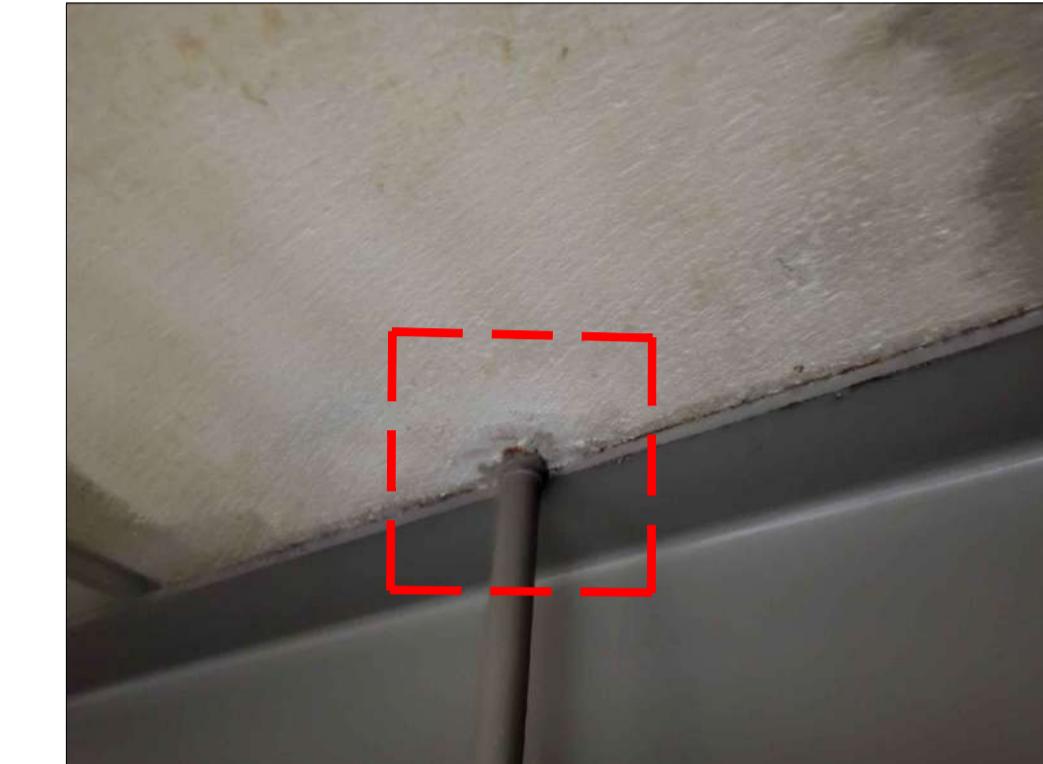
PHOTO 77 - PLANK No. 200
2No. SERVICE HOLES

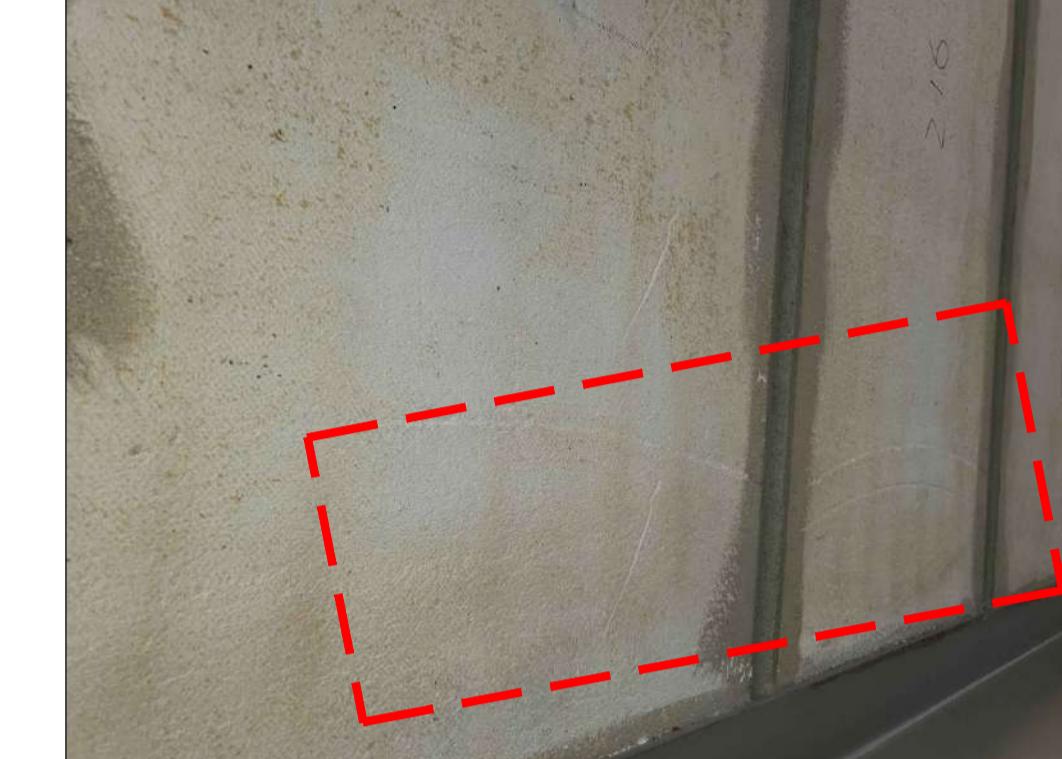
PHOTO 92 - PLANK No. 218 & 219
SCAR AT END 1

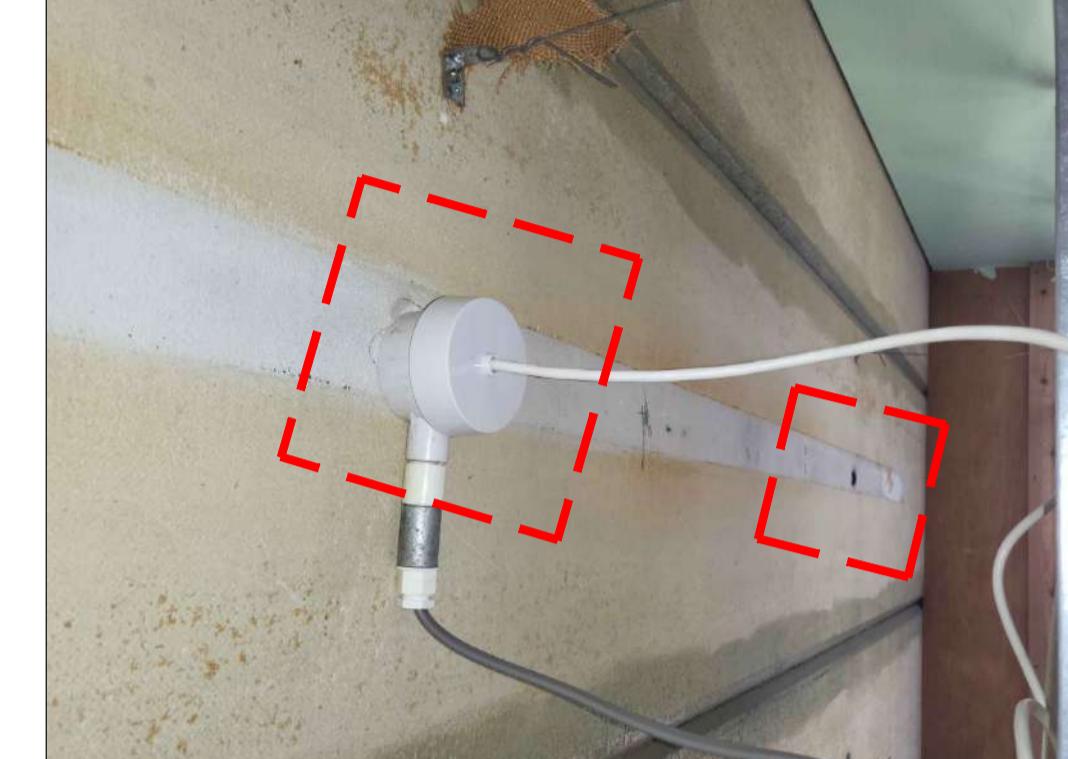
PHOTO 94 - PLANK No. 217
2No. SERVICE HOLES

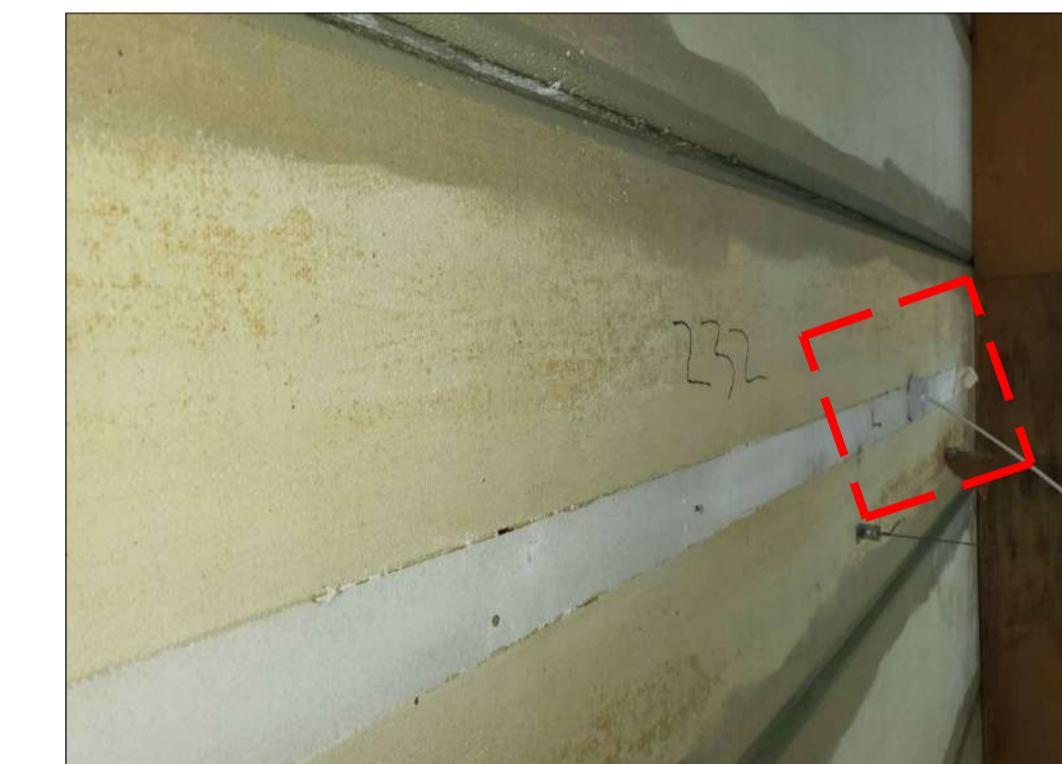
PHOTO 97 - PLANK No. 221
SCAR AT END 2

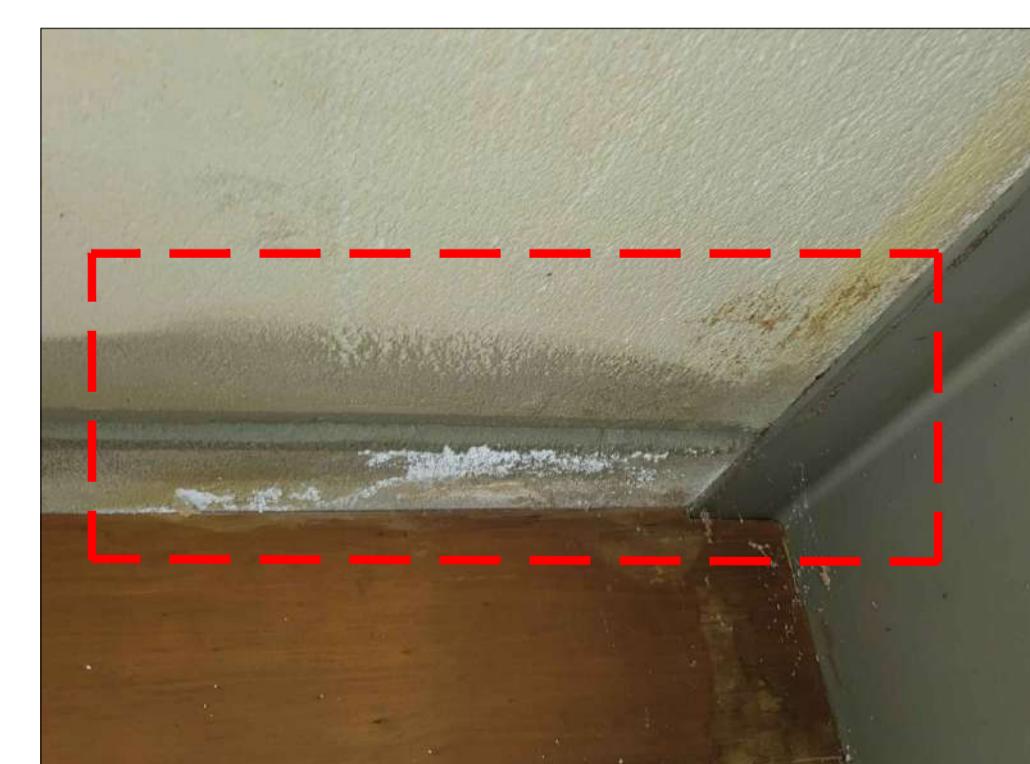
PHOTO 101 - PLANK No. 236
2No. SERVICE HOLES
